Facilities Study - Summary of Findings

August 21, 2019

Facilities Study Document - Malone Elementary

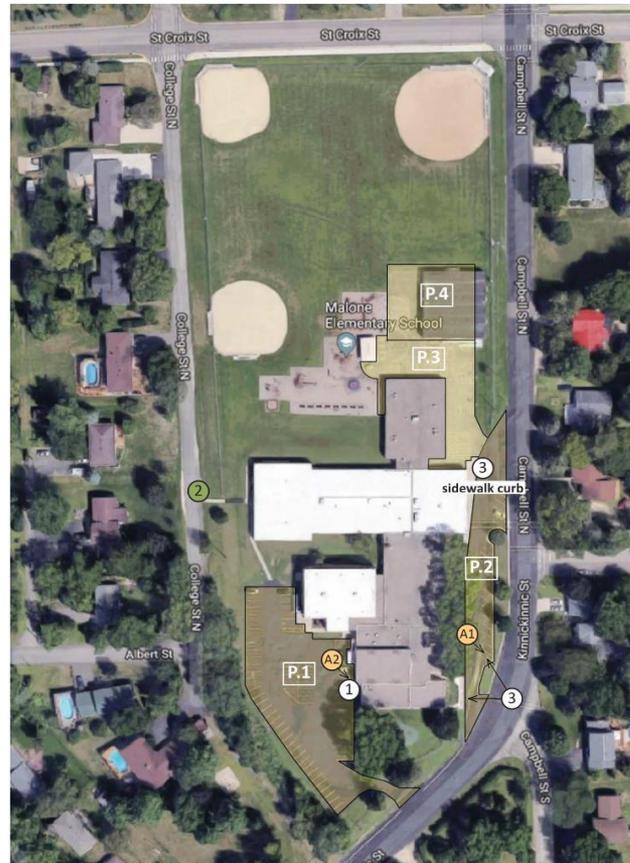
- ① Damage/worn stoop
- ② Bus drop off is not ideal for supervision or building access
- ③ Concentrated area of damage/worn paving

Paved Area P.1
Description: Faculty Parking
Type: Asphalt
Area: Approx. 27,100 SF
Rating: 6

Paved Area P.2
Description: Visitor Parking
Type: Asphalt
Area: Approx. 12,600 SF
Rating: 5-6

Paved Area P.3
Description: Playground
Type: Asphalt
Area: Approx. 11,750 SF
Rating: 3-4

Paved Area P.4
Description: Playground
Type: Asphalt
Area: Approx. 10,620 SF
Rating: 8-9

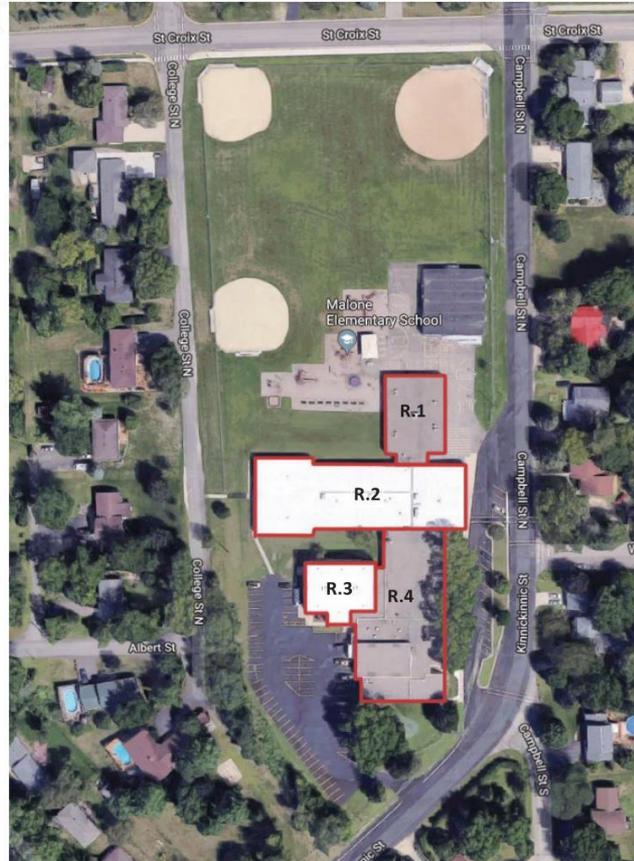
Roof Area R.1

- Roof Type: BUR
- Area: 7,790 SF
- Year Installed: 2001
- Condition: Fair
- Current Age: 18 years

Roof Area R.2

- Roof Type: TPO
- Area: 22,170 SF
- Year Installed: 2009
- Condition: Good
- Current Age: 10 years

Roof Area R.3

- Roof Type: TPO
- Area: 5,420 SF
- Year Installed: 2009
- Condition: Good
- Current Age: 10 years

Roof Area R.4

- Roof Type: BUR
- Area: 21,260 SF
- Year Installed: 2001
- Condition: Fair
- Current Age: 18 years

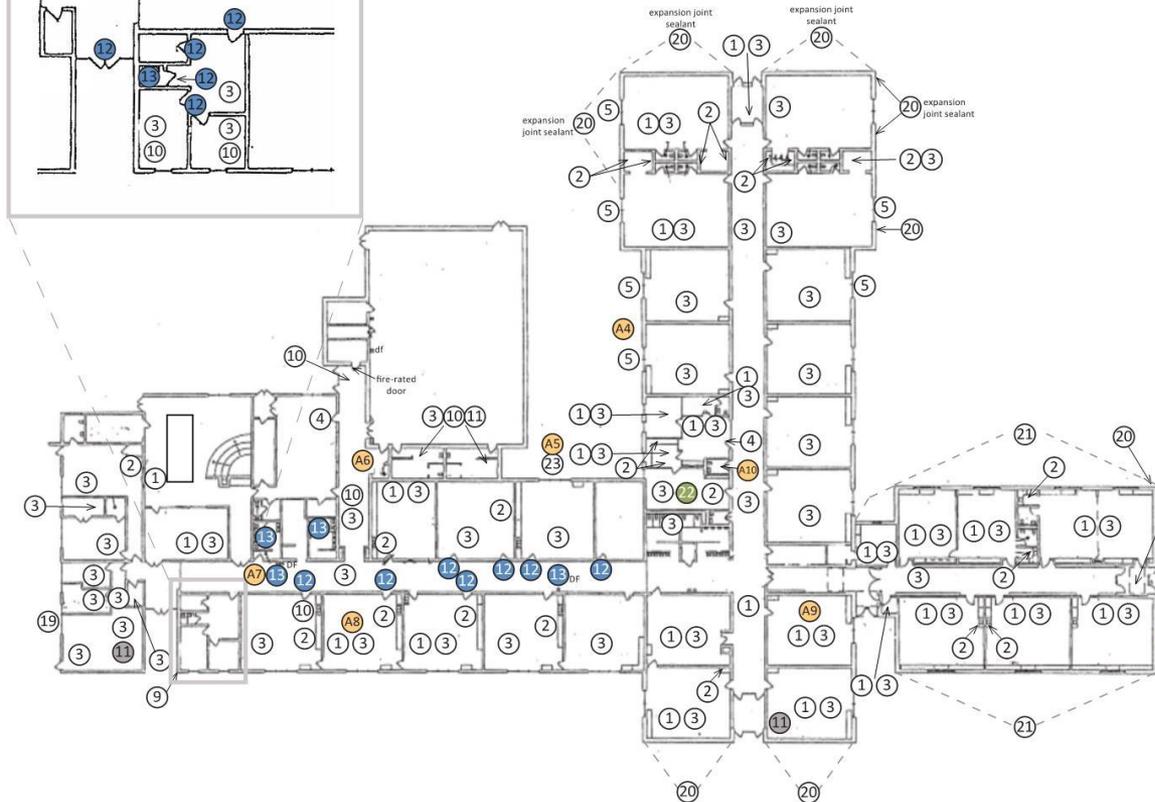
- ① Damaged/worn flooring
 - ② Damaged/worn casework
 - ③ Damaged/worn ceiling
 - ④ Damaged/worn door and/or door hardware
 - ⑤ Damaged/worn window
 - ⑥ Damaged/worn wall

- ⑦ Damaged/worn plumbing fixtures
 - ⑧ Cracks along foundation wall
 - ⑨ Water related wall damage
 - ⑩ Water related ceiling damage
 - ⑪ Inefficient or improper use of space

- ⑫ ADA non-compliant accessible route/entry/reach
 - ⑬ ADA non-compliant toilet room/drinking fountain
 - ⑭ ADA non-compliant locker room/shower
 - ⑮ Code - Construction

- ⑯ Code - Exiting/Travel Distance
 - ⑰ Code - Stair/Ramp
 - ⑱ Possible Asbestos tile flooring
 - ⑲ Damaged/worn gutter
 - ⑳ Tuckpointing or expansion joint sealant in need of repair

- ㉑ Wall weeps and/or flashing needs repair
 - ㉒ No visual connection from Office to main entrance
 - ㉓ Damaged roof drain outlet and splash block
-
- Ⓜ Photos

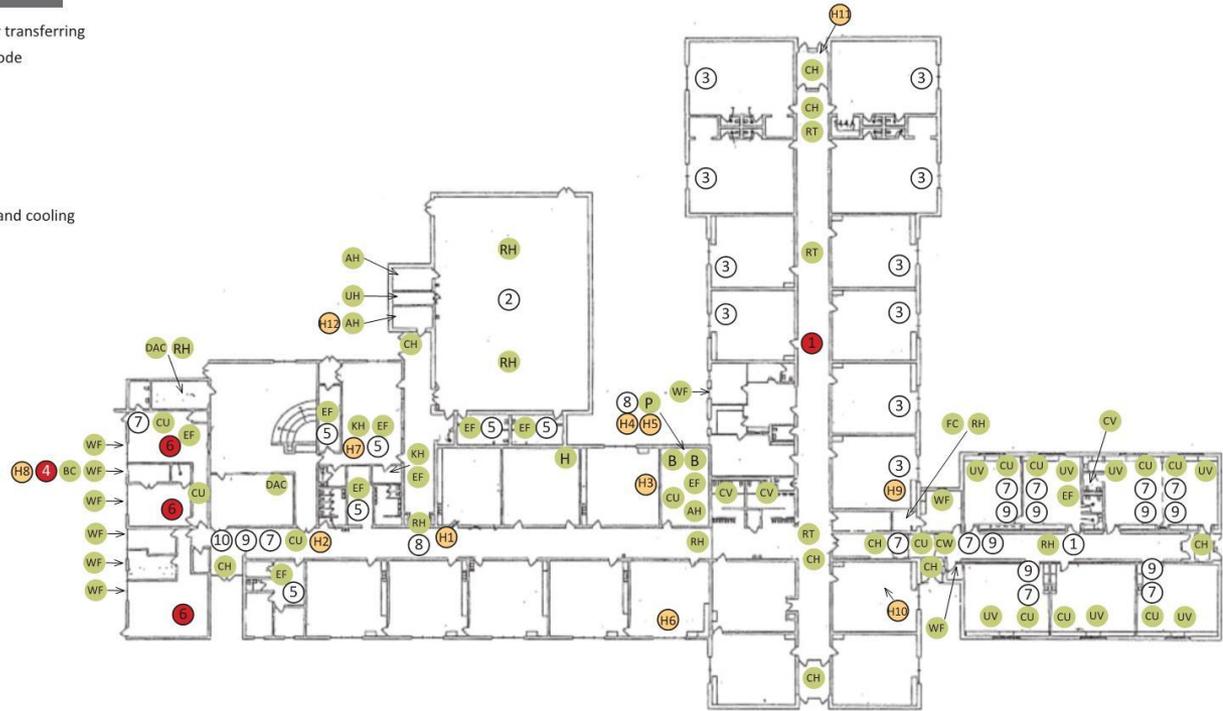
- 1 Corridor is being used as a relief air plenum with air transferring from rooms, code compliant at time of work. Not code compliant under current code
- 2 No air conditioning in gym
- 3 Unit ventilator abandoned in place
- 4 Provide ducted outside air to unit
- 5 Units approaching end of useful life
- 6 Upgrade controls to prevent simultaneous heating and cooling
- 7 R-22 refrigerant
- 8 Rust
- 9 Missing or damaged DX pipe insulation
- 10 Seal wall opening at DX pipe

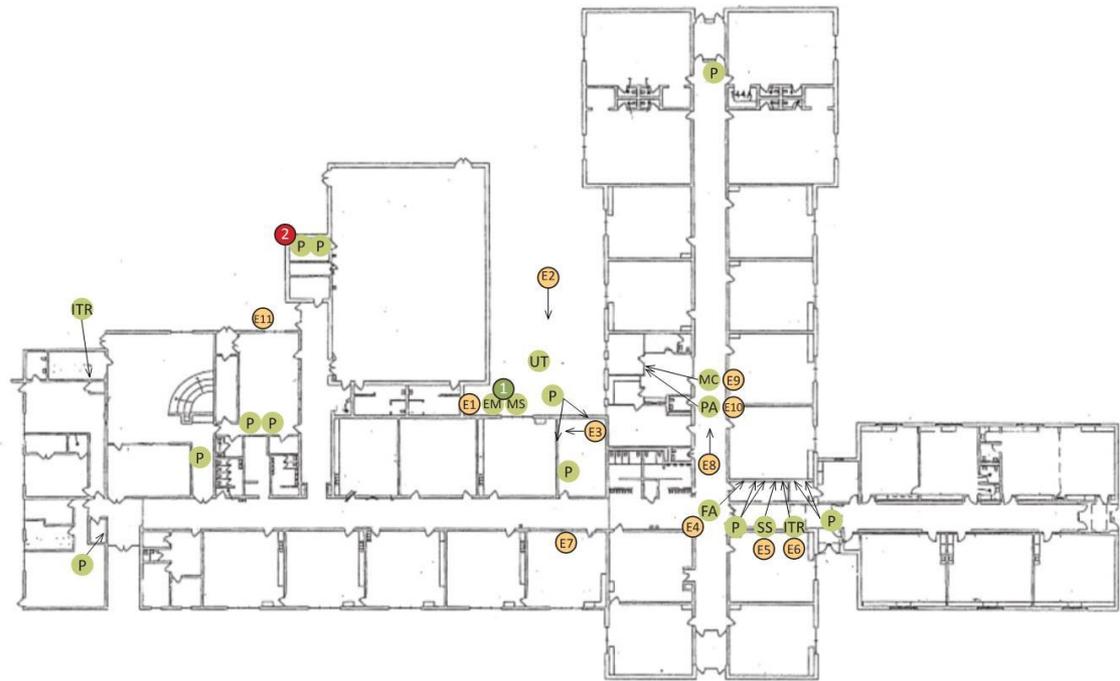
- 1 Electrical service panel has missing blank covers exposing live parts
- 2 Panelboard does not have required working clearances.

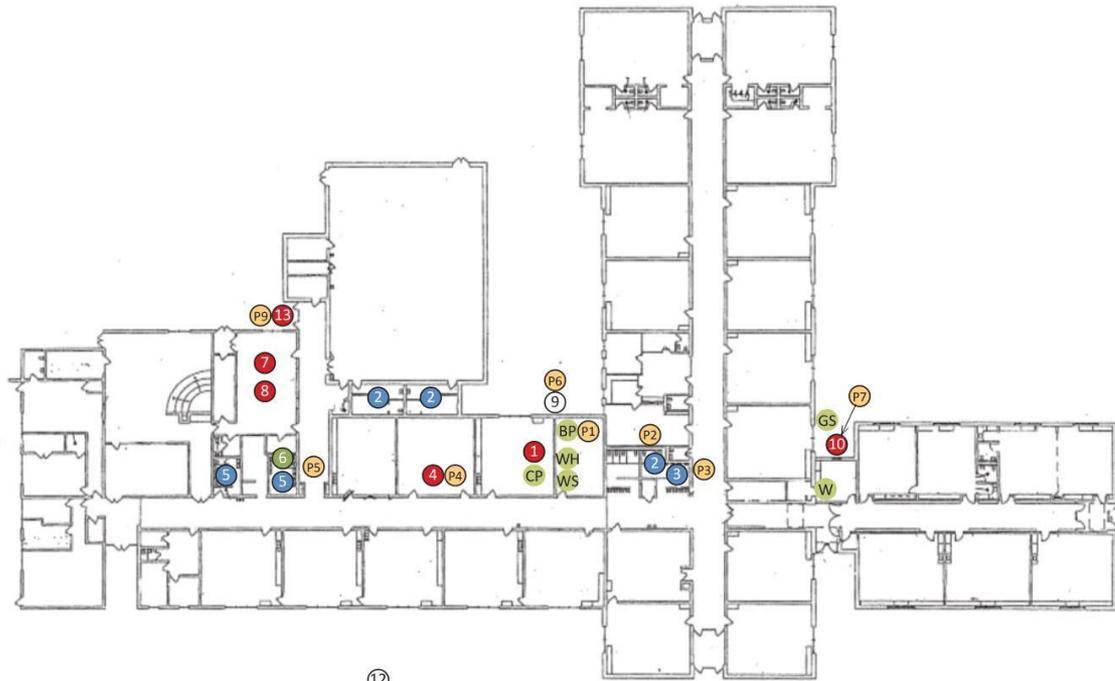
- 1 Hot water piping at new (2016) water heater is not insulated per code
- 2 Plumbing fixtures are not compliant with ADA Standards for Accessible Design

- 3 Reach distance at urinals for handle operation are not ADA compliant
- 4 Art room sink does not have solids/clay interceptor
- 5 Sinks do not have waste, trap, or supplies insulated per ADA standards

- 6 Urinals only flush all together by a gravity tank installed above; not able to flush individually; this is a sanitary and water consumption issue
- 7 Dishwasher and wash sinks should be discharging through a grease interceptor

- 8 Prep sink waste is not connected to the sanitary by way of air gap connection
- 9 Rain leader discharges to grade (no freeze protection)
- 10 No cover at sanitary clean out

- 11 Guard at drinking fountain has broken off
- 12 Several exterior hose bibs are no longer functioning, unable to obtain parts for repair
- 13 Exterior hose bib is in an undesirable location; potential trip hazard when in use and hose lays in front of doors

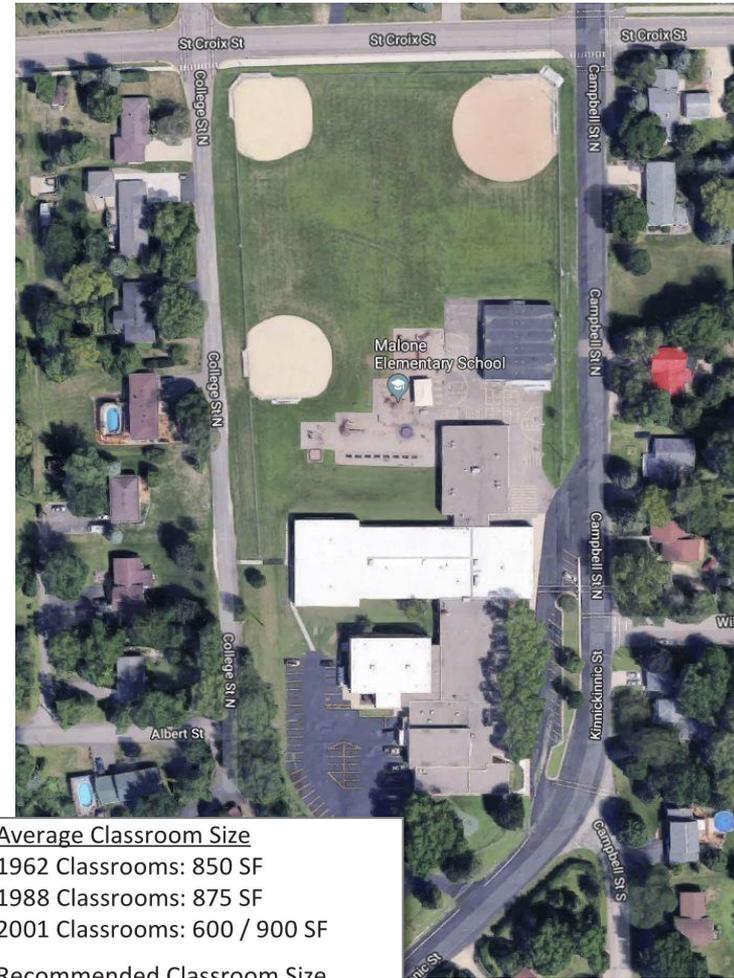
- 1963 Original Construction, 1988 Addition, 2001 Addition
- Identified issues to note:
 - Bus drop off is not ideal for supervision or building access
 - Limited off-street parking
 - **No visual connection from Office to front entrance (Security)**
 - Finish and cosmetic updates
 - Roofing replacement
 - HVAC items are minor; no A/C in Gym/Cafeteria; upgrade recommended in south rooms
 - Electrical systems are reaching end of their useful life, some significant costs to replace; lighting and control upgrades
 - Plumbing items are minor, ADA non-compliant fixtures; majority of piping is original

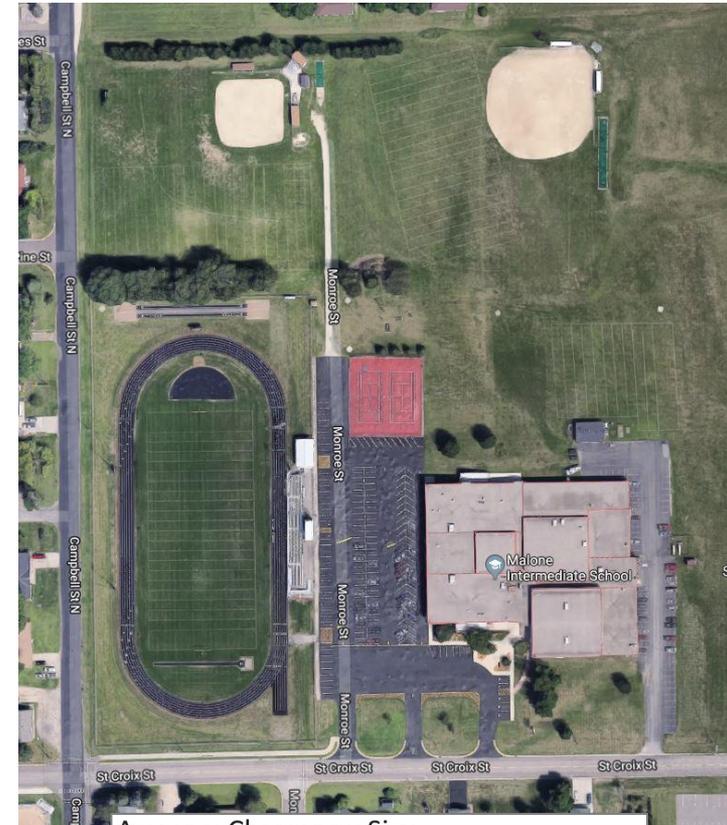
- 1968 Original Construction
- Most underutilized building; highest GSF/student
- Identified issues to note:
 - Parent drop not ideal
 - **No visual connection from Office to front entrance (Security)**
 - Finish and cosmetic updates
 - **Asbestos flooring in many areas**
 - ADA non-compliant door hardware in many areas
 - **No natural light in over half of the occupied areas**
 - Possible structural issues at several locations, further investigation needed
 - Acoustic transfer issues on lower level
 - **Roofing replacement: 24 years old and in fair/poor condition**
 - HVAC equipment on roof is original; some code issues in boiler room
 - Electrical systems are reaching end of their useful life; equipment room clearance issues; lighting controls upgrade; replace generator
 - Plumbing items are minor, ADA non-compliant fixtures; majority of piping is original

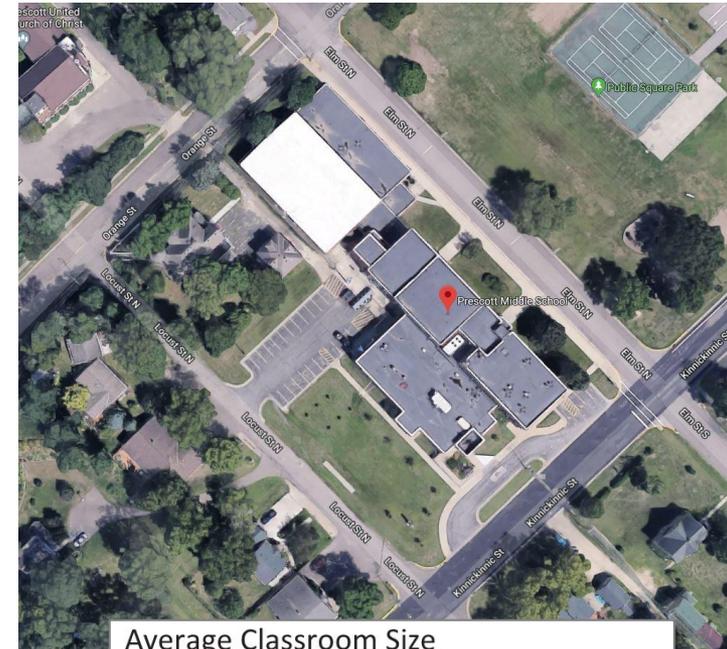
- 1924 Original Construction, 1955 Addition, 1963 Addition, 2004 Addition
- Most inefficient building
- Identified issues to note:
 - Congested parent drop
 - Bus drop on street
 - Limited off-street parking
 - **No visual connection from Office to front entrance (Security)**
 - Some finish and cosmetic updates
 - **Classroom sizes**
 - Many repairs needed to building exterior
 - Majority of areas do not have A/C; three-story building contains aging equipment; did not receive ACT 32 upgrades
 - Some electrical systems are reaching end of their useful life, not as significant as other buildings; lighting upgrades
 - Plumbing items are minor, ADA non-compliant fixtures; majority of piping may be original
