THE SCHOOL DISTRICT OF  
**PRESCOTT**  
Prescott, Wisconsin

# Facilities Study

SDS PROJECT NO.: 1913  
SUMMER 2019

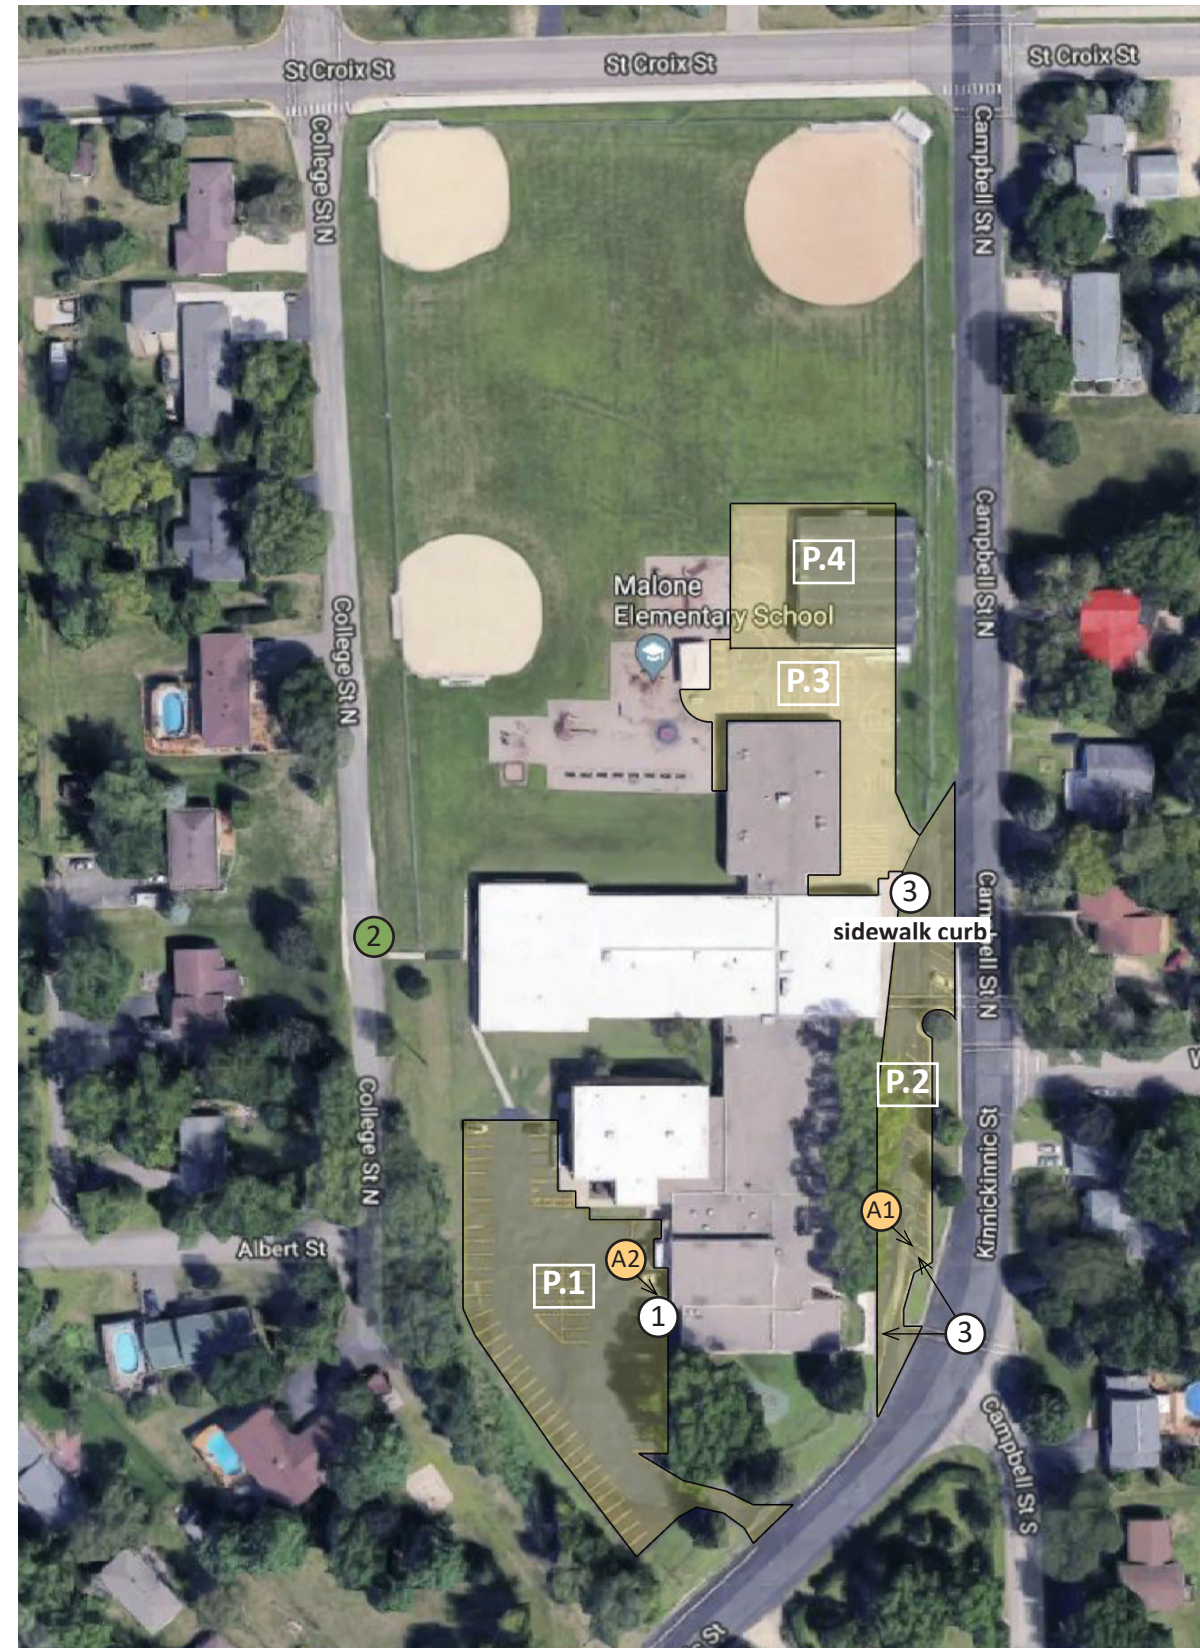
Site Analysis

- ① Damage/worn stoop
- ② Bus drop off is not ideal for supervision or building access
- ③ Concentrated area of damage/worn paving

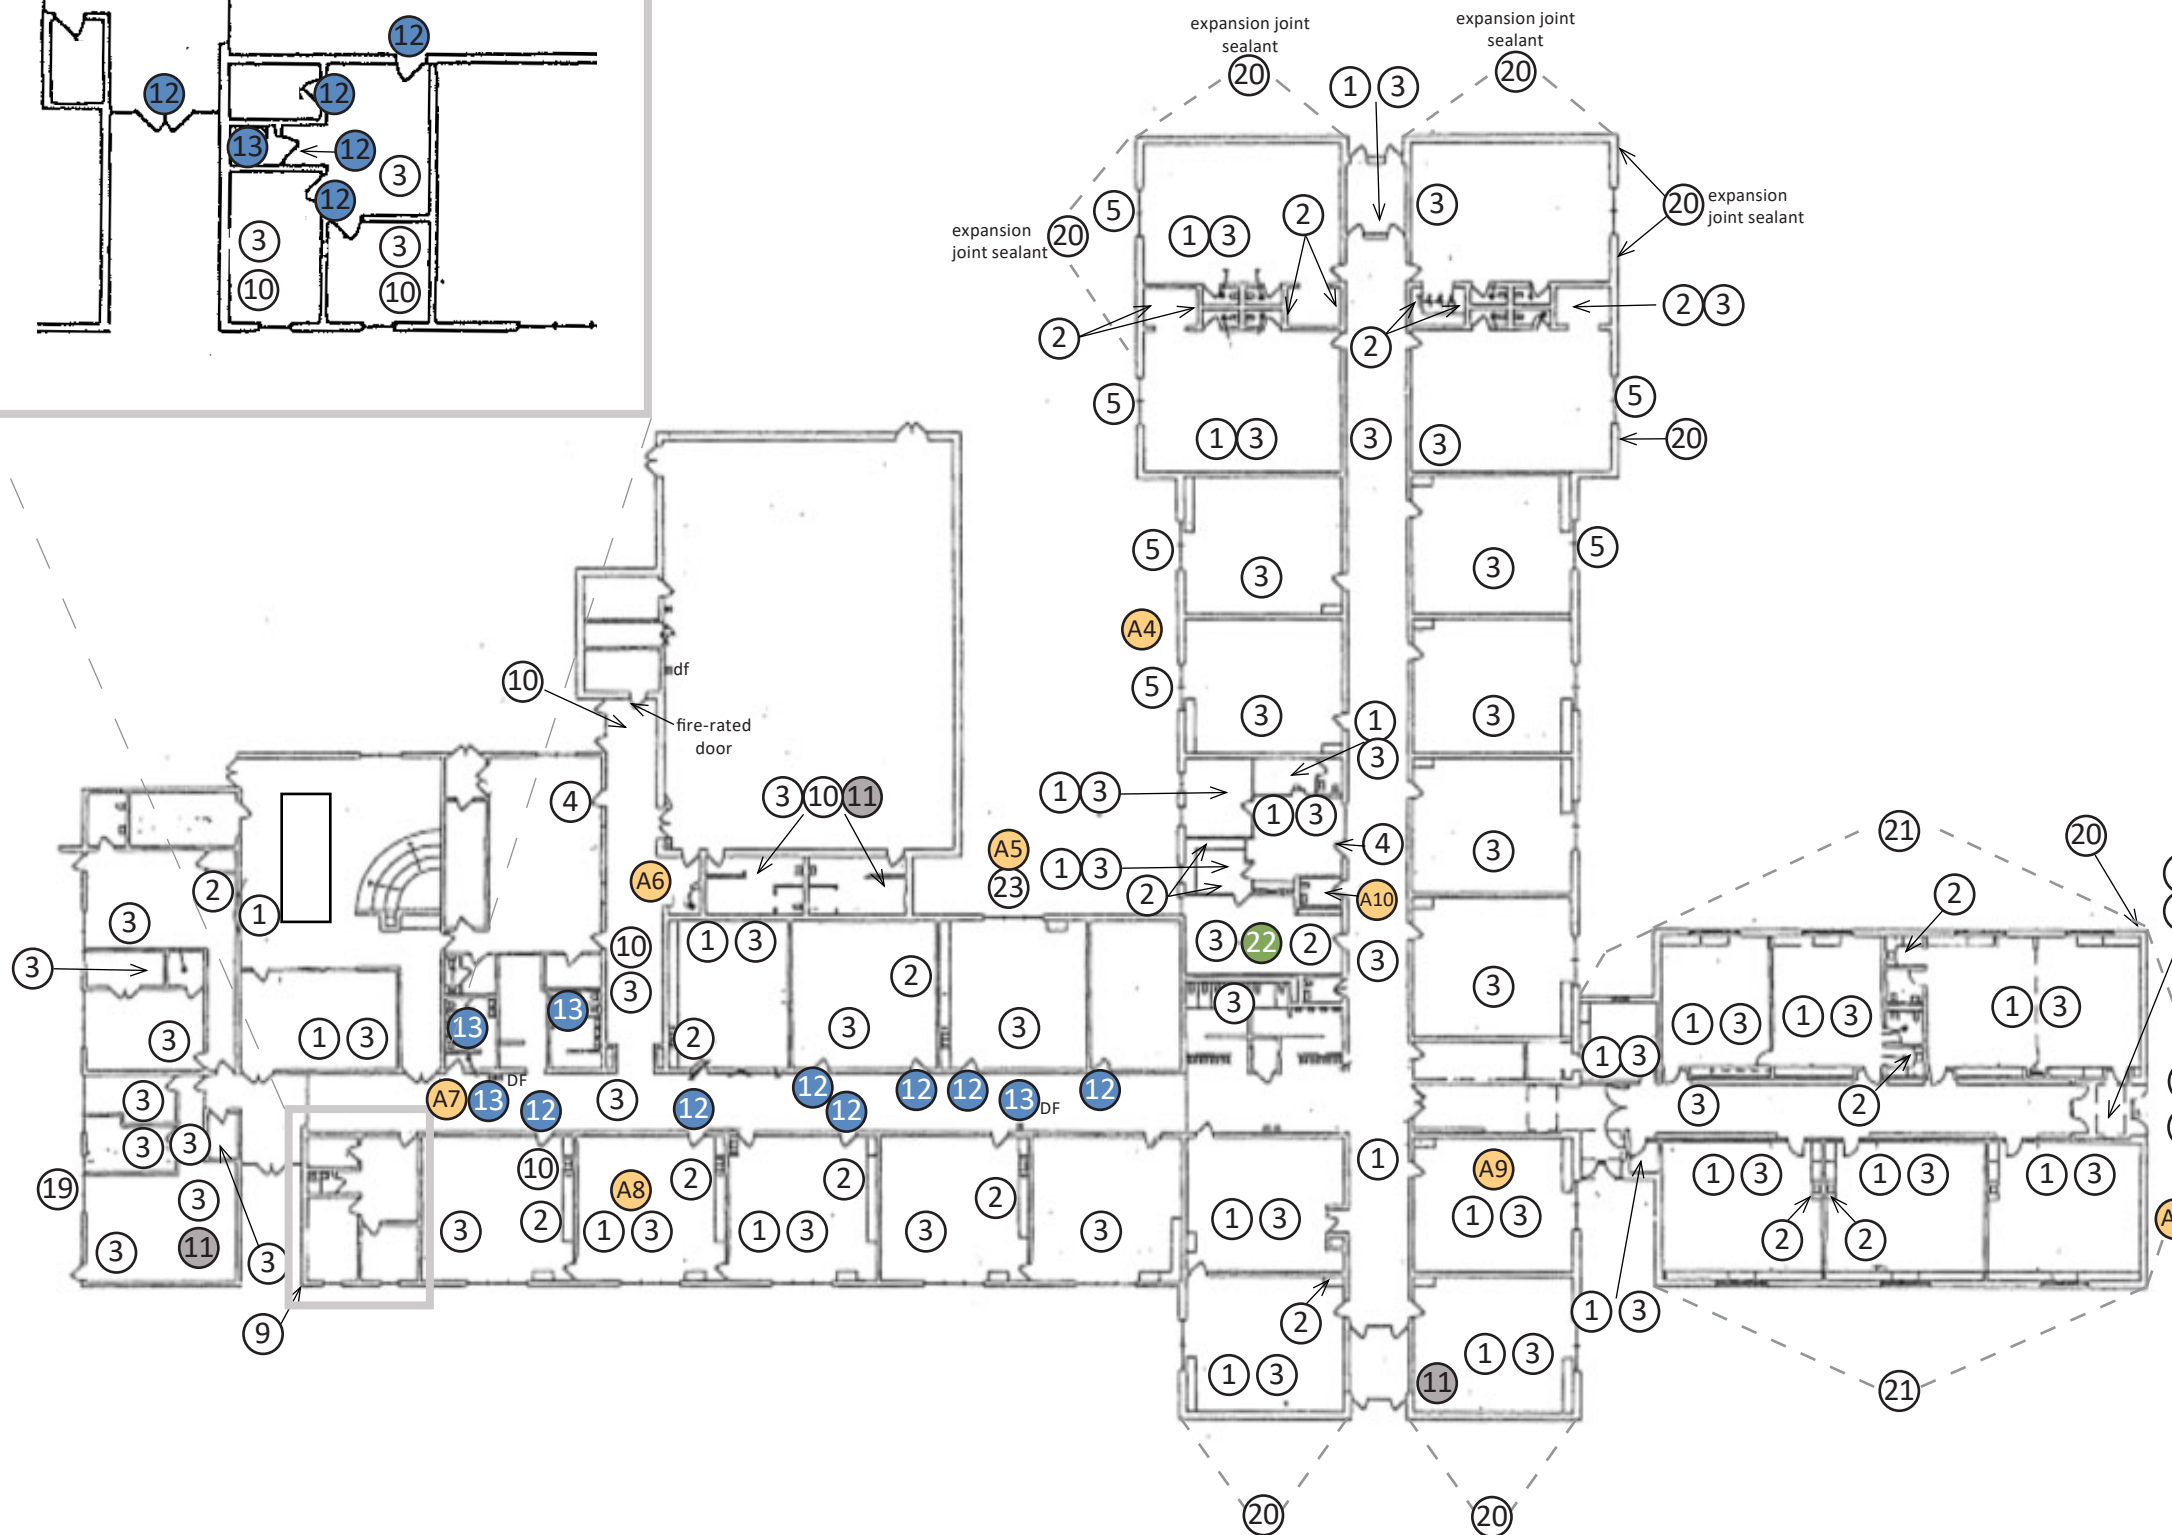
Floor Plan Analysis (not all notes will be used)

- ① Damaged/worn flooring
- ② Damaged/worn casework
- ③ Damaged/worn ceiling
- ④ Damaged/worn door and/or door hardware
- ⑤ Damaged/worn window
- ⑥ Damaged/worn wall
- ⑦ Damaged/worn plumbing fixtures
- ⑧ Cracks along foundation wall
- ⑨ Water related wall damage
- ⑩ Water related ceiling damage
- ⑪ Inefficient or improper use of space
- ⑫ ADA non-compliant accessible route/entry/reach
- ⑬ ADA non-compliant toilet room/drinking fountain
- ⑭ ADA non-compliant locker room/shower
- ⑮ Code - Construction
- ⑯ Code - Exiting/Travel Distance
- ⑰ Code - Stair/Ramp
- ⑱ Possible Asbestos tile flooring
- ⑲ Damaged/worn gutter
- ⑳ Tuckpointing or expansion joint sealant in need of repair
- ㉑ Wall weeps and/or flashing needs repair
- ㉒ No visual connection from Office to main entrance
- ㉓ Damaged roof drain outlet and splash block

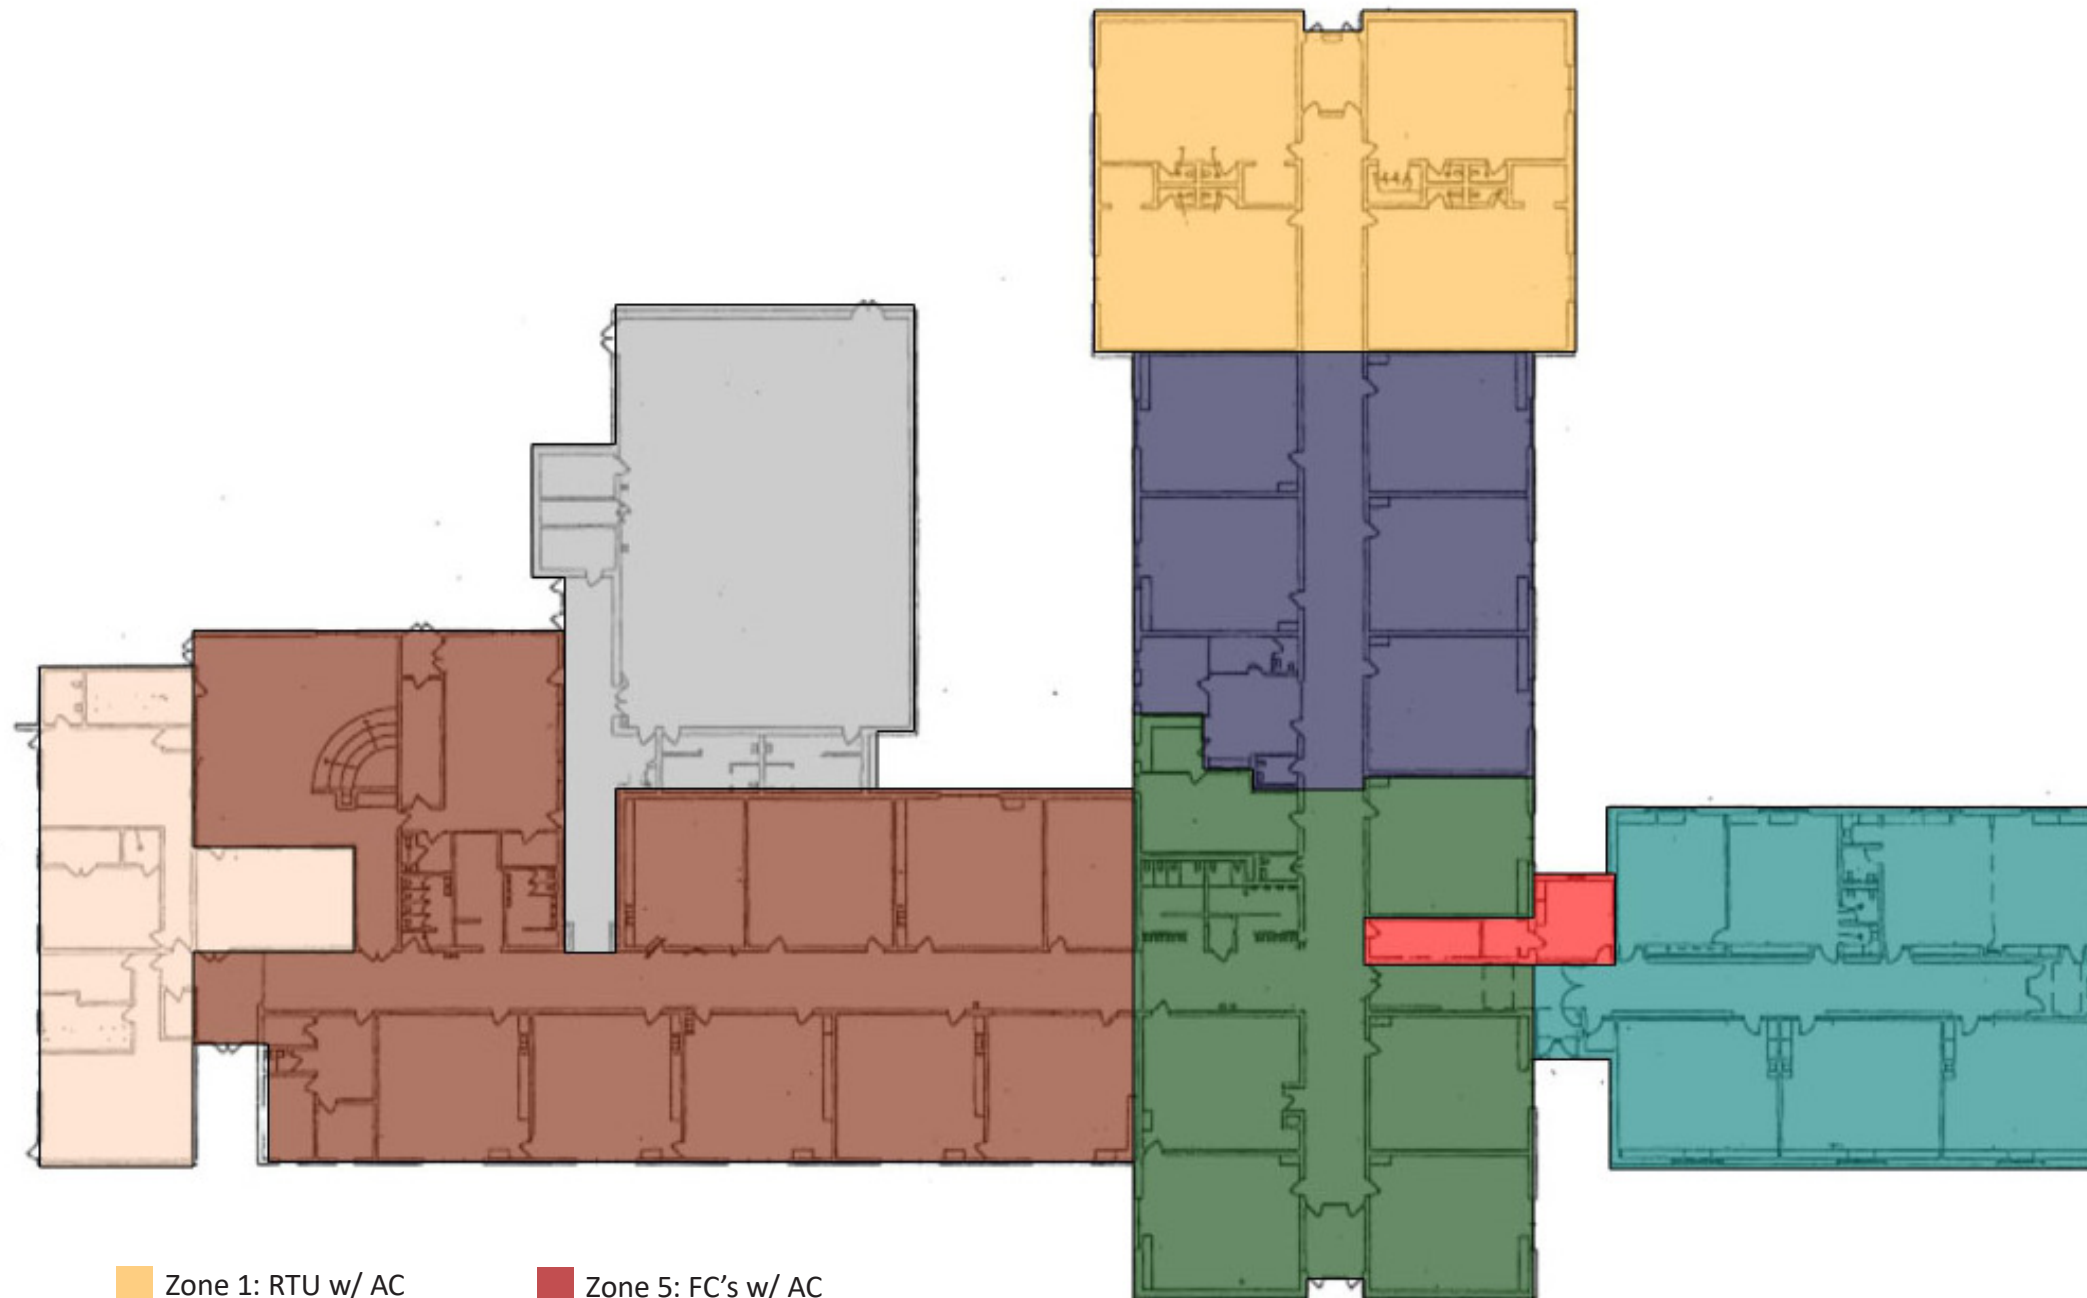
Mechanical Analysis - HVAC Zones

- Zone 1: RTU w/ AC
- Zone 2: RTU w/ AC
- Zone 3: RTU w/ AC
- Zone 4: AHU/VAV w/ AC
- Zone 5: FC's w/ AC
- Zone 6 - UV's w/ AC
- Zone 7 - AHU's w/ No AC
- Zone 8 - AHU w/ separate units added for AC

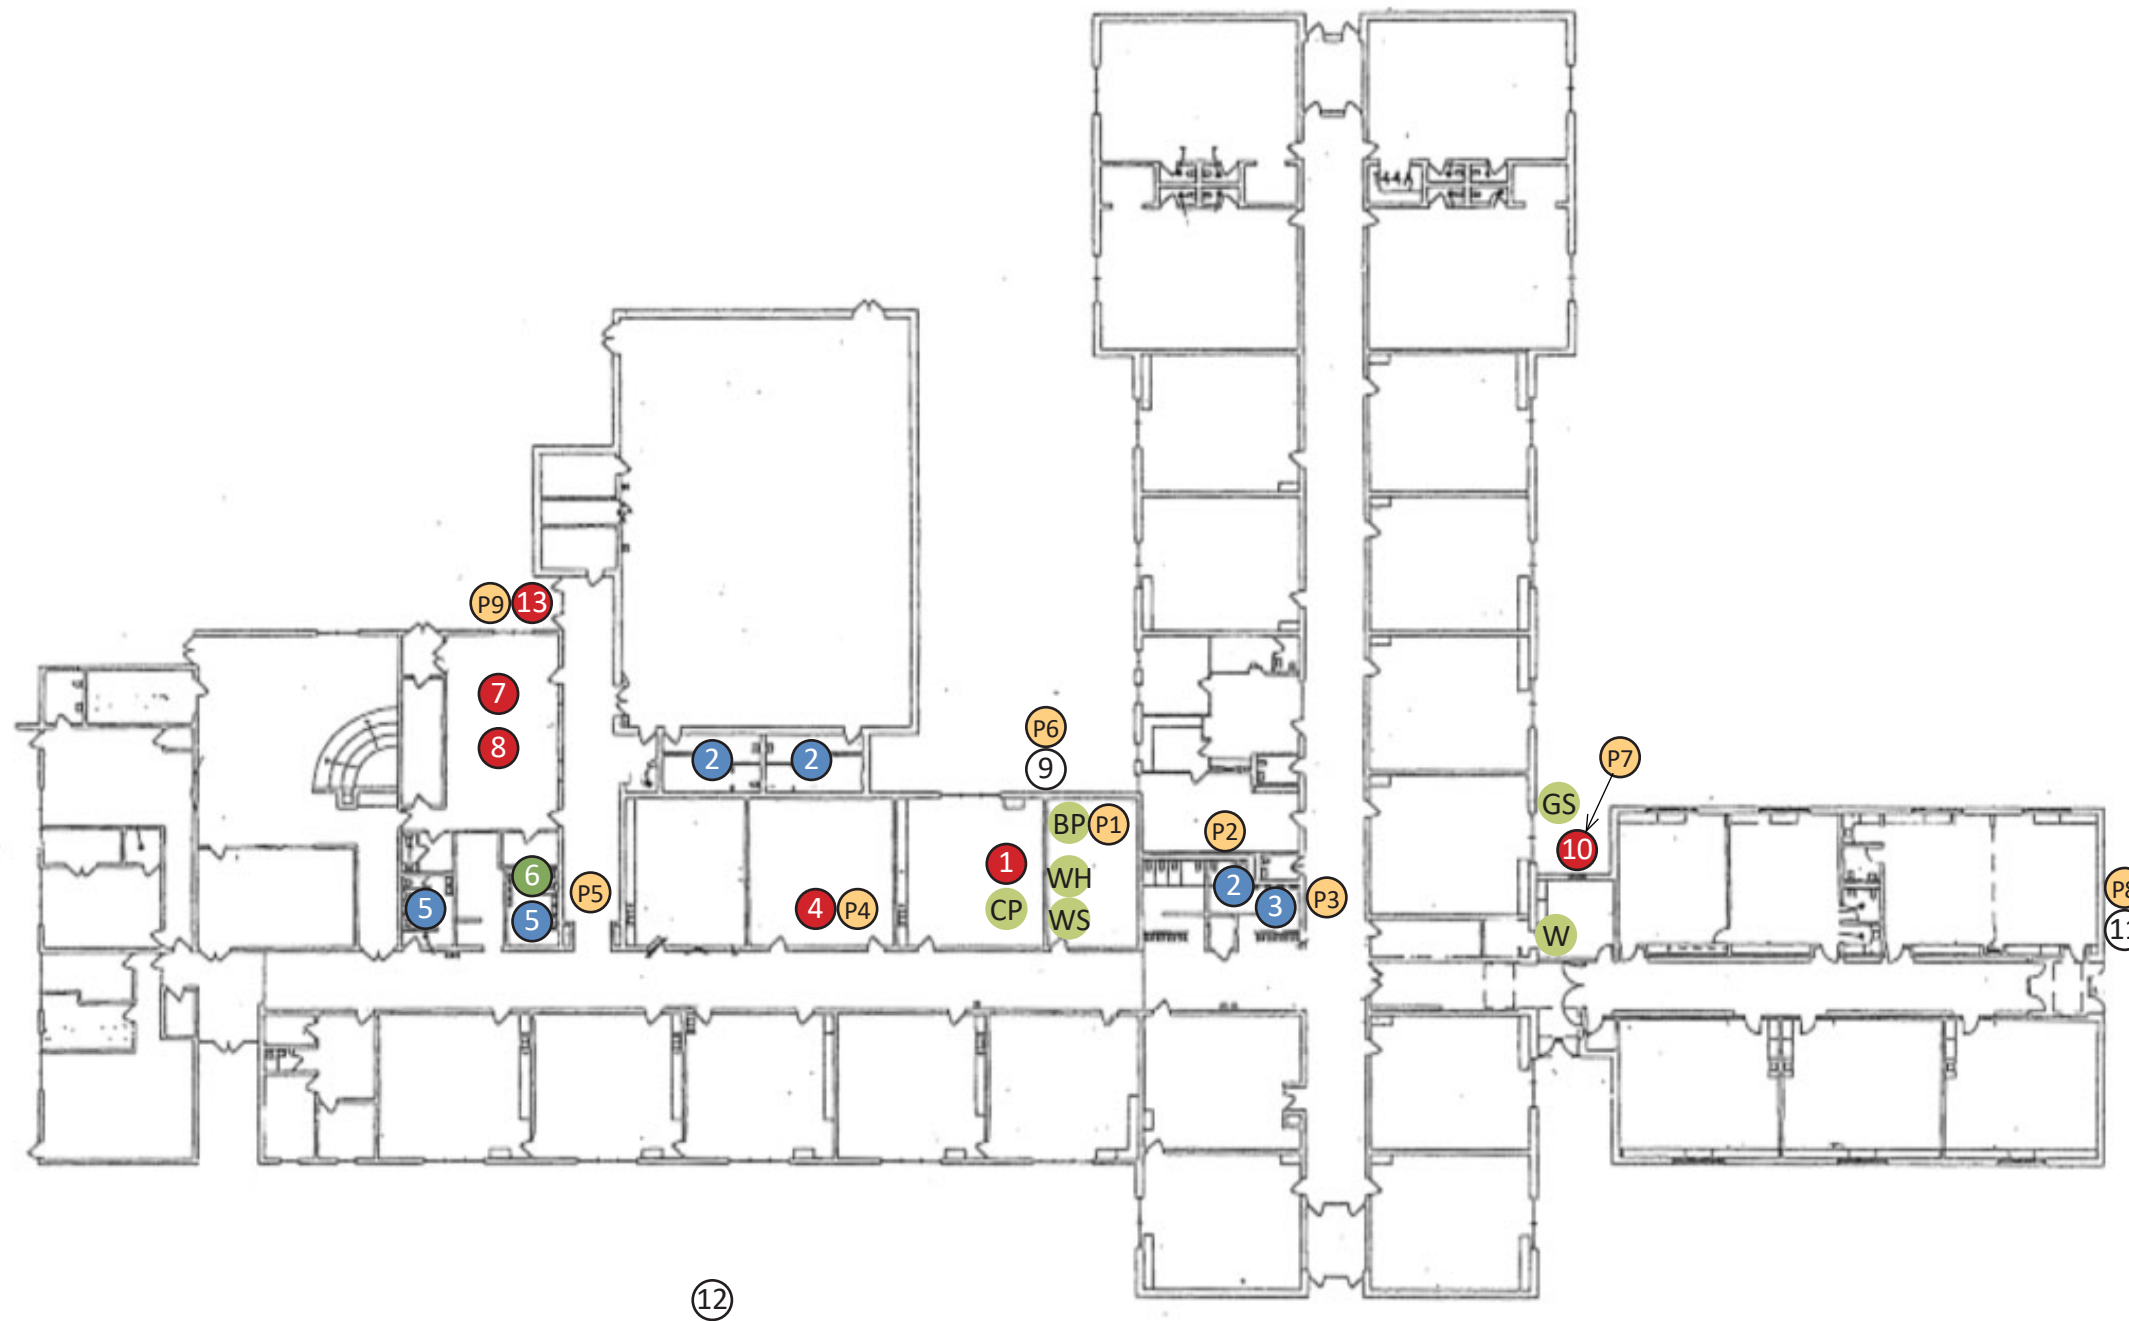
Plumbing Analysis

- 1 Hot water piping at new (2016) water heater is not insulated per code
- 2 Plumbing fixtures are not compliant with ADA Standards for Accessible Design

- 3 Reach distance at urinals for handle operation are not ADA compliant
- 4 Art room sink does not have solids/clay interceptor
- 5 Sinks do not have waste, trap, or supplies insulated per ADA standards

- 11 Guard at drinking fountain has broken off
- 12 Several exterior hose bibs are no longer functioning, unable to obtain parts for repair
- 13 Exterior hose bib is in an undesirable location; potential trip hazard when in use and hose lays in front of doors

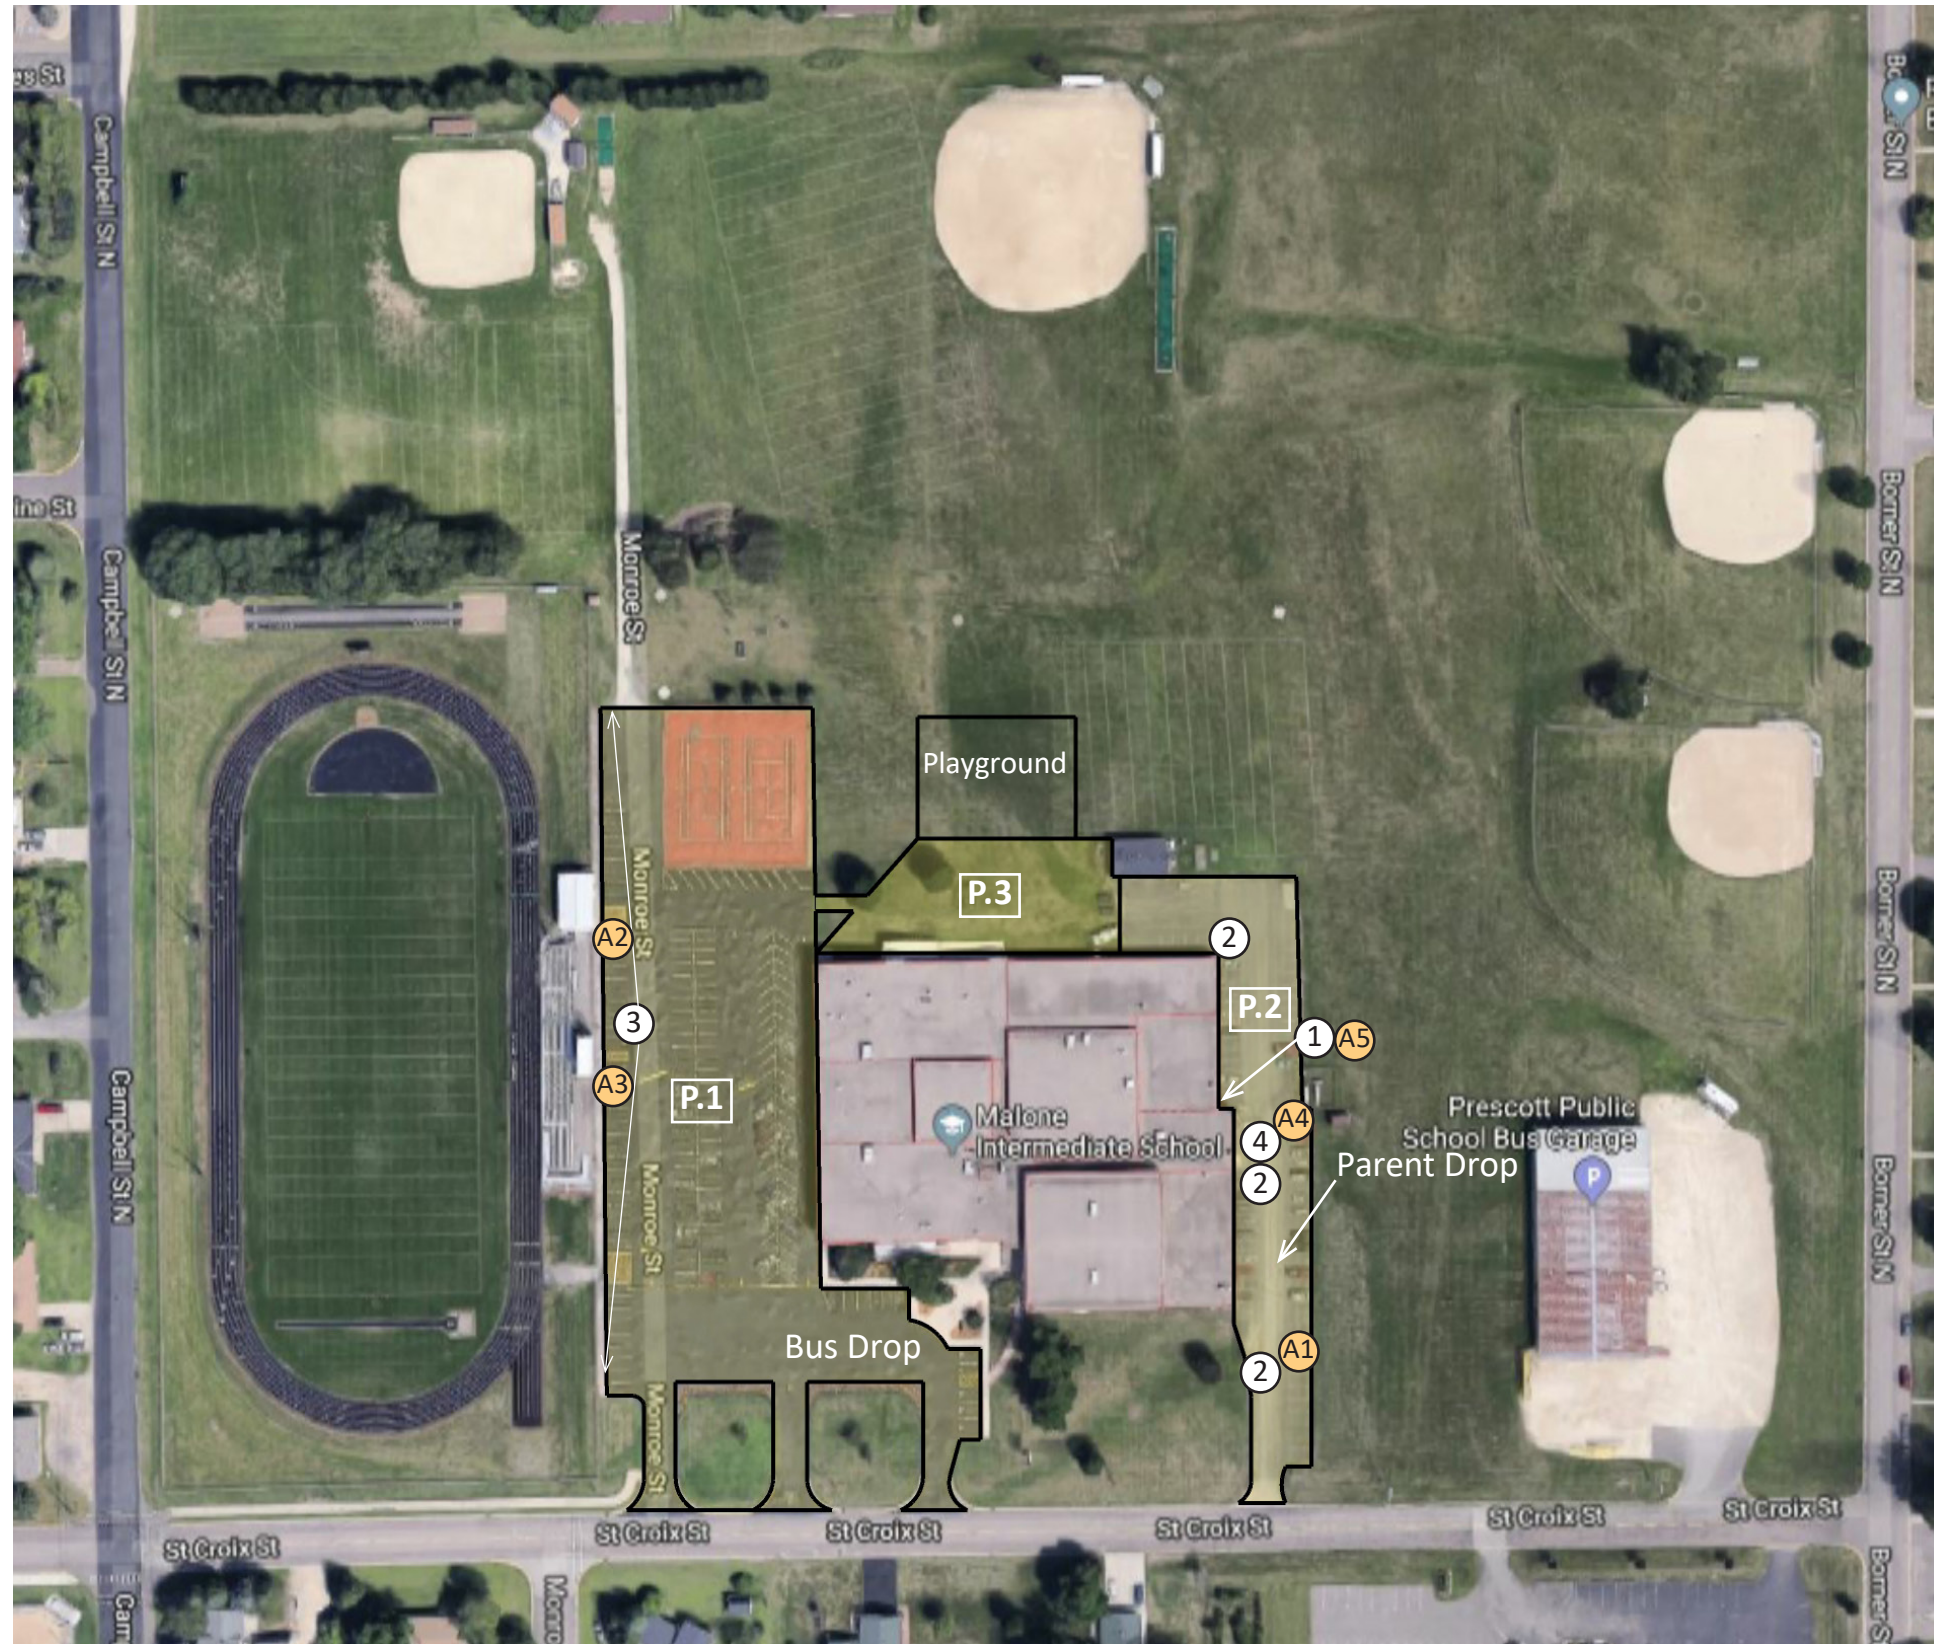
Site Analysis

- ① Roof overflow scupper located directly above electrical equipment
- ② Concentrated area of damage/worn paving
- ③ Curb area is damaged/worn
- ④ Stoop at entrance damaged/worn

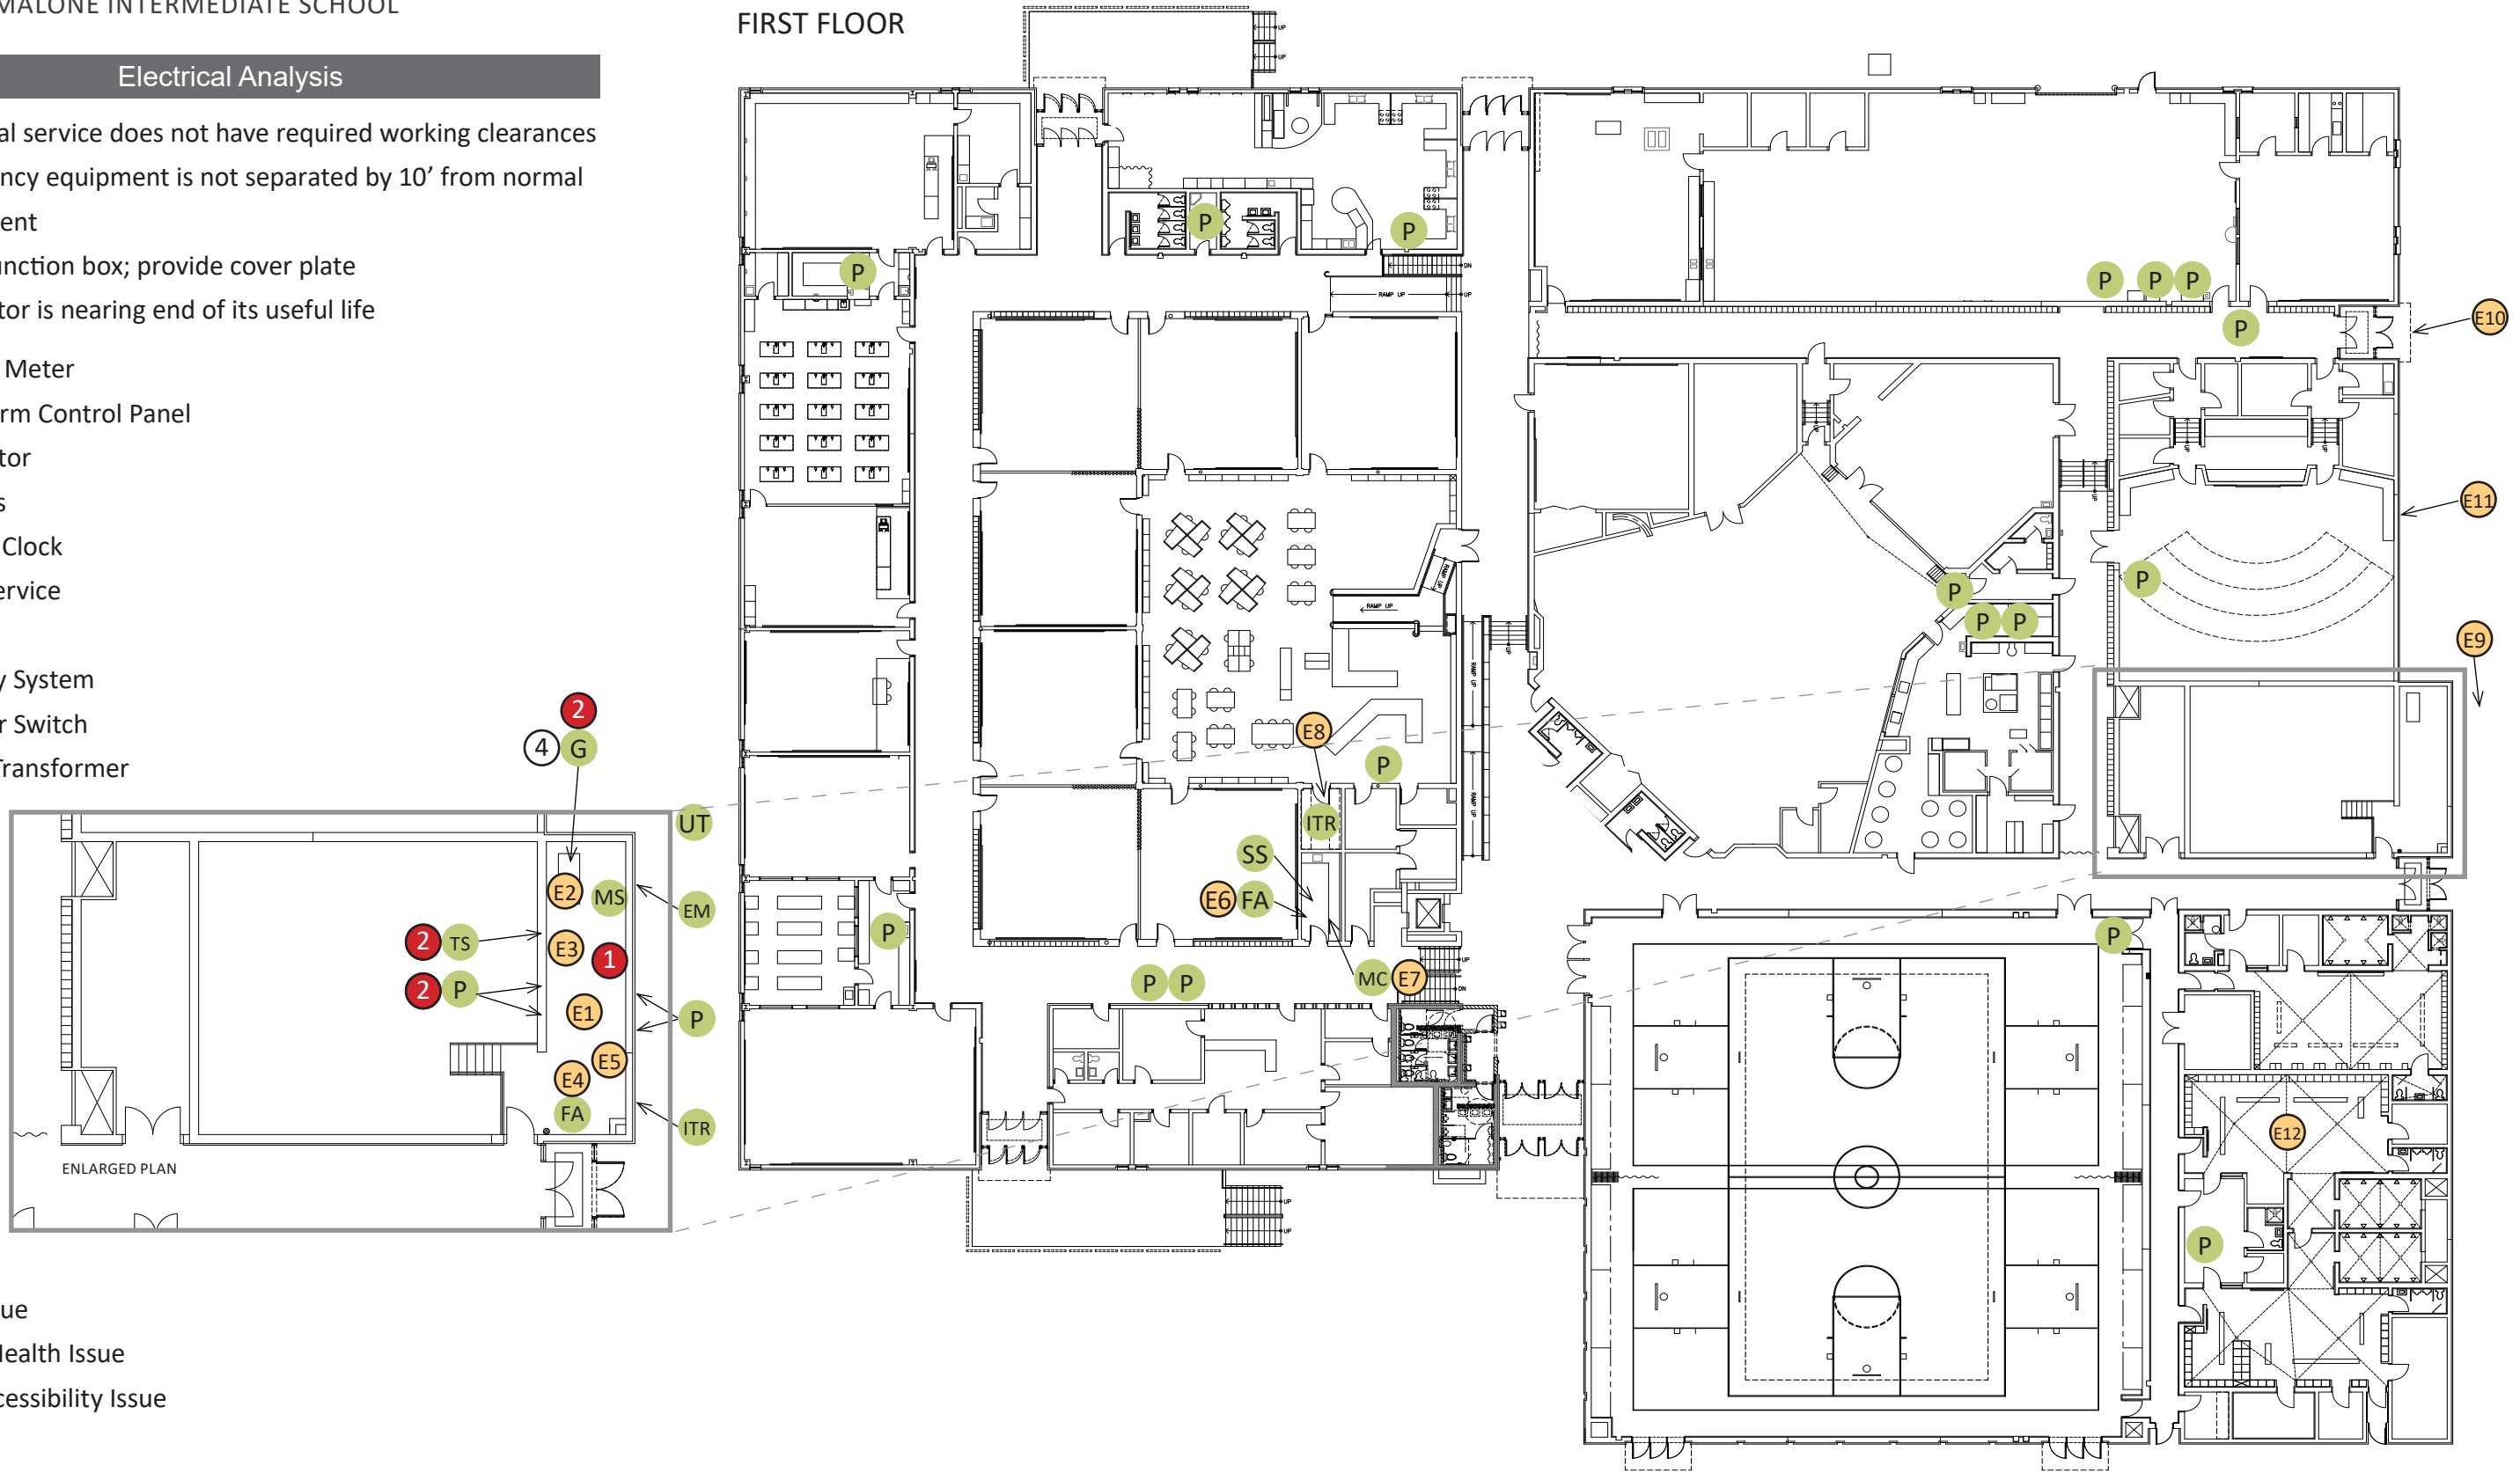
Electrical Analysis

- 1 Electrical service does not have required working clearances
- 2 Emergency equipment is not separated by 10' from normal equipment
- 3 Open junction box; provide cover plate
- 4 Generator is nearing end of its useful life

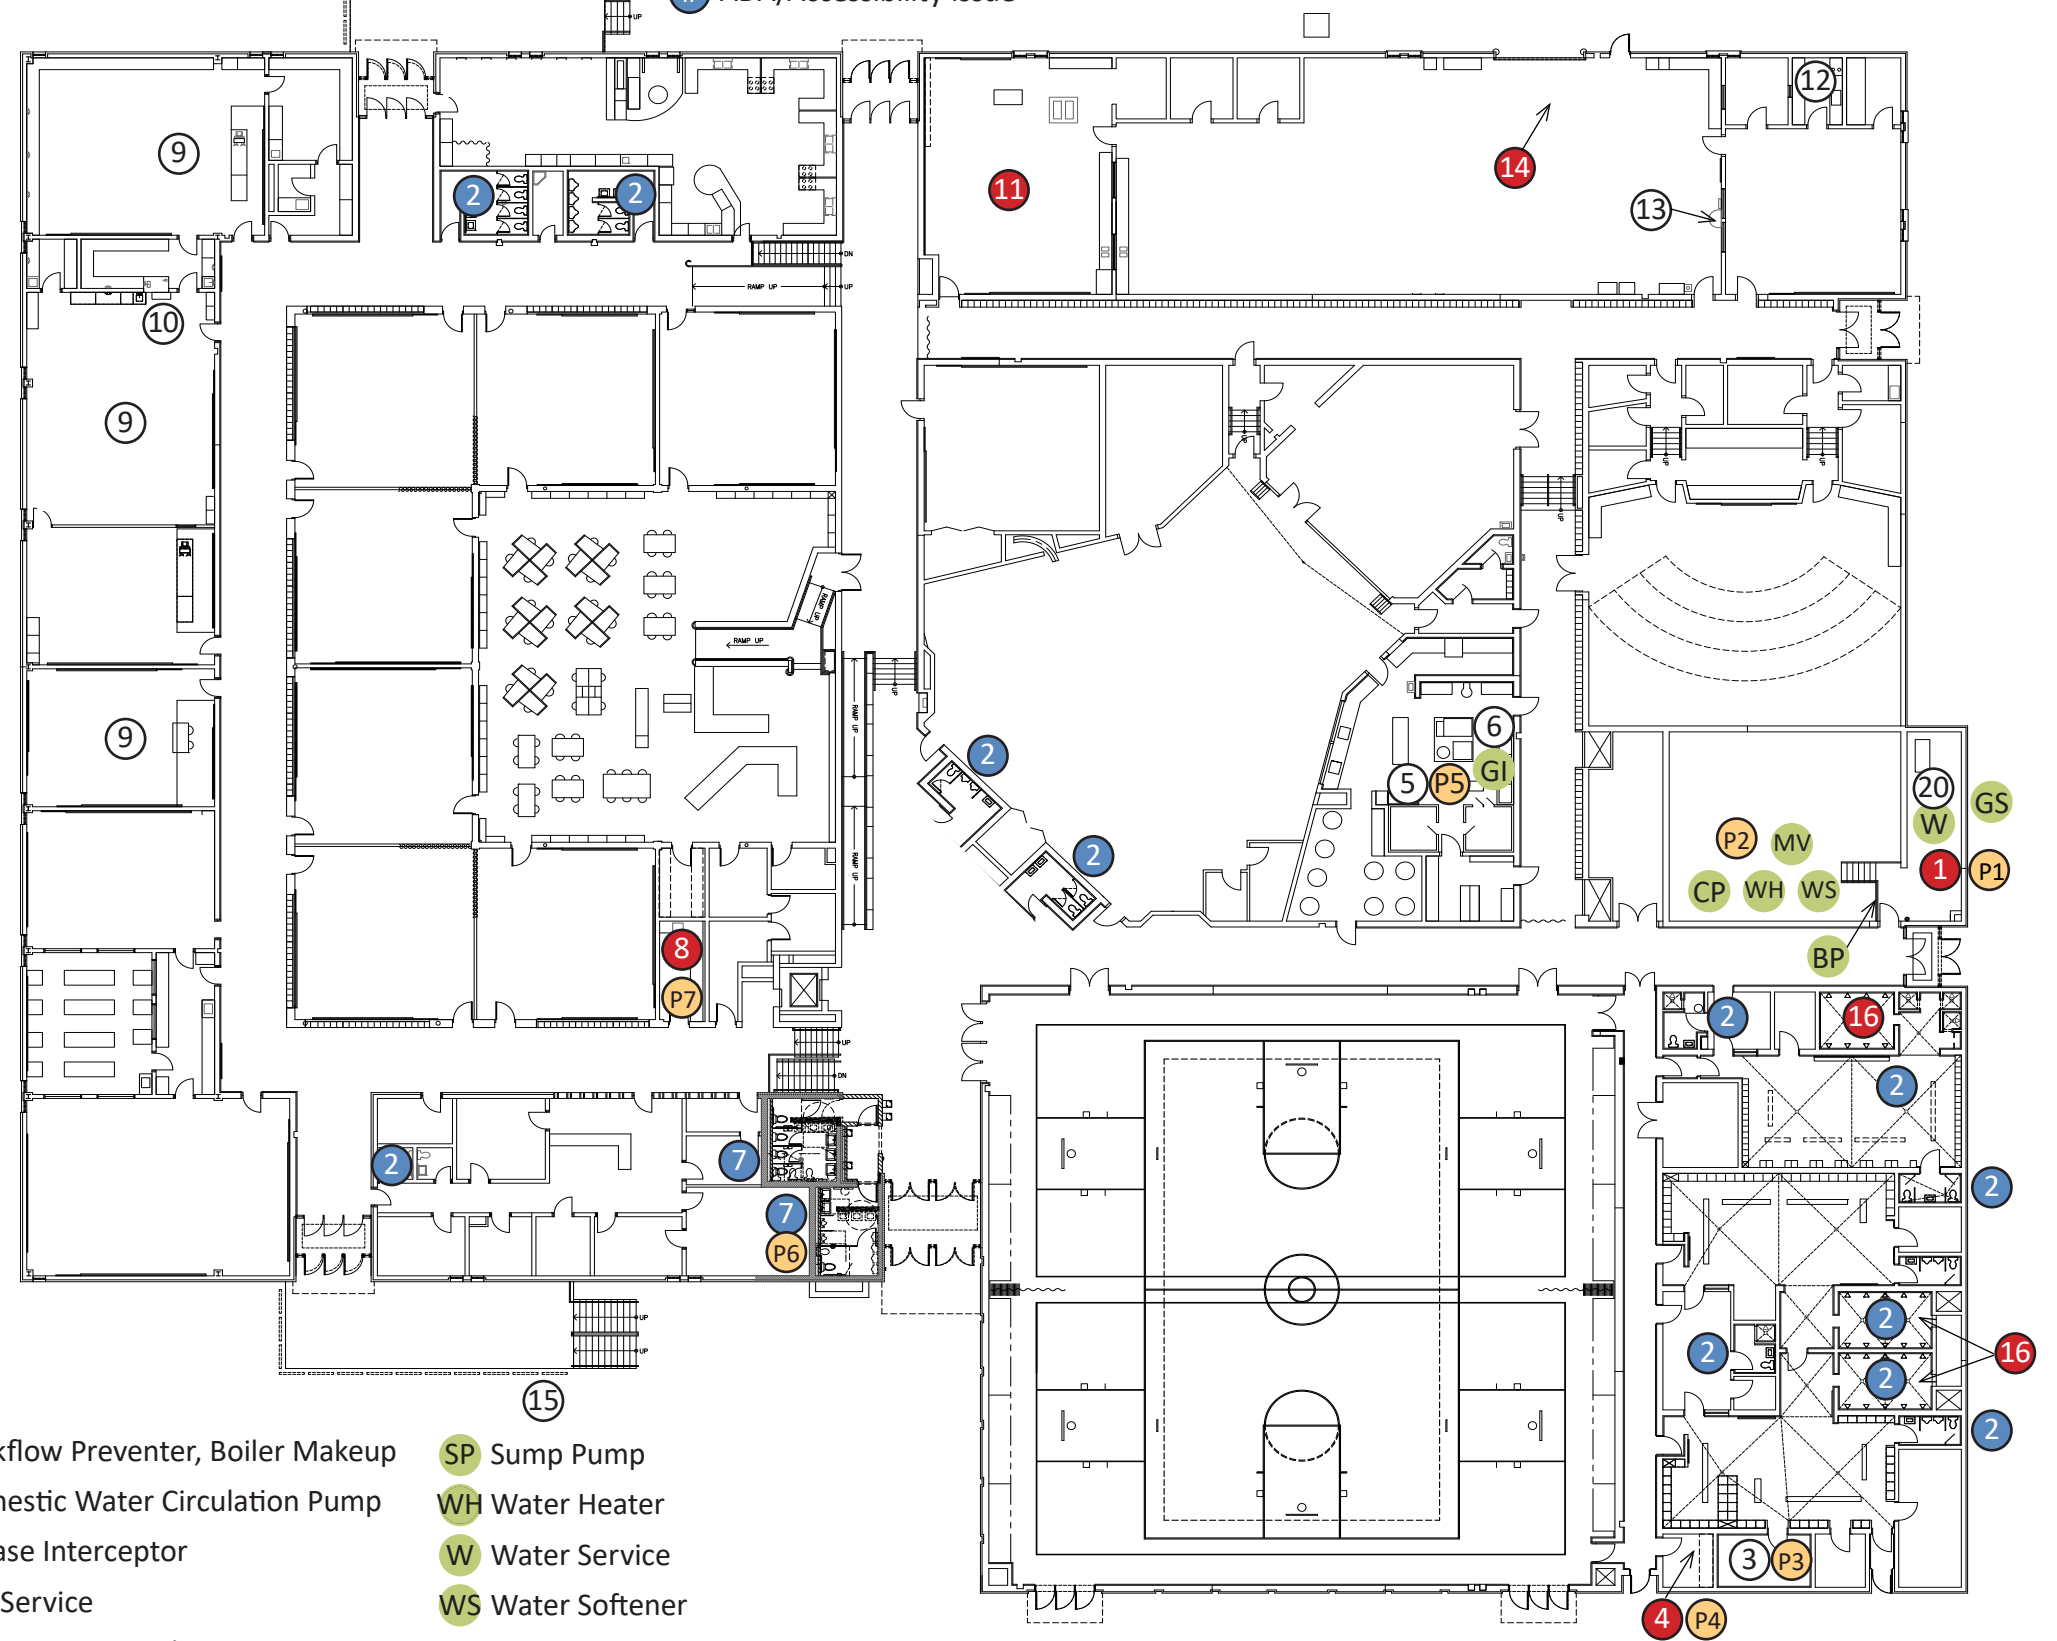
Plumbing Analysis

- 17 Reach distance at urinals for handle operation are not ADA compliant
- 18 Sinks do not have waste, trap, or supplies insulated per ADA standards
- 19 Double bowl sink is not ADA compliant for knee clearance; waste, trap and supplies are not insulated per ADA standards
- 20 No water filter at water service, maintenance issue
