THE SCHOOL DISTRICT OF  
**PRESCOTT**  
Prescott, Wisconsin

# Facilities Study

SDS PROJECT NO.: 1913  
SUMMER 2019

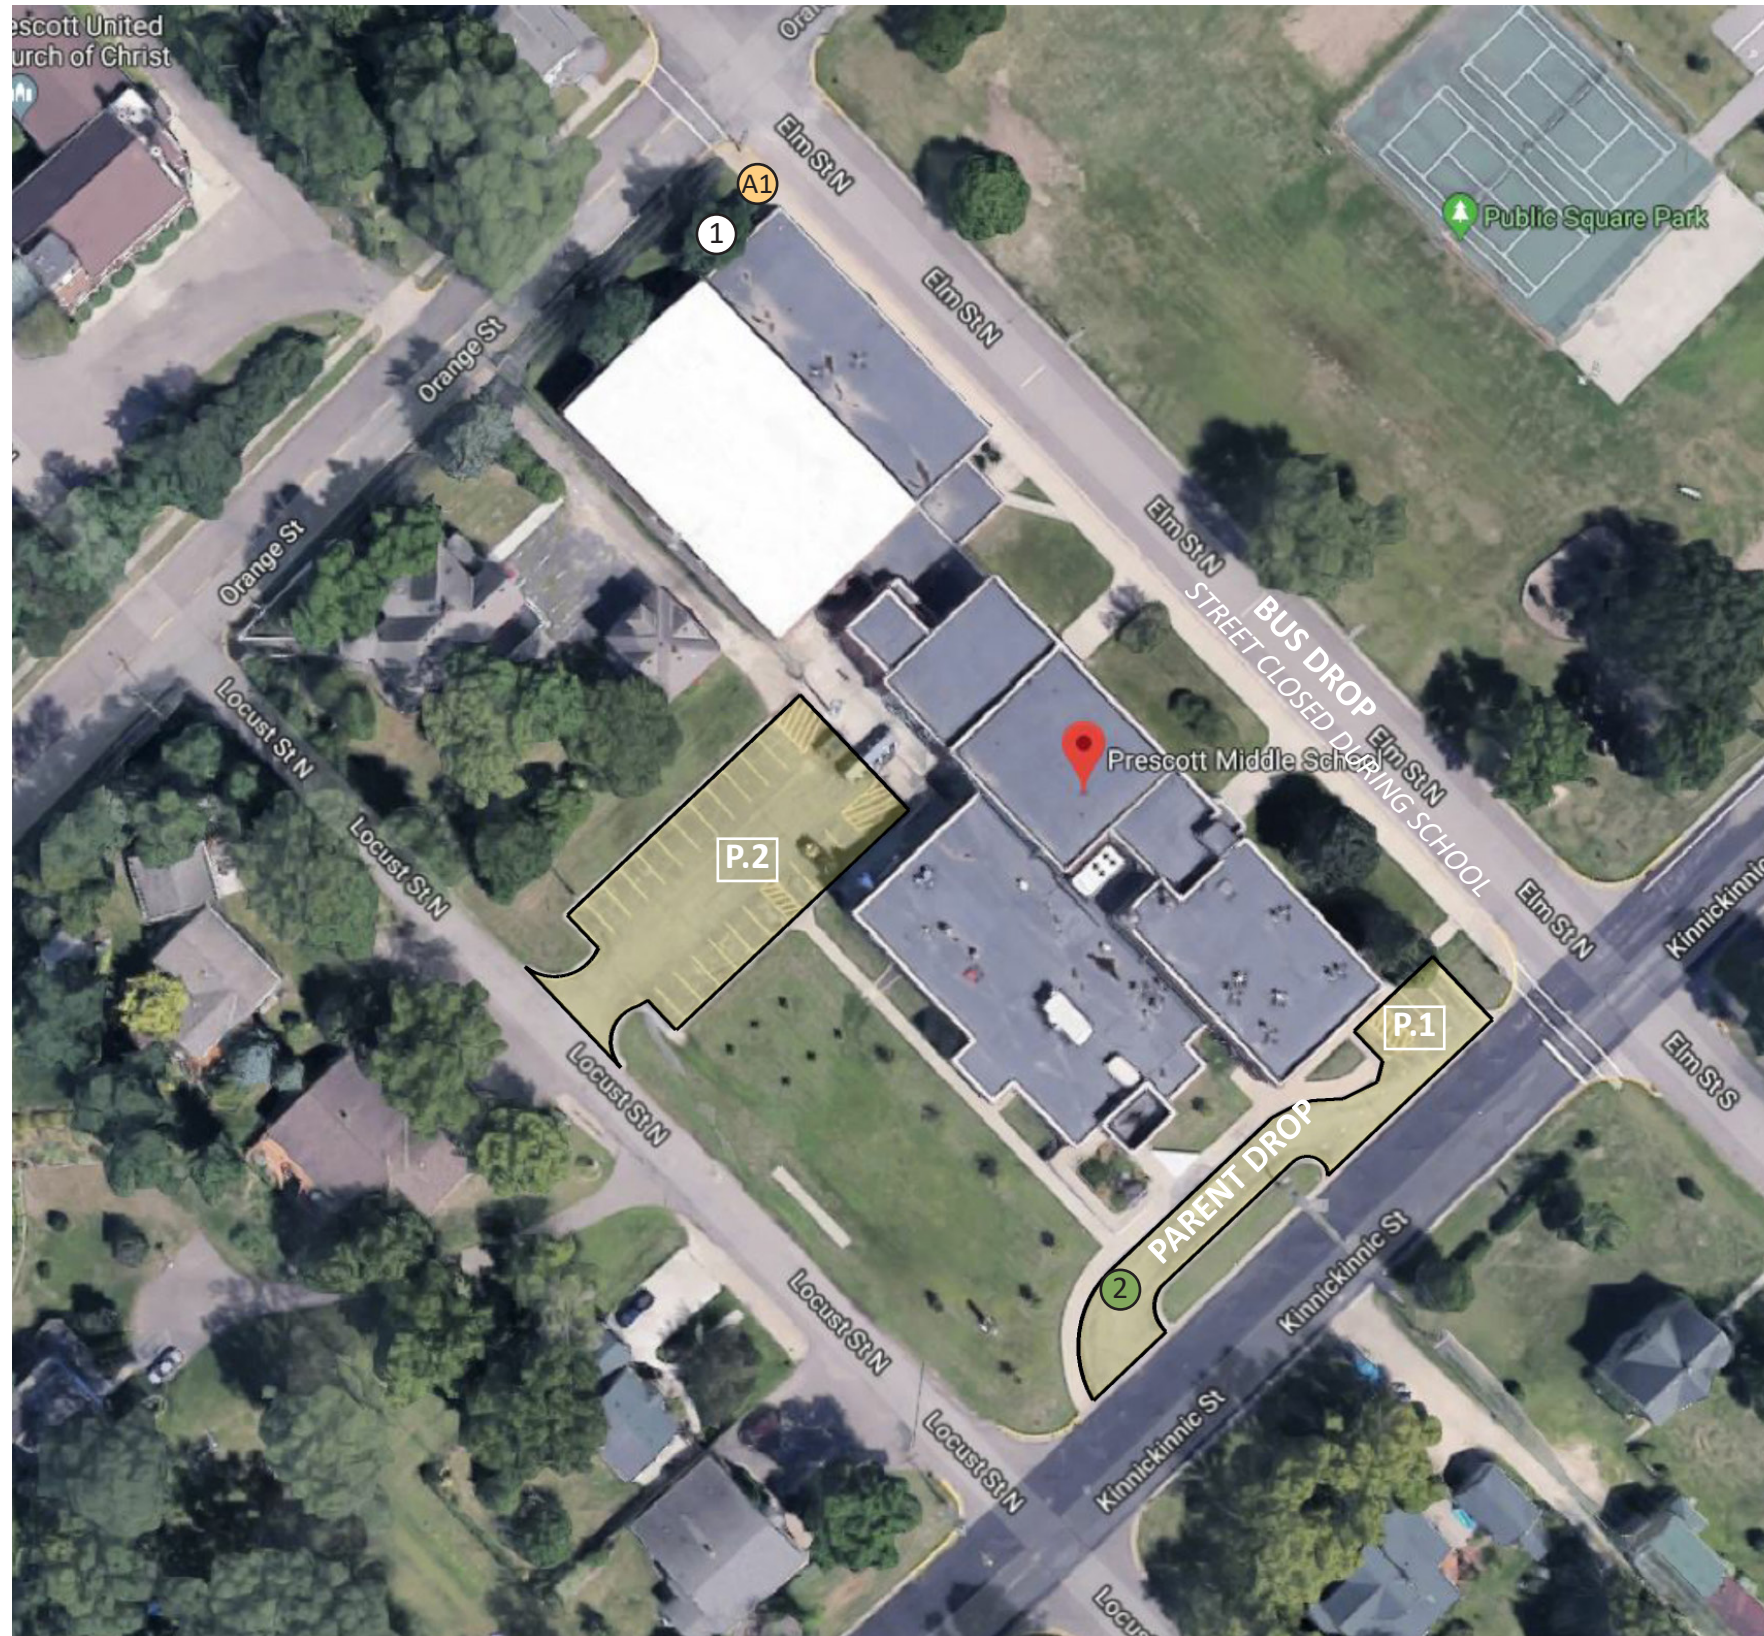
Site Analysis

- ① Damaged sidewalk; needs handrail; drainage issue caused by sidewalk sloping towards building
- ② Parent drop becomes very congested during drop-off and pick-up

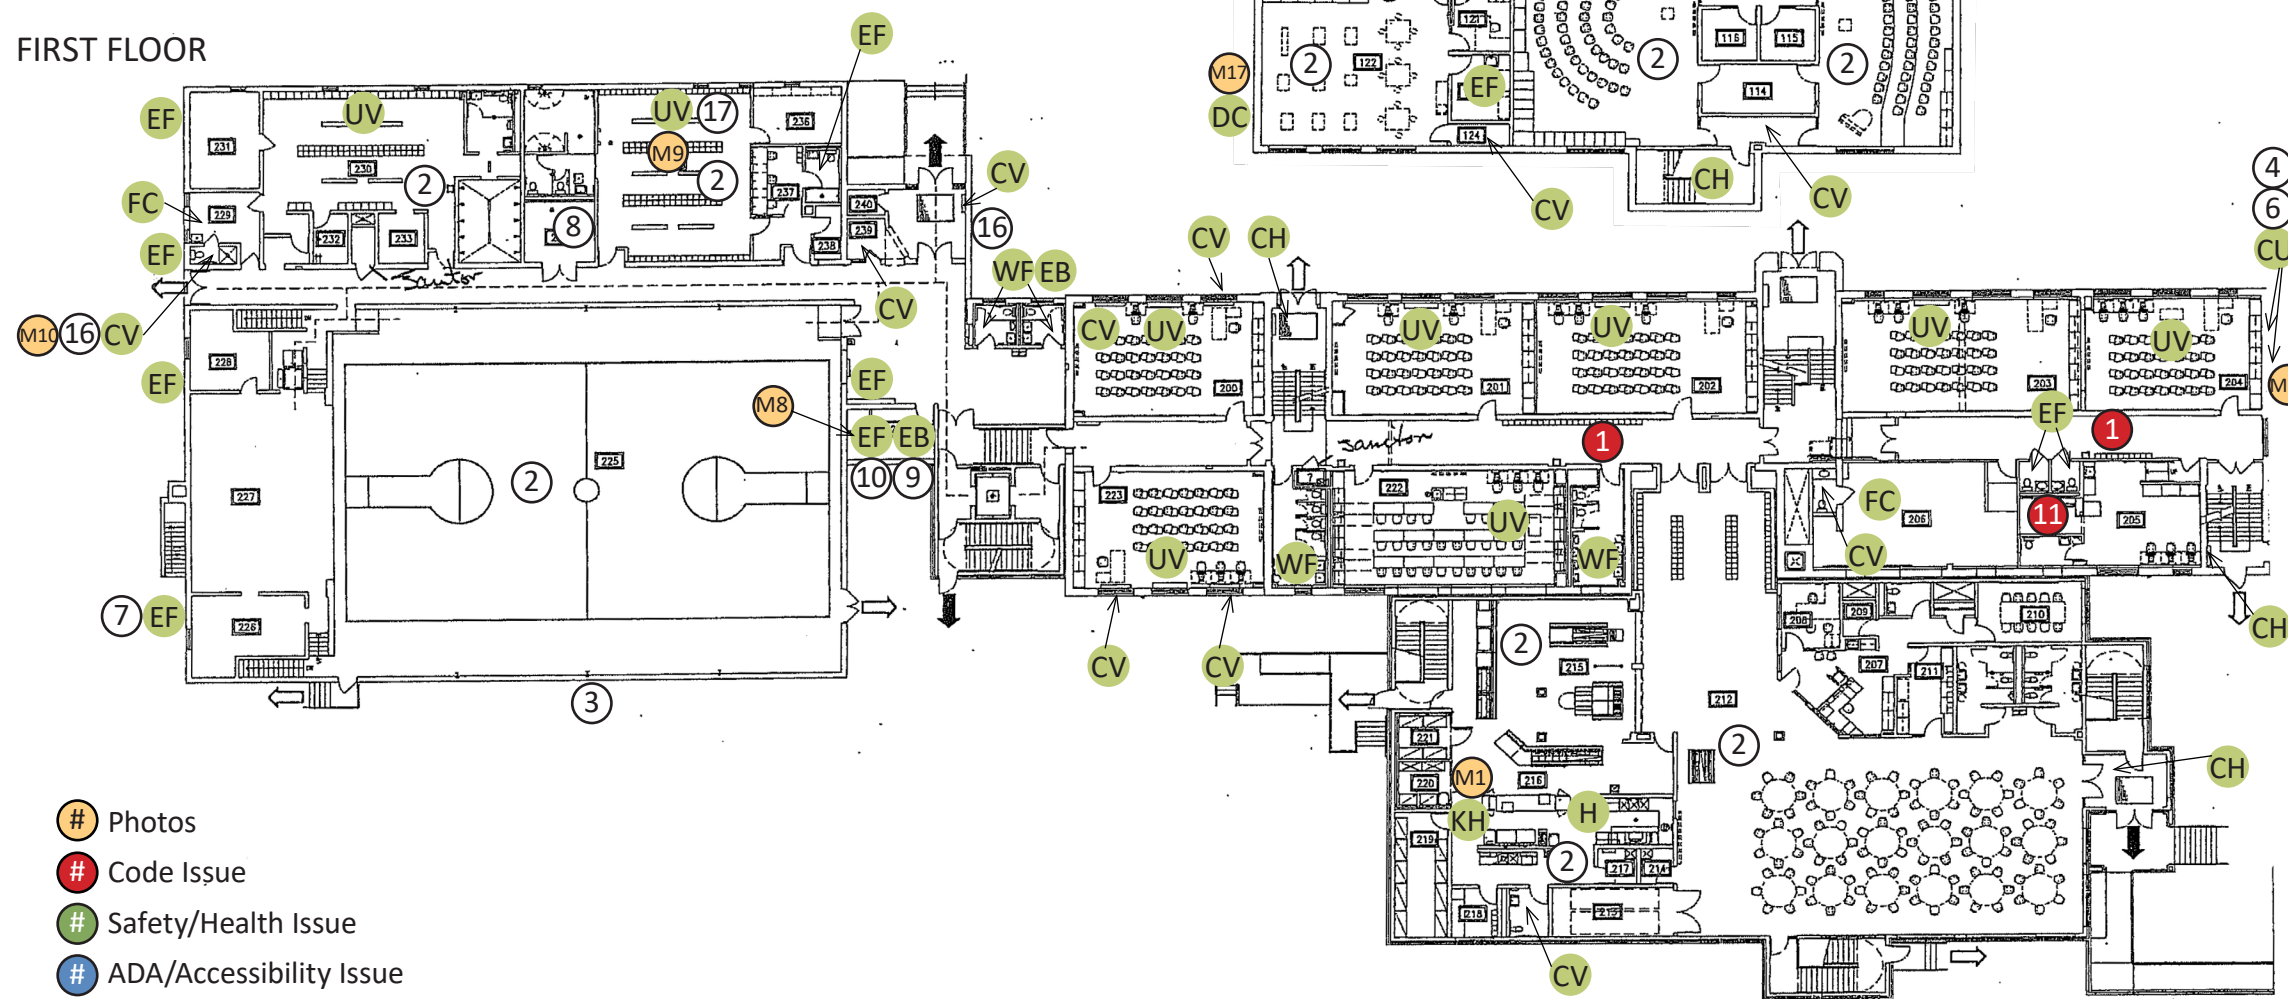
1 Corridor is being used as a relief air plenum with air transferring from rooms. Code compliant at time of work, not code compliant under current code.

2 No air conditioning

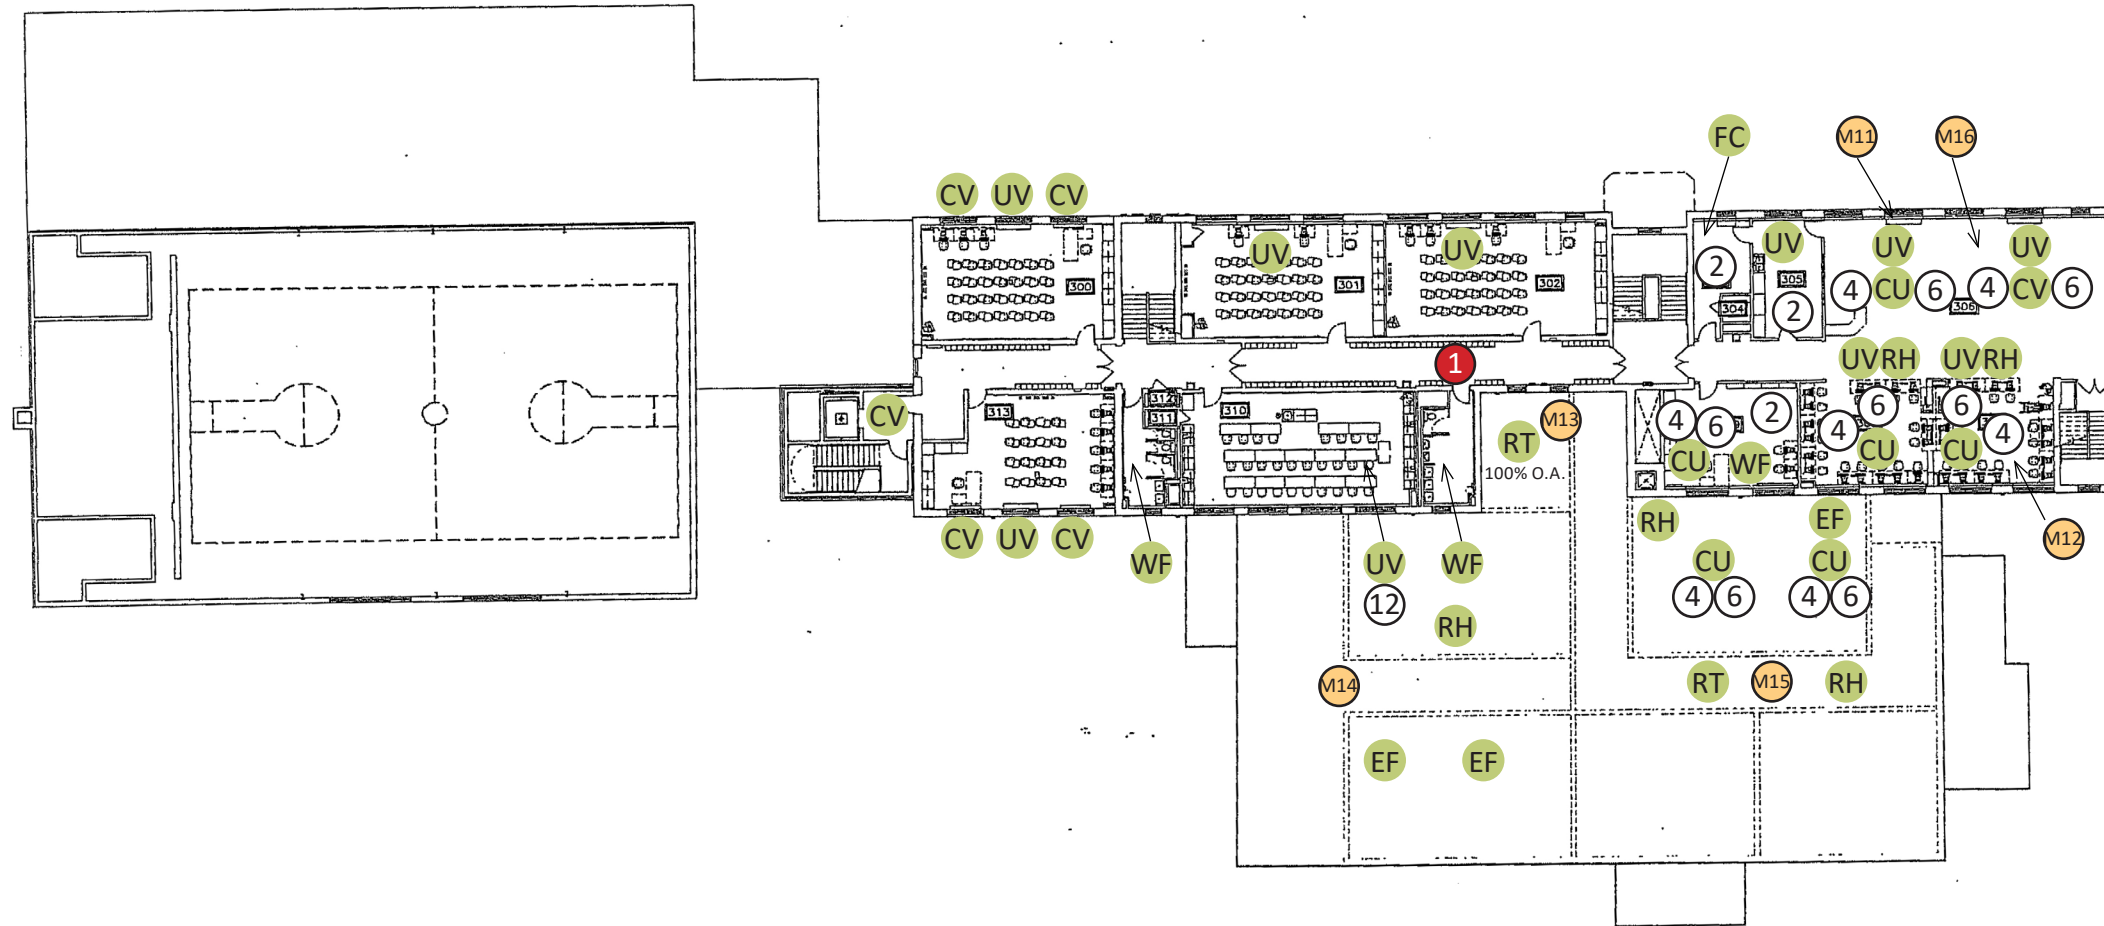
1 Corridor is being used as a relief air plenum with air transferring from rooms. Code compliant at time of work, not code compliant under current code.

2 No air conditioning

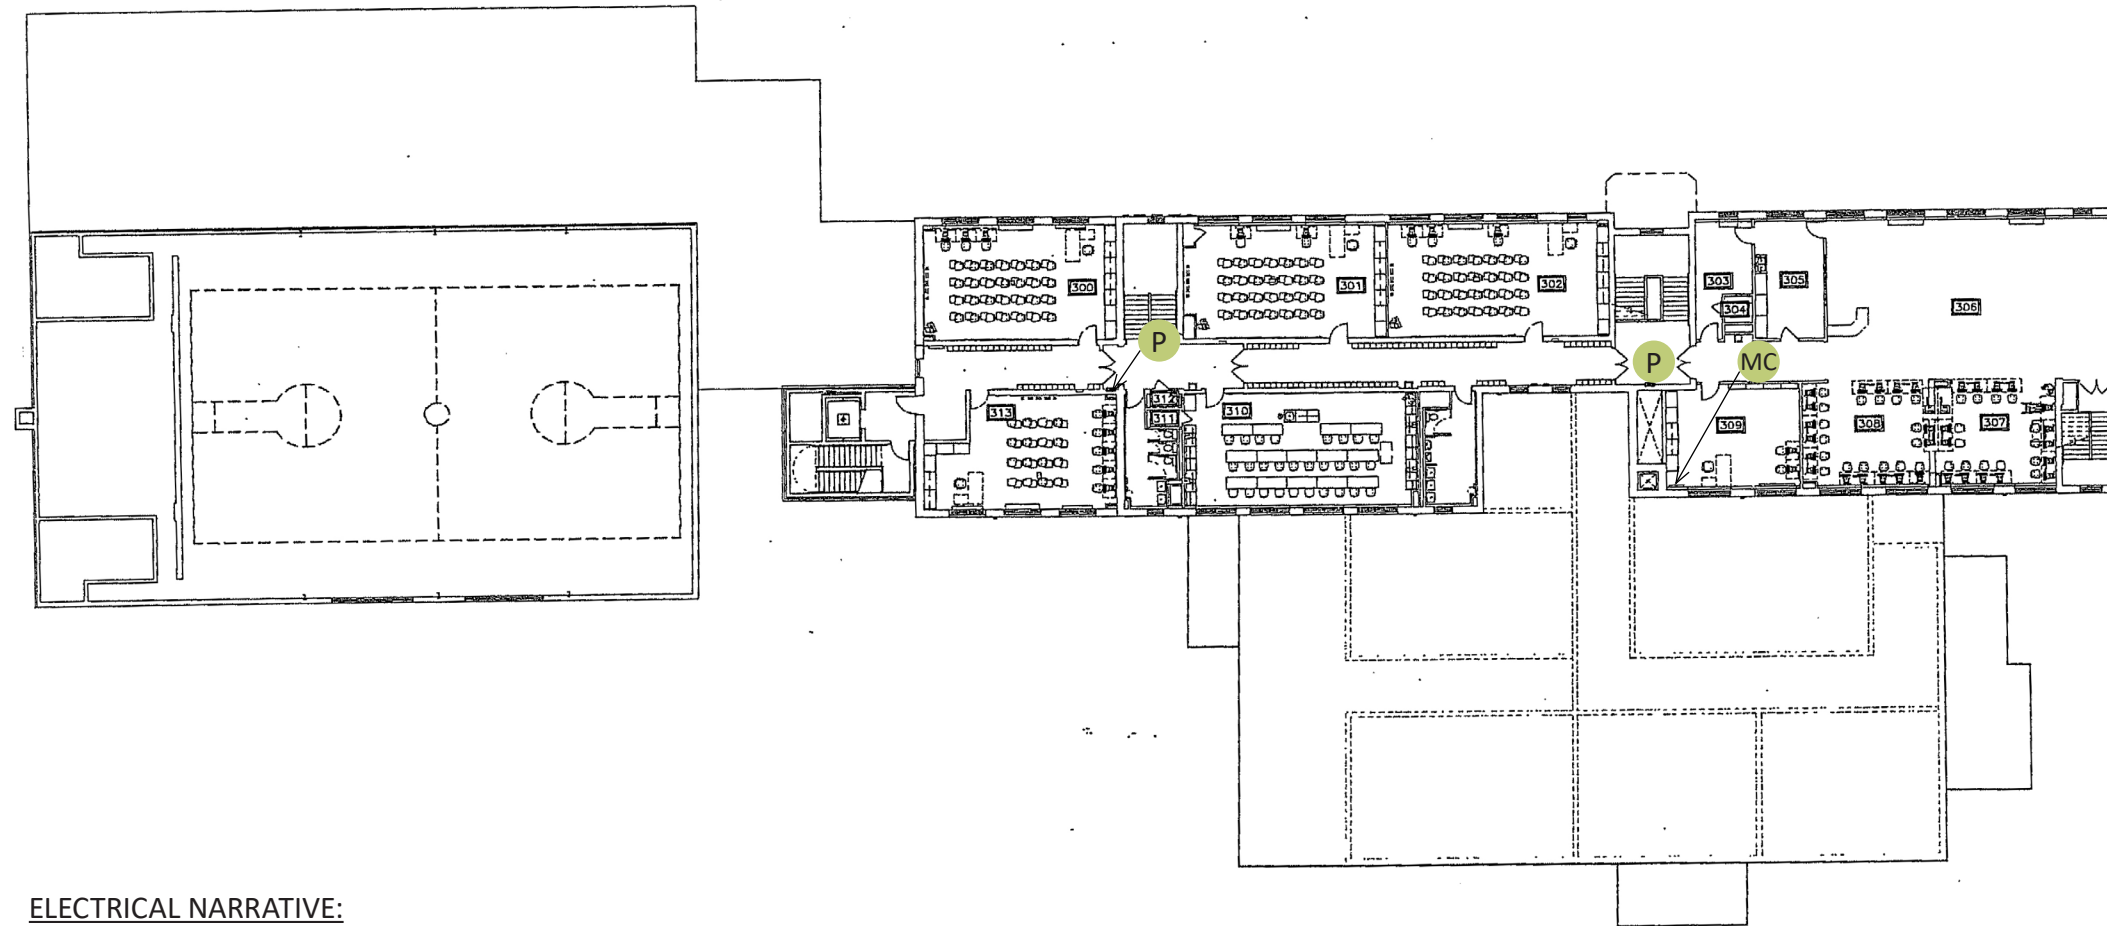
Electrical Analysis

- 1 Wheelchair does not have disconnecting means within line of site per code
- 2 Lockable switch to serve elevator cab lighting is not present in elevator equipment room

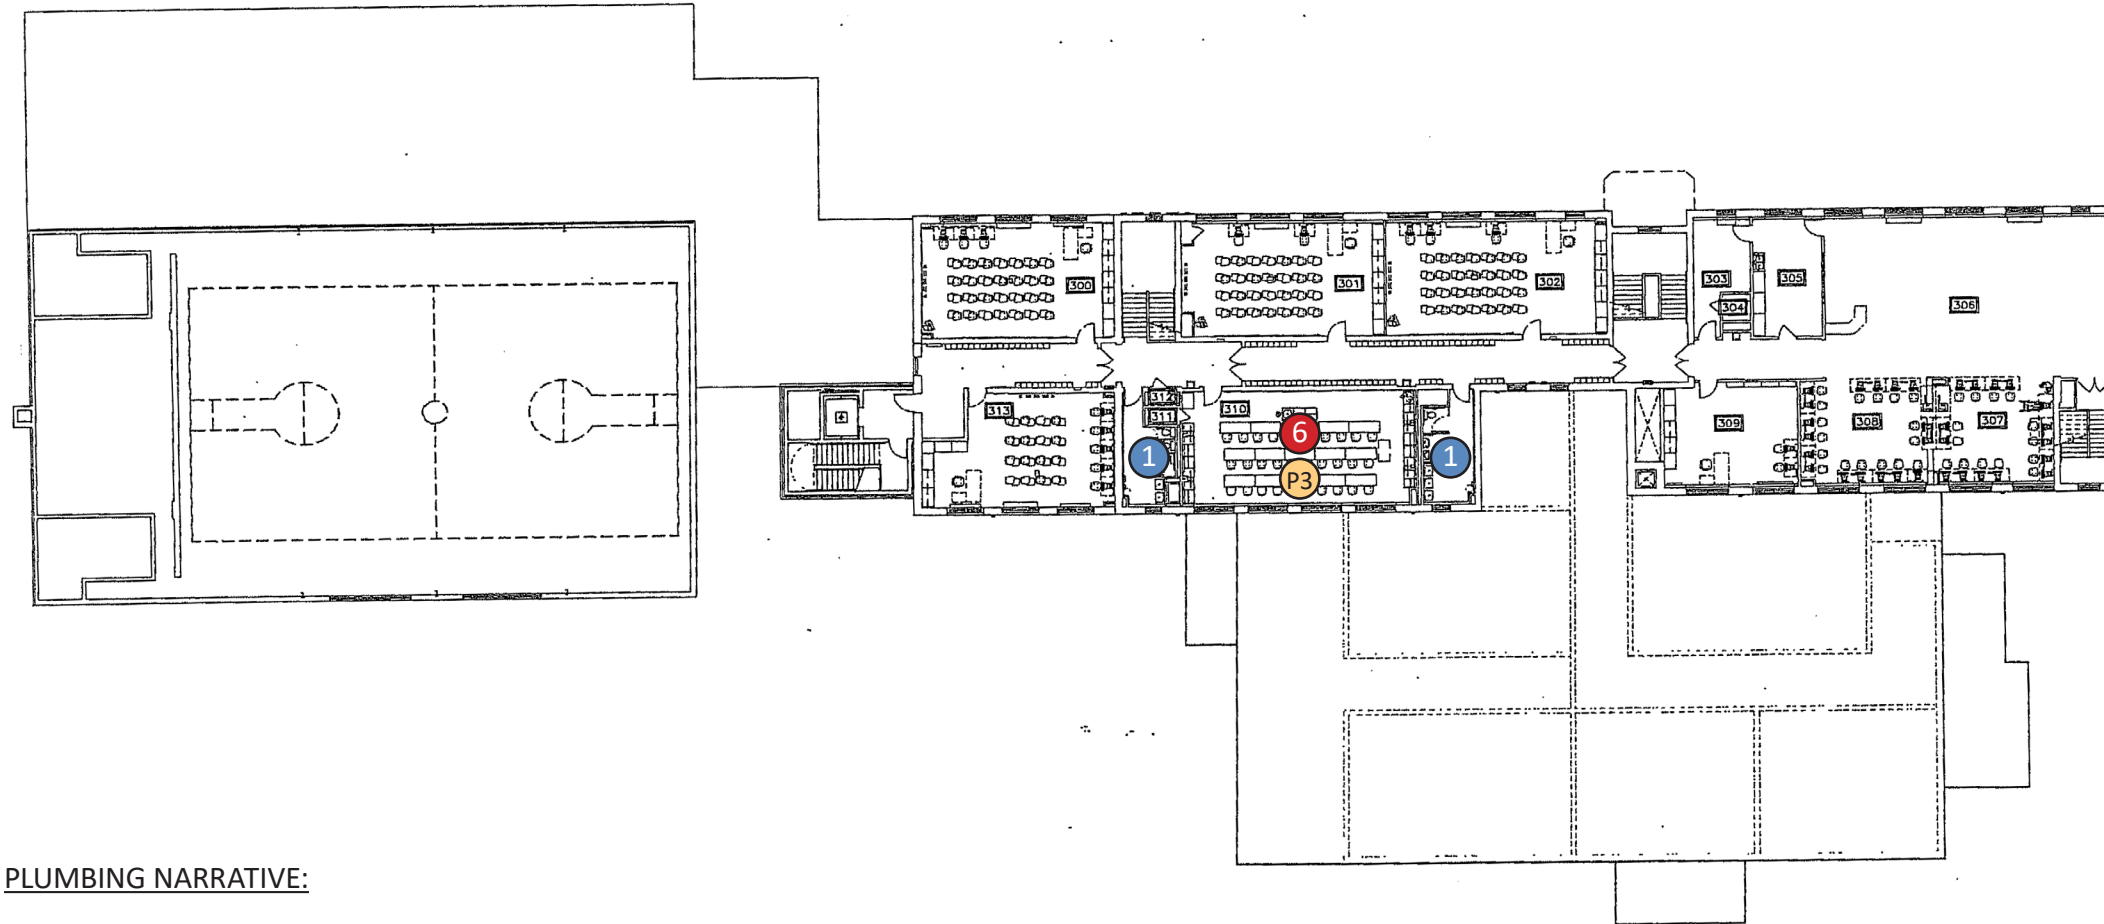
Plumbing Analysis

- 1 Plumbing fixtures are not compliant with ADA Standards for Accessible Design
- 2 Eye wash does not have code compliant clearance/access
- 3 Indirect waste discharging into mop sink; which is not an approved receptor
- 4 Indirect waste over 30" in length is required to be trapped
- 5 Time operated gas valve located at teacher's station is not secured from general access
- 6 Eye wash and/or safety shower is cold water only, code requires tempered water be provided
- 7 Because the shower drains are centrally located, users have to pass through other user's water drainage path
