Facilities Study - Summary of Findings

August 21, 2019

Facilities Study Document - Malone Elementary

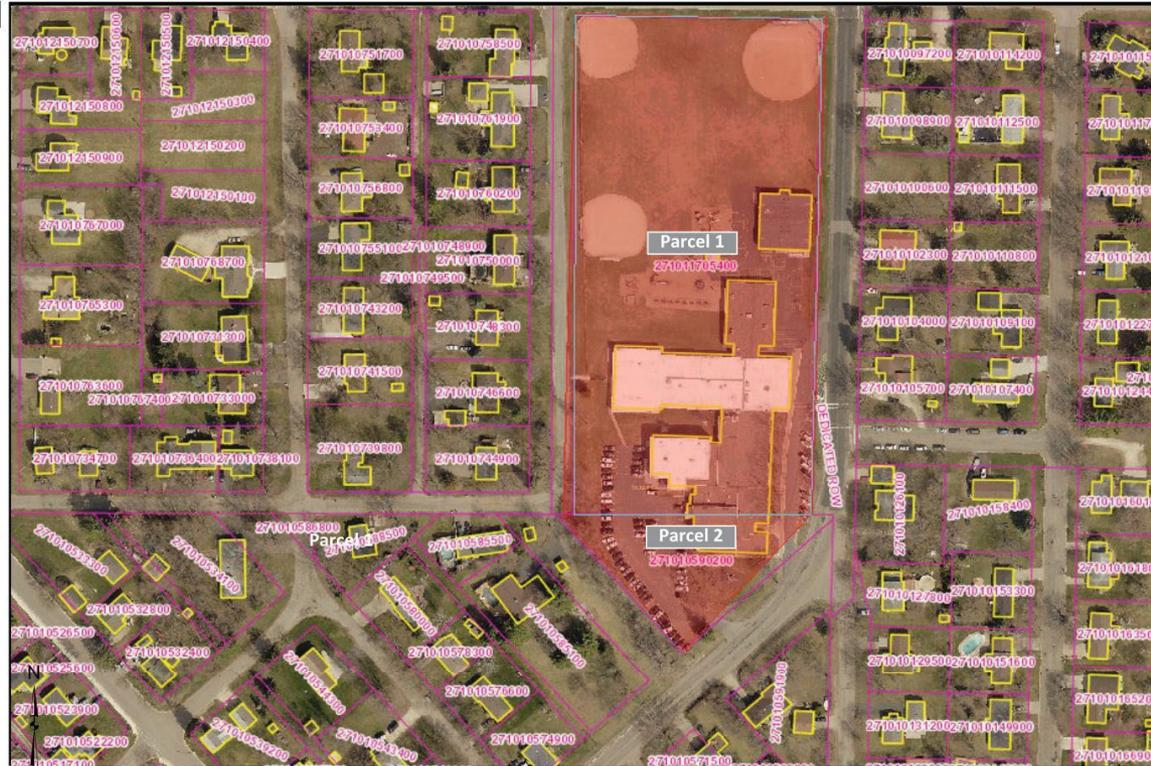
- ① Damage/worn stoop
- ② Bus drop off is not ideal for supervision or building access
- ③ Concentrated area of damage/worn paving

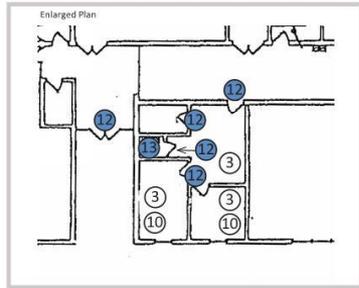
- ① Damaged/worn flooring
 - ② Damaged/worn casework
 - ③ Damaged/worn ceiling
 - ④ Damaged/worn door and/or door hardware
 - ⑤ Damaged/worn window
 - ⑥ Damaged/worn wall

- ⑦ Damaged/worn plumbing fixtures
 - ⑧ Cracks along foundation wall
 - ⑨ Water related wall damage
 - ⑩ Water related ceiling damage
 - ⑪ Inefficient or improper use of space

- ⑯ Code - Exiting/Travel Distance
 - ⑰ Code - Stair/Ramp
 - ⑱ Possible Asbestos tile flooring
 - ⑲ Damaged/worn gutter
 - ⑳ Tuckpointing or expansion joint sealant in need of repair

- ㉑ Wall weeps and/or flashing needs repair
 - ㉒ No visual connection from Office to main entrance
 - ㉓ Damaged roof drain outlet and splash block
-
- Ⓜ Photos

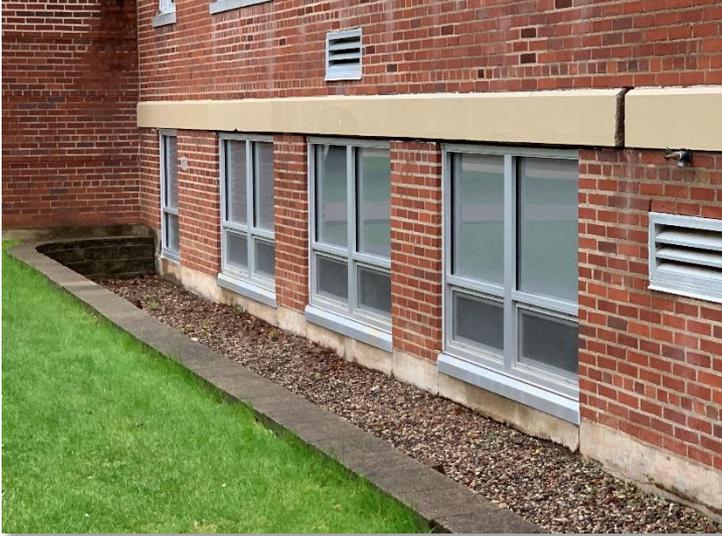
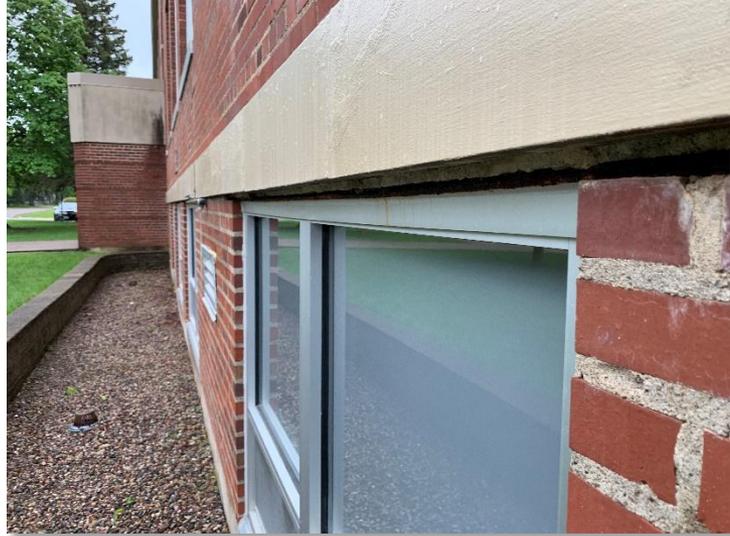
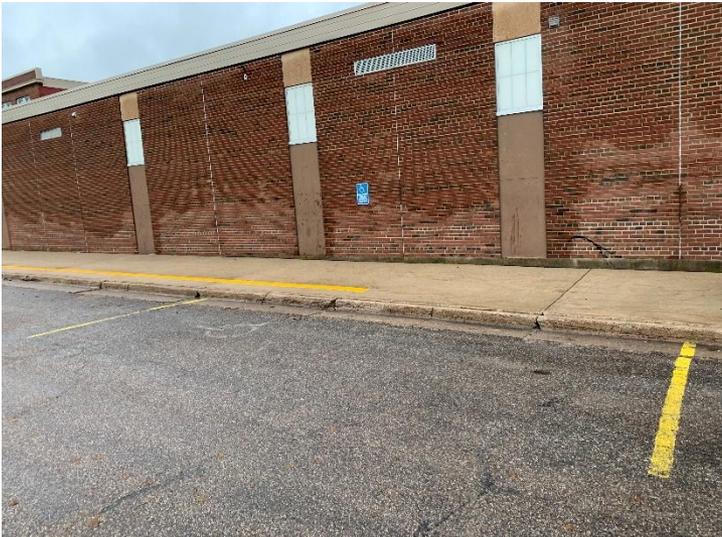
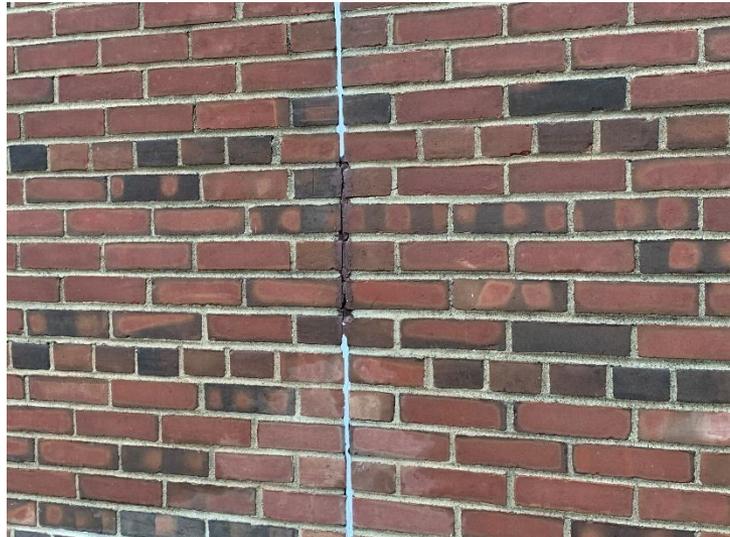
Summary of Findings - Middle School

- 1924 Original Construction, 1955 Addition, 1963 Addition, 2004 Addition
- Most inefficient building
- Identified issues to note:
 - Congested parent drop
 - Bus drop on street
 - Limited off-street parking
 - **No visual connection from Office to front entrance (Security)**
 - Some finish and cosmetic updates
 - **Classroom sizes**
 - Many repairs needed to building exterior
 - Majority of areas do not have A/C; three-story building contains aging equipment; did not receive ACT 32 upgrades
 - Some electrical systems are reaching end of their useful life, not as significant as other buildings; lighting upgrades
 - Plumbing items are minor, ADA non-compliant fixtures; majority of piping may be original
