THE SCHOOL DISTRICT OF  
**PRESCOTT**  
Prescott, Wisconsin

# Facilities Study

SDS PROJECT NO.: 1913  
SUMMER 2019

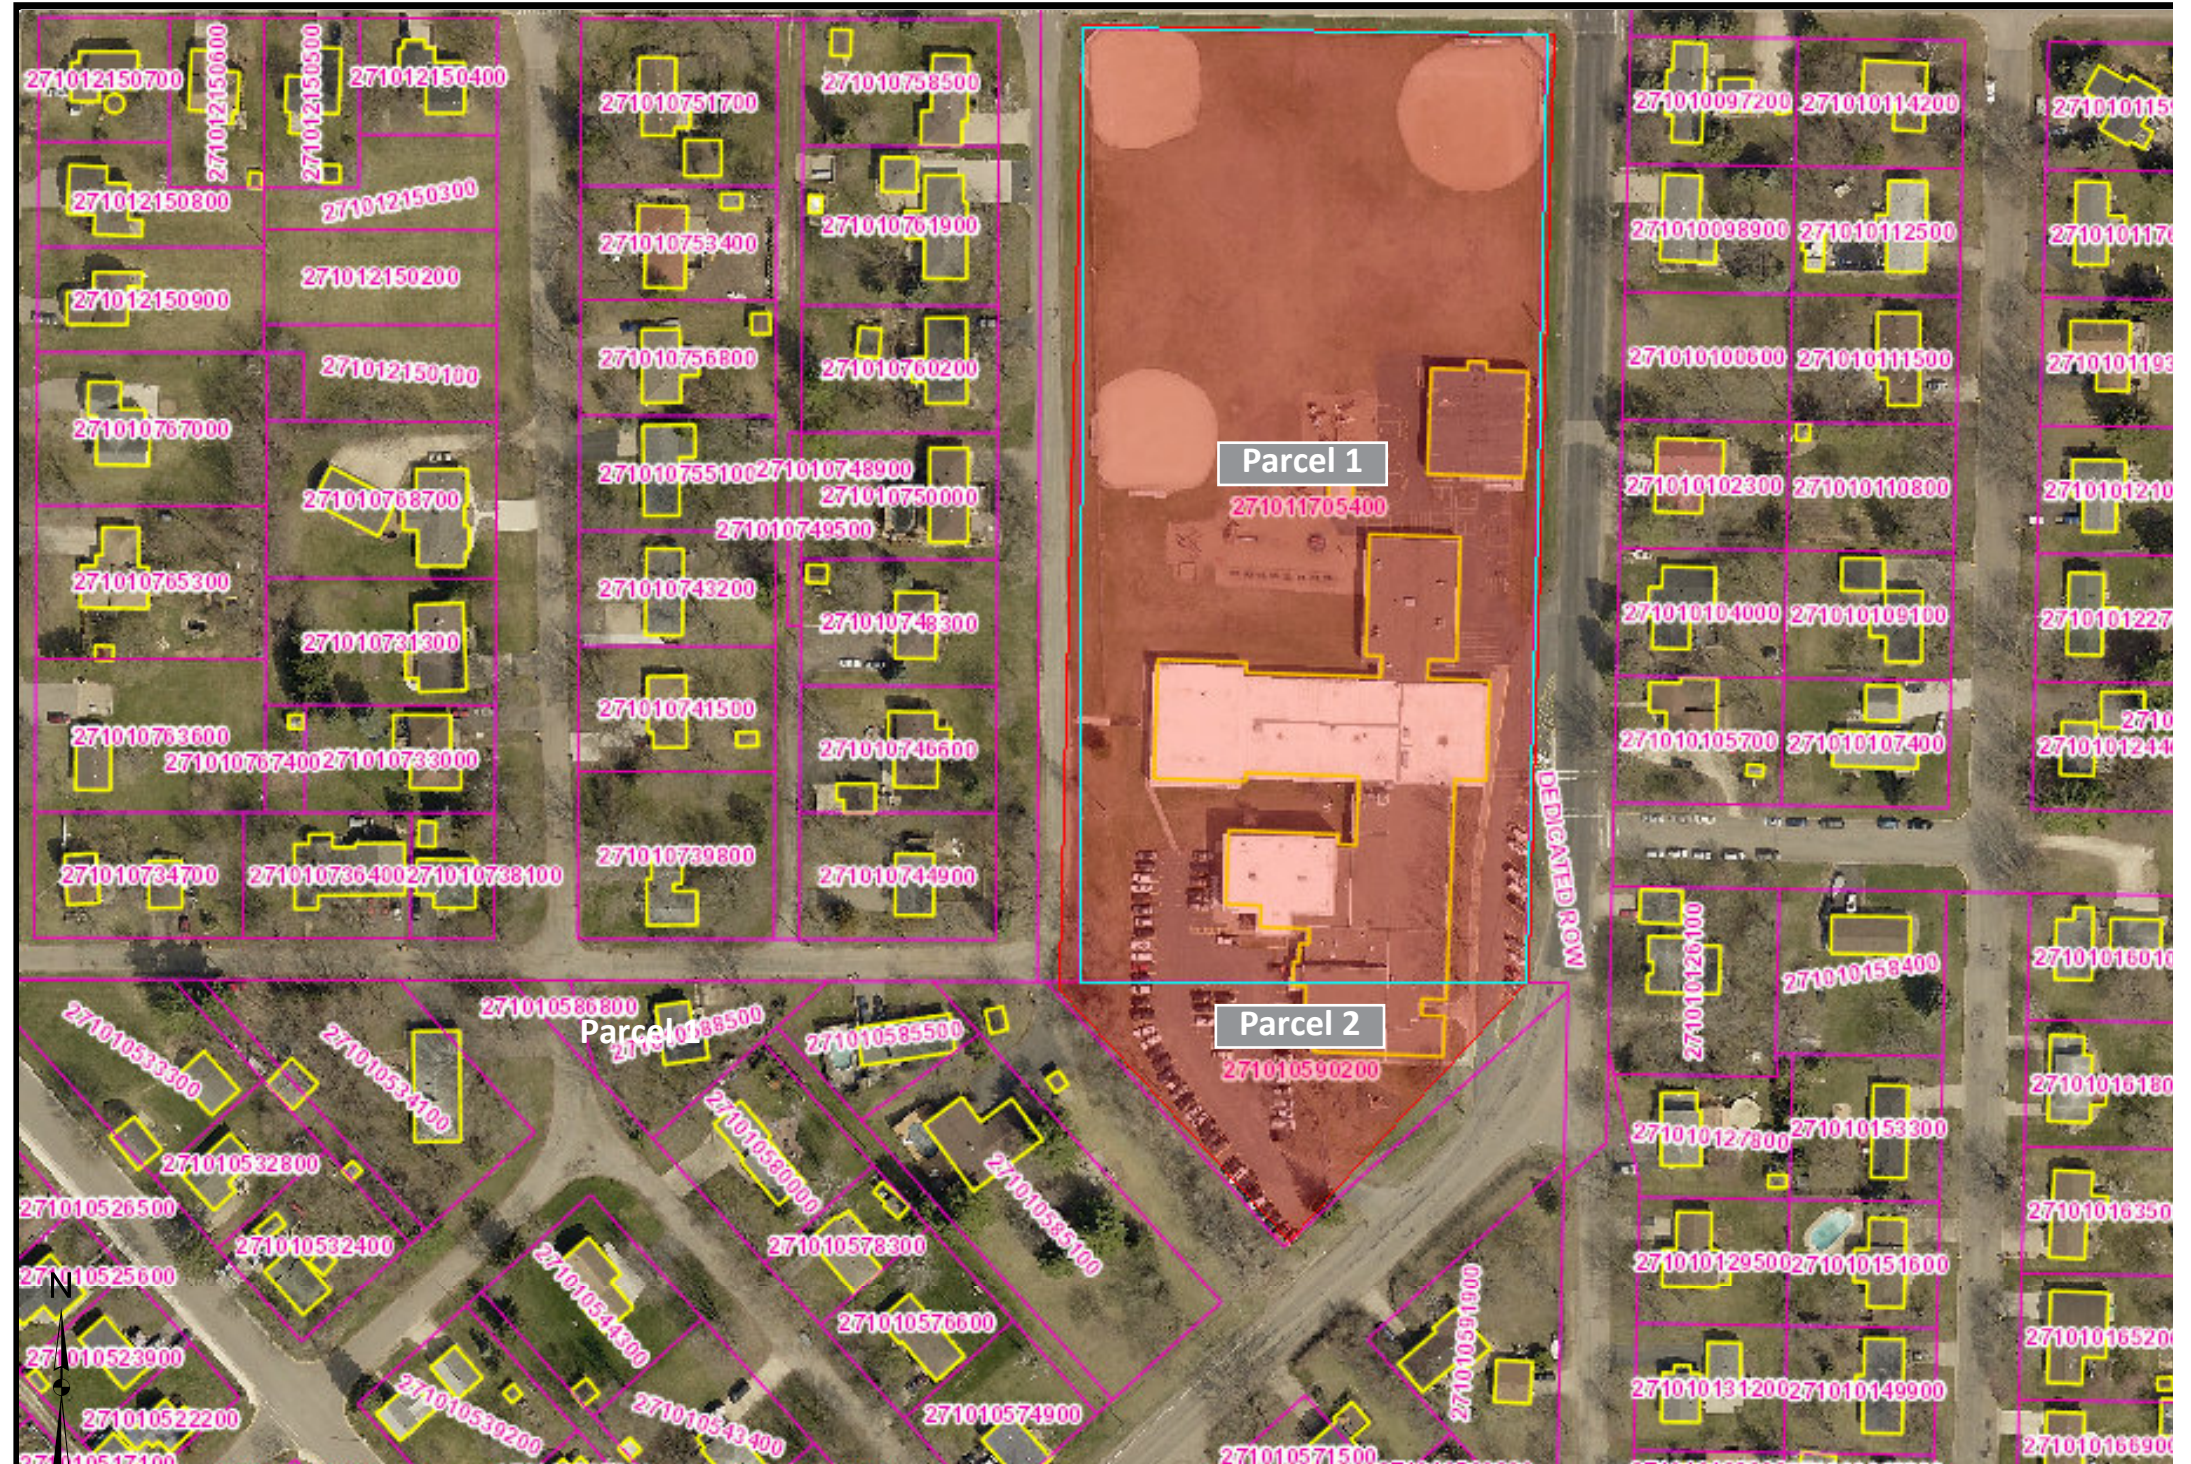
- ① Damage/worn stoop
- ② Bus drop off is not ideal for supervision or building access
- ③ Concentrated area of damage/worn paving

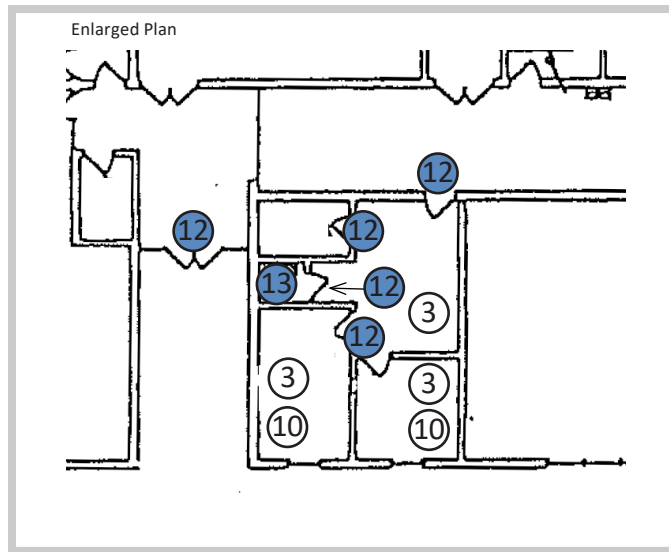
Floor Plan Analysis (not all notes will be used)

- ① Damaged/worn flooring
- ② Damaged/worn casework
- ③ Damaged/worn ceiling
- ④ Damaged/worn door and/or door hardware
- ⑤ Damaged/worn window
- ⑥ Damaged/worn wall
- ⑦ Damaged/worn plumbing fixtures
- ⑧ Cracks along foundation wall
- ⑨ Water related wall damage
- ⑩ Water related ceiling damage
- ⑪ Inefficient or improper use of space
- ⑫ ADA non-compliant accessible route/entry/reach
- ⑬ ADA non-compliant toilet room/drinking fountain
- ⑭ ADA non-compliant locker room/shower
- ⑮ Code - Construction
- ⑯ Code - Exiting/Travel Distance
- ⑰ Code - Stair/Ramp
- ⑱ Possible Asbestos tile flooring
- ⑲ Damaged/worn gutter
- ⑳ Tuckpointing or expansion joint sealant in need of repair
- ㉑ Wall weeps and/or flashing needs repair
- ㉒ No visual connection from Office to main entrance
- ㉓ Damaged roof drain outlet and splash block

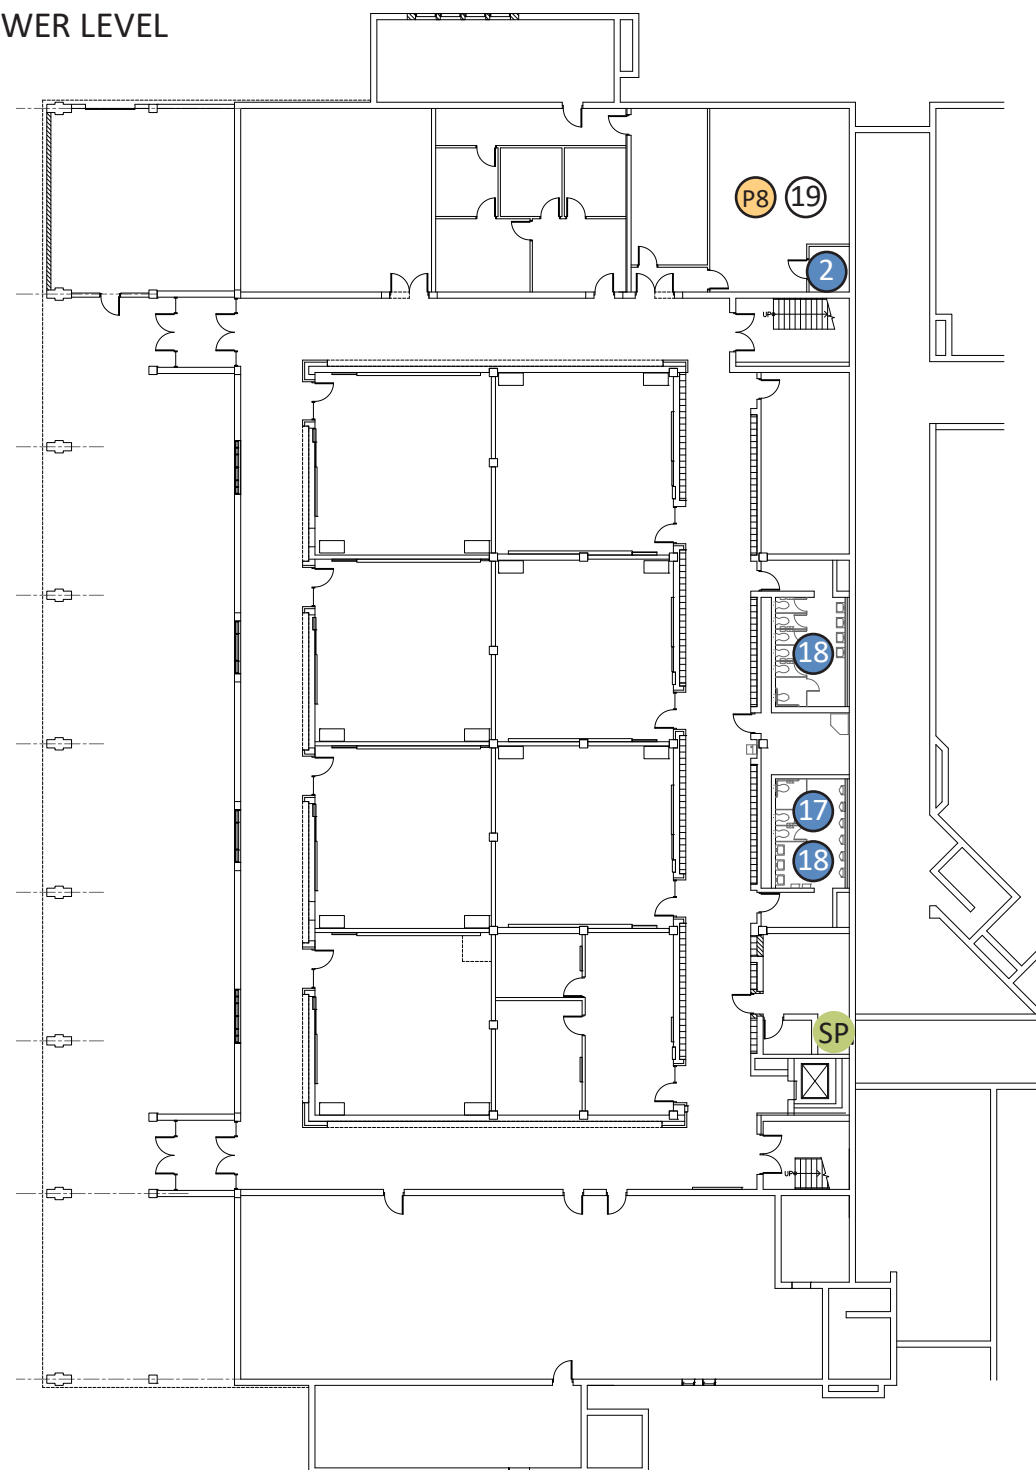
LOWER LEVEL

- 17 Reach distance at urinals for handle operation are not ADA compliant
- 18 Sinks do not have waste, trap, or supplies insulated per ADA standards
- 19 Double bowl sink is not ADA compliant for knee clearance; waste, trap and supplies are not insulated per ADA standards
- 20 No water filter at water service, maintenance issue

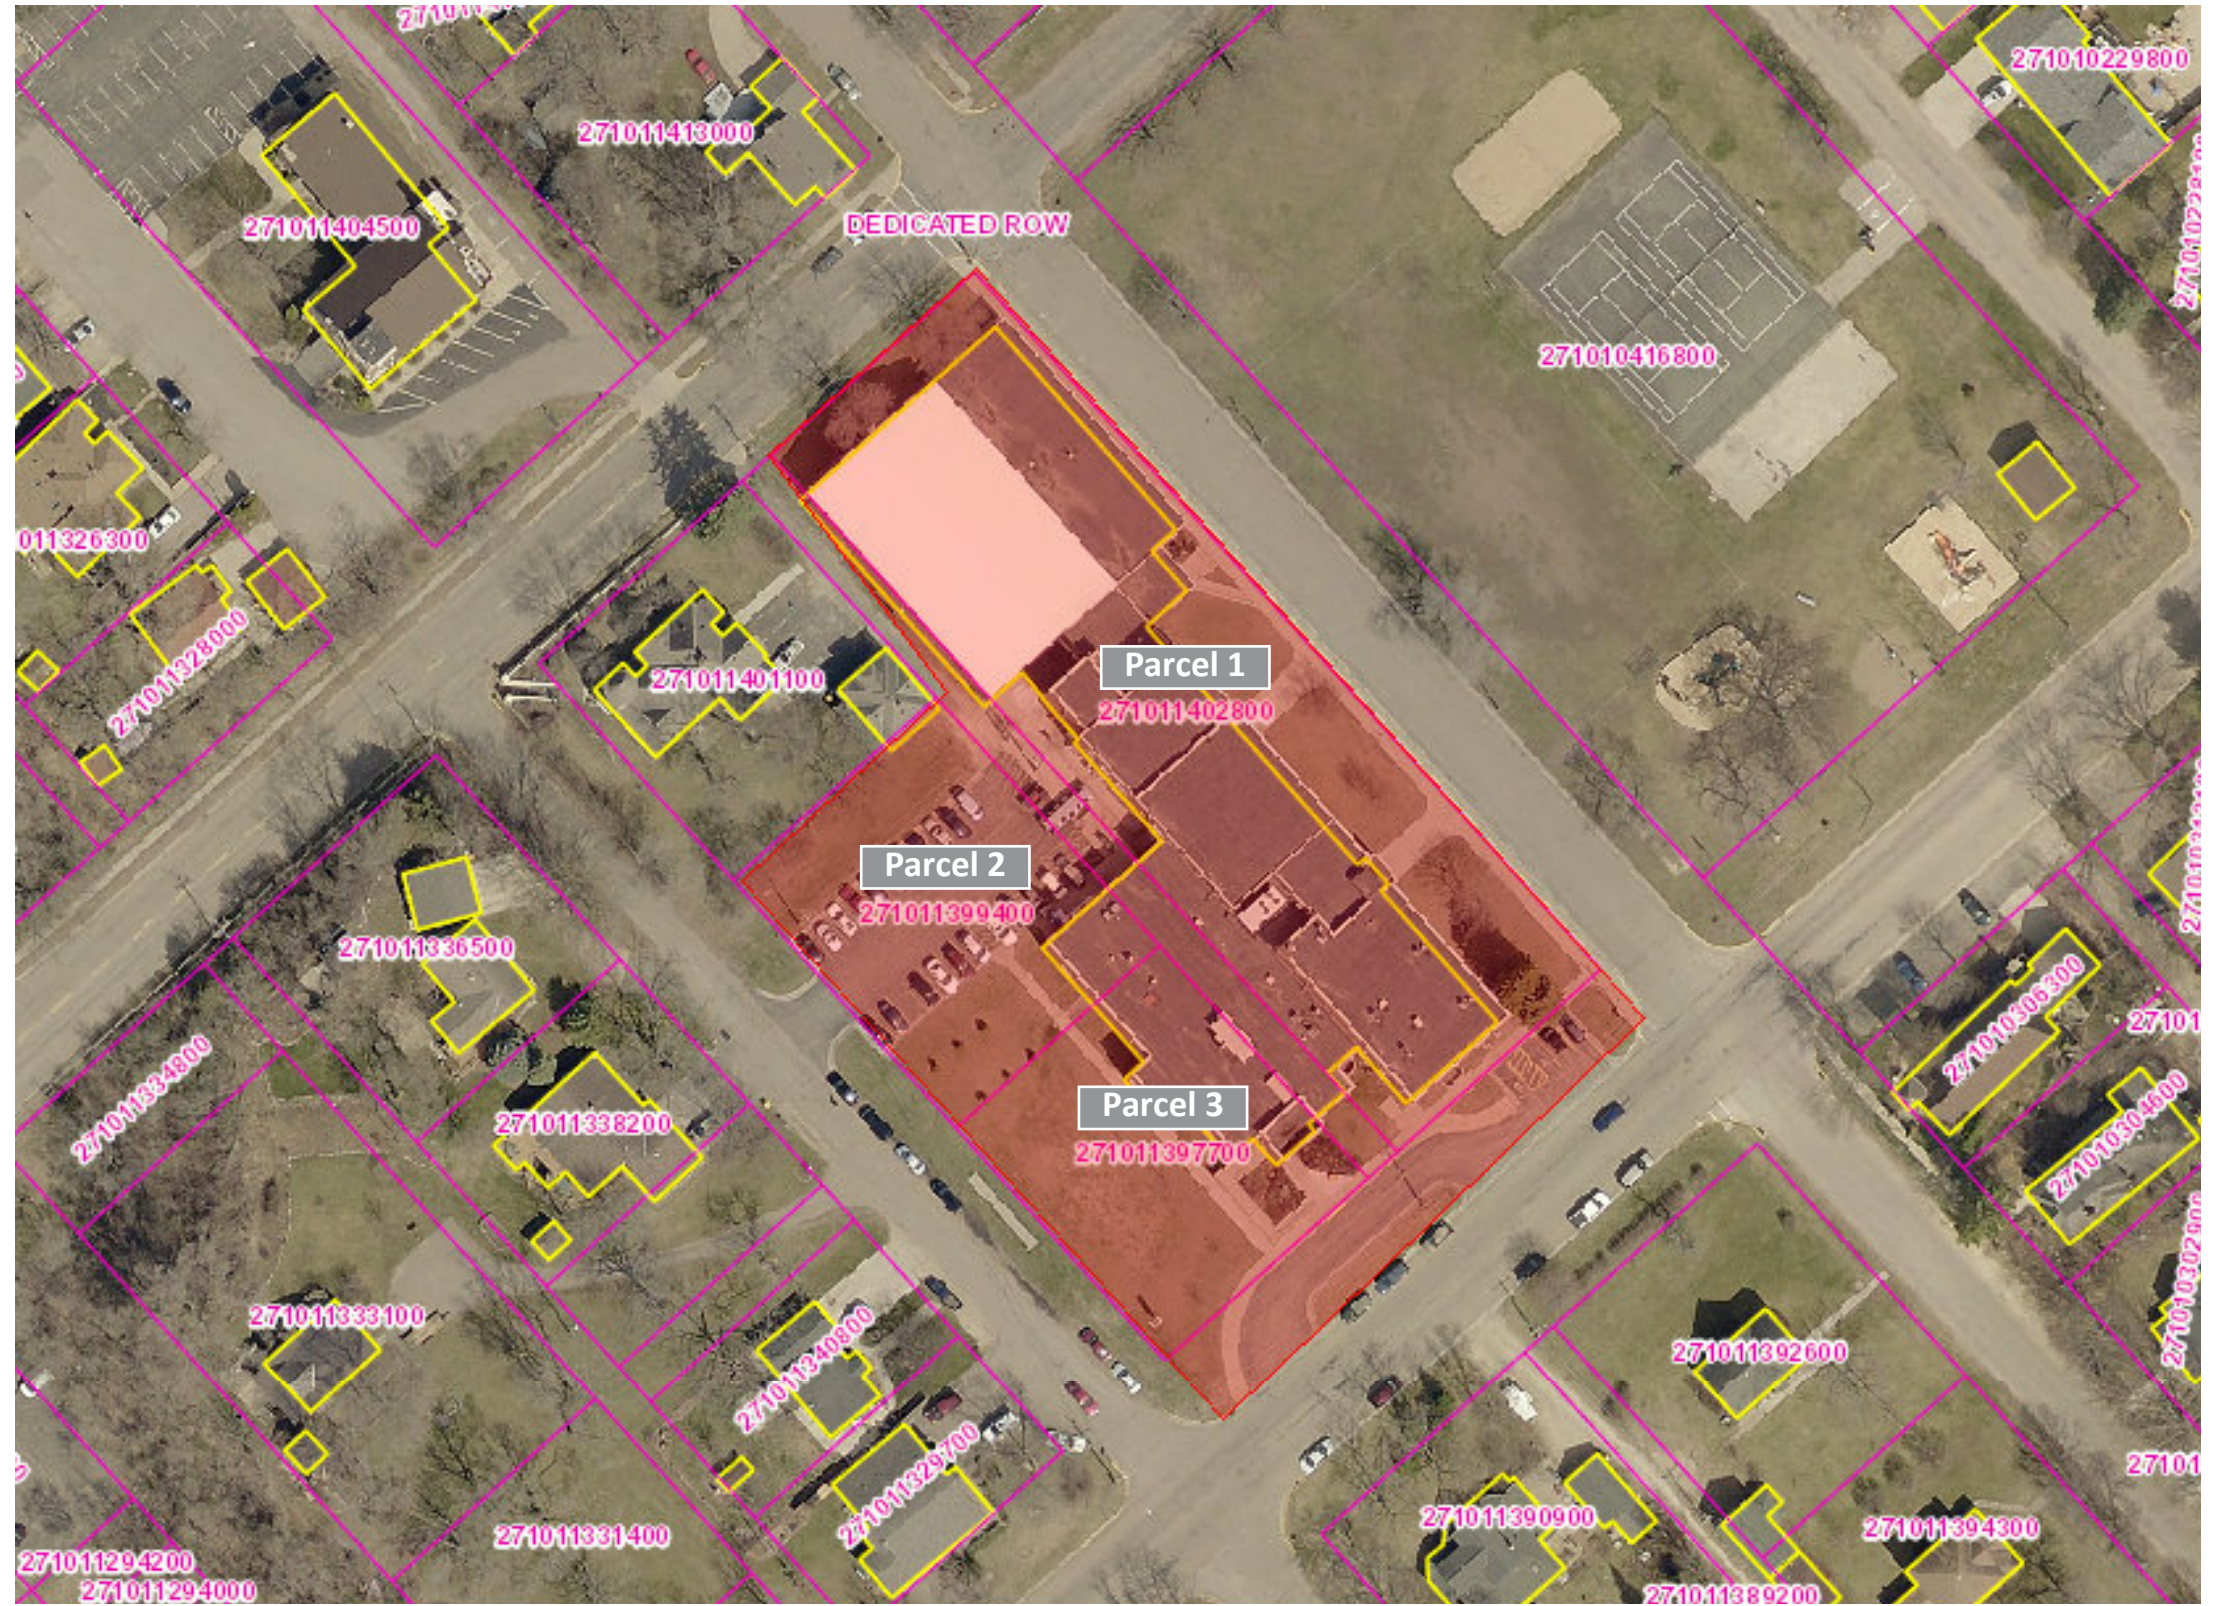
- ① Damaged sidewalk; needs handrail; drainage issue caused by sidewalk sloping towards building
- ② Parent drop becomes very congested during drop-off and pick-up

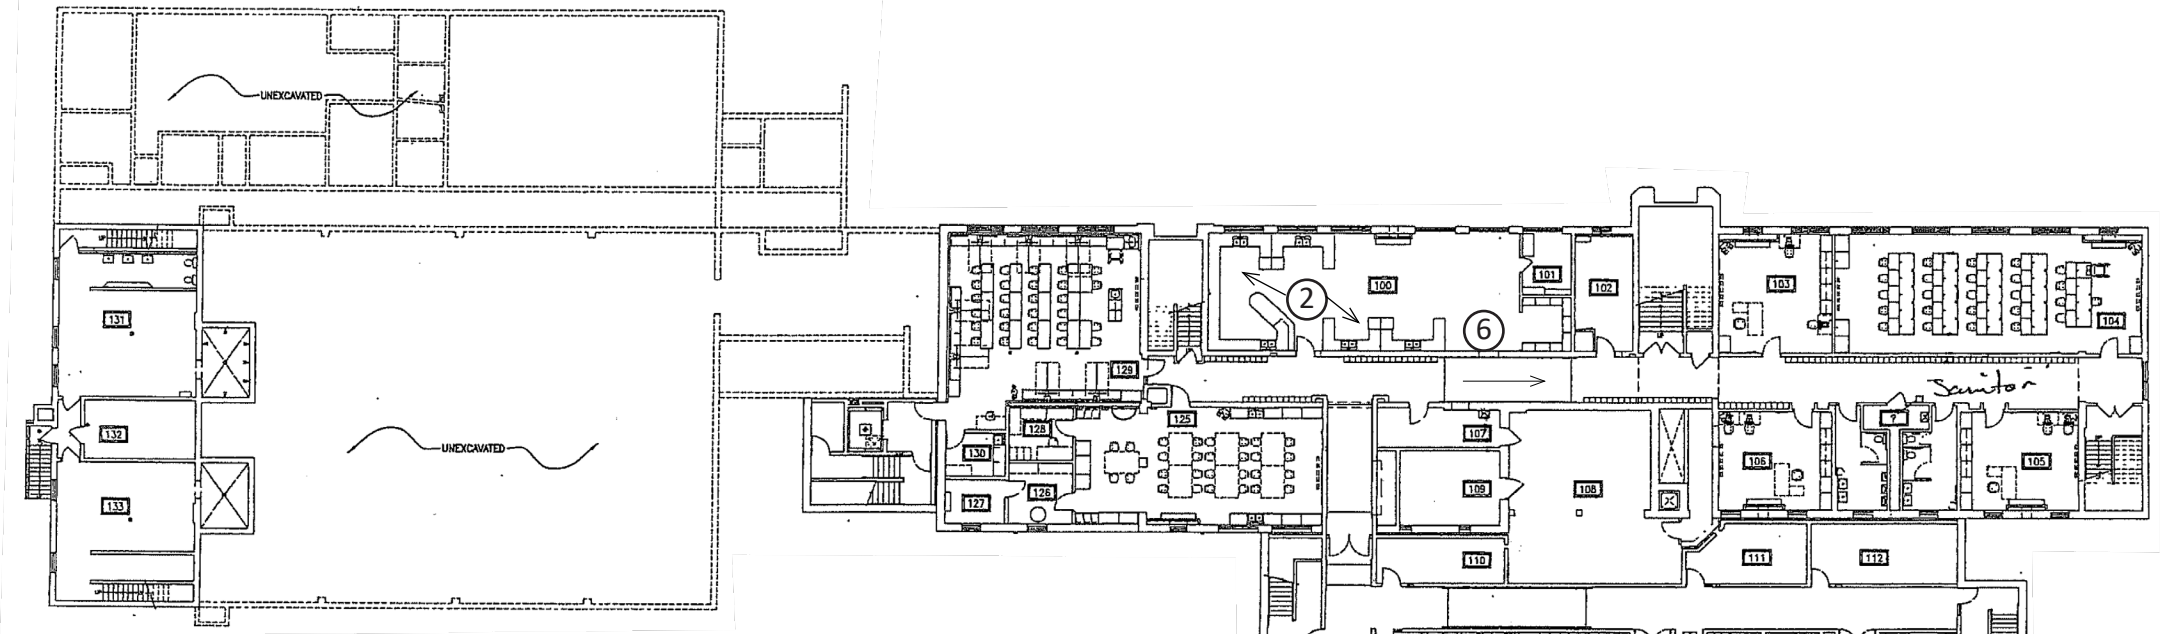
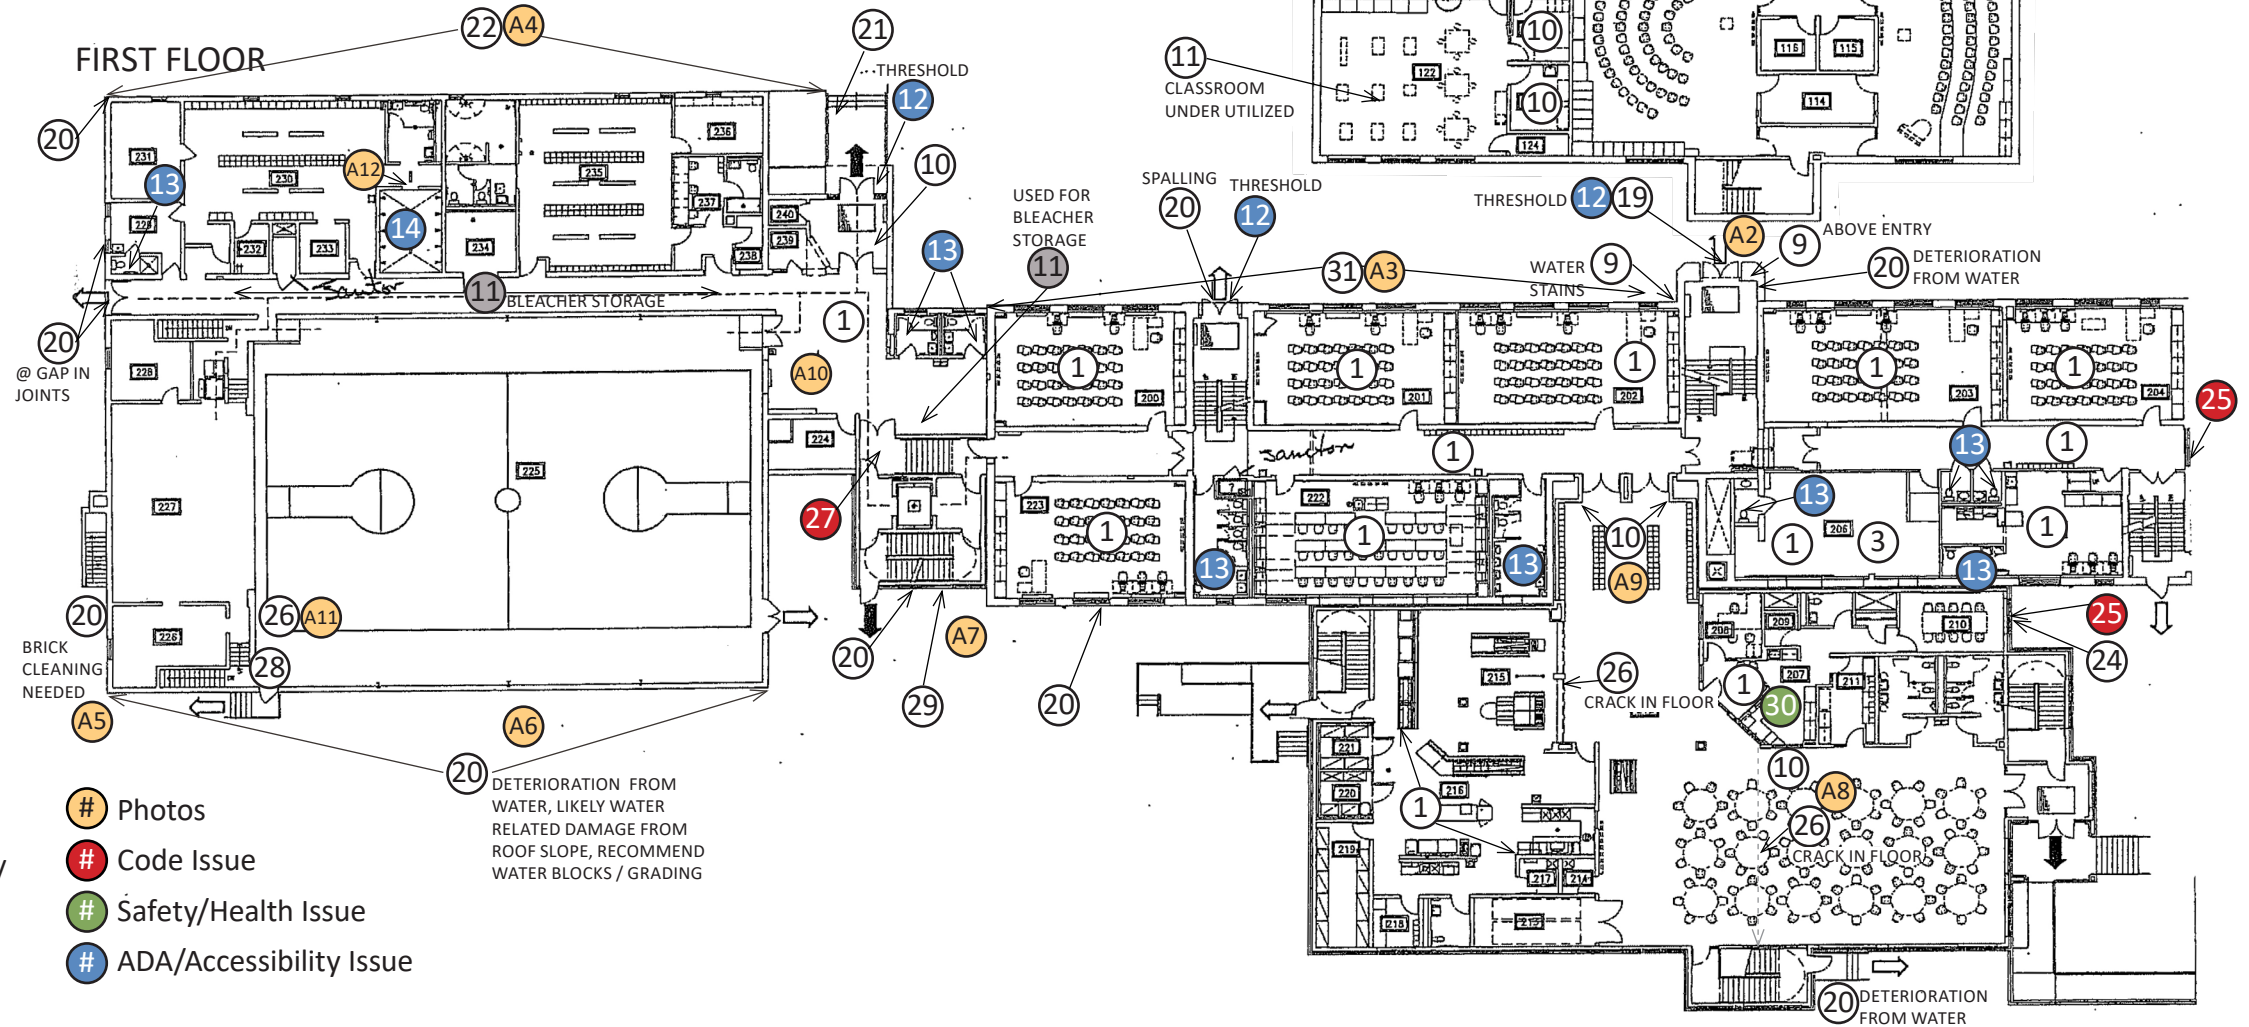
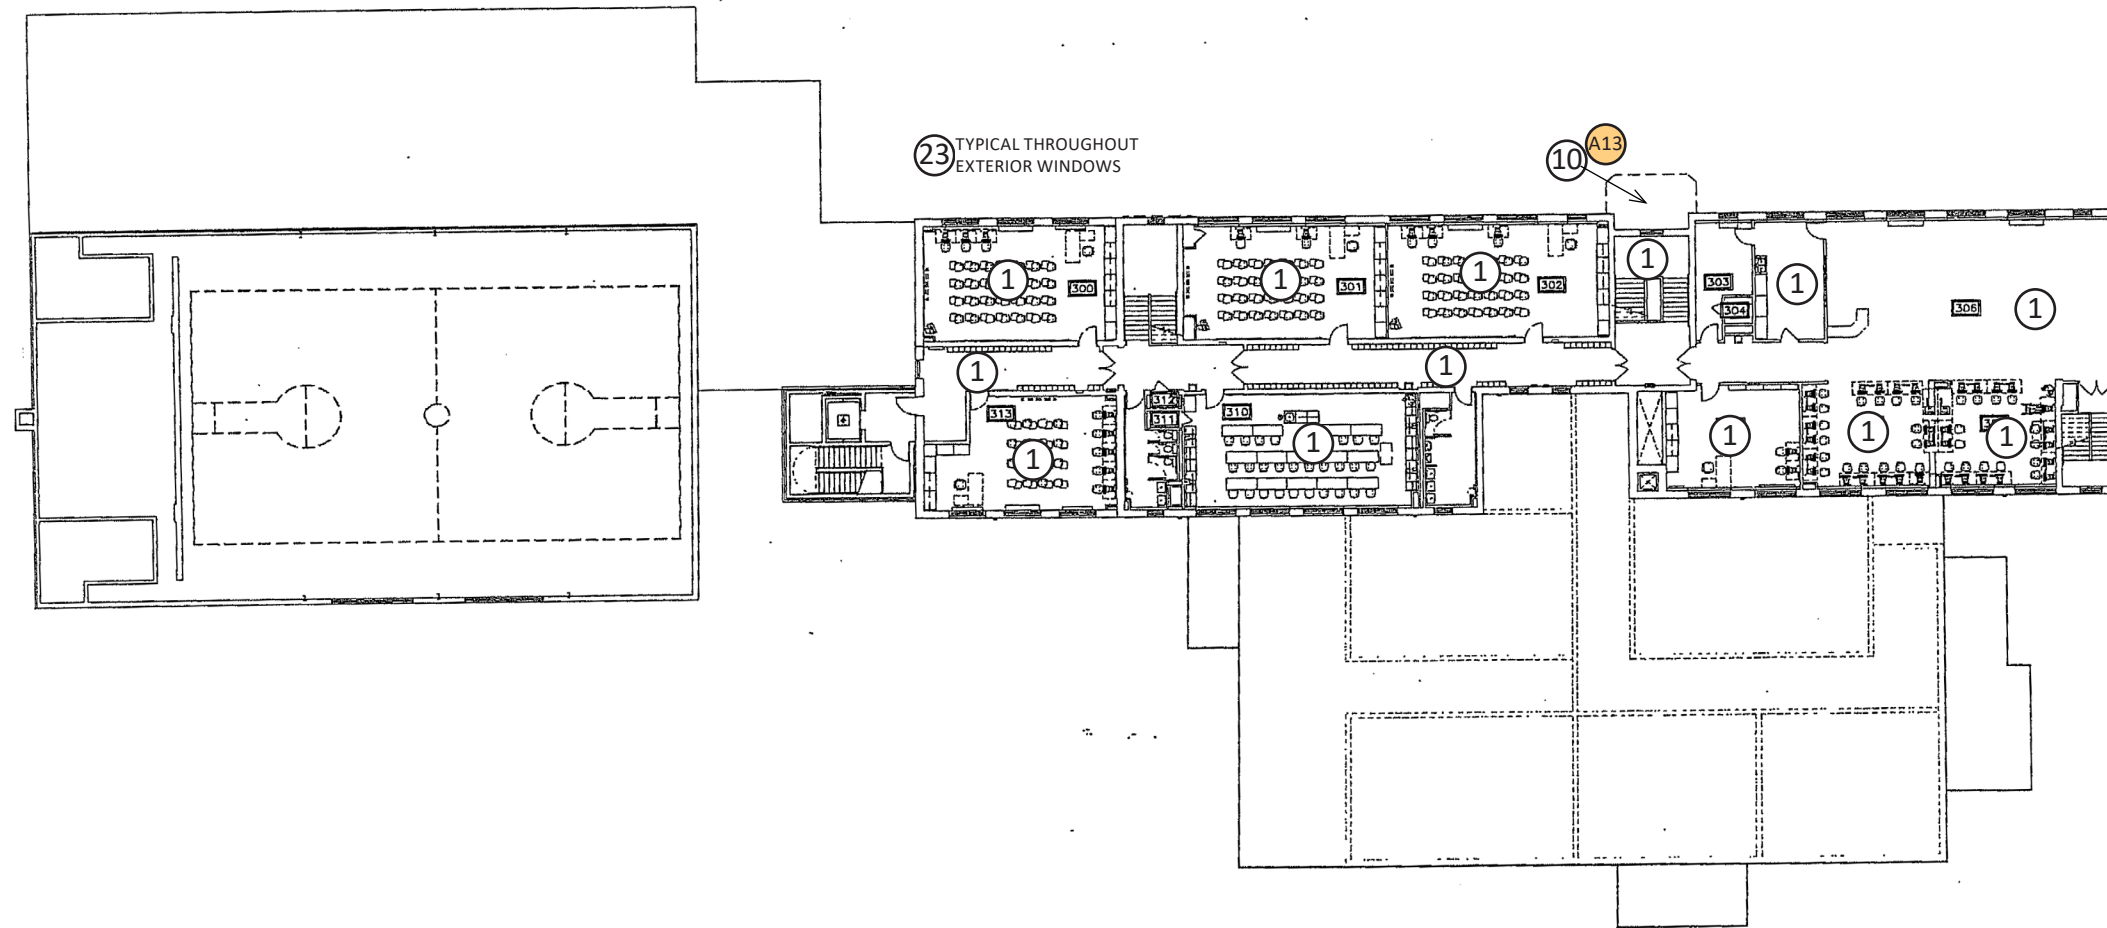
- ① Damaged/worn flooring
- ② Damaged/worn casework
- ③ Damaged/worn ceiling
- ④ Damaged/worn door and/or door hardware
- ⑤ Damaged/worn window
- ⑥ Damaged/worn wall

- ⑦ Damaged/worn plumbing fixtures
- ⑧ Cracks along foundation wall
- ⑨ Water related wall damage
- ⑩ Water related ceiling damage
- ⑪ Inefficient or improper use of space

- ⑯ Code - Exiting/Travel Distance
- ⑰ Code - Stair/Ramp
- ⑱ Possible asbestos tile flooring
- ⑲ Stoop has shifted creating too high of a threshold
- ⑳ Damaged/worn brick and/or masonry

- ㉑ Damaged/worn stoop, exterior stair, & railings
- ㉒ Damaged/worn sealant at expansion joints
- ㉓ Damaged/worn window sealant (typical throughout)
- ㉔ Exposed insulation/membrane at area well

- ㉕ Exterior railing is not code compliant (safety issue also)
- ㉖ Structural issue evident at this location
- ㉗ Door hold open is not code compliant
- ㉘ Door opening not sealed, causing frost issues

- ㉙ Standing water from gutter due to sidewalk not sloping/draining properly
- ㉚ No visual connection from office to main entrance
- ㉛ Rusted/detached lintel

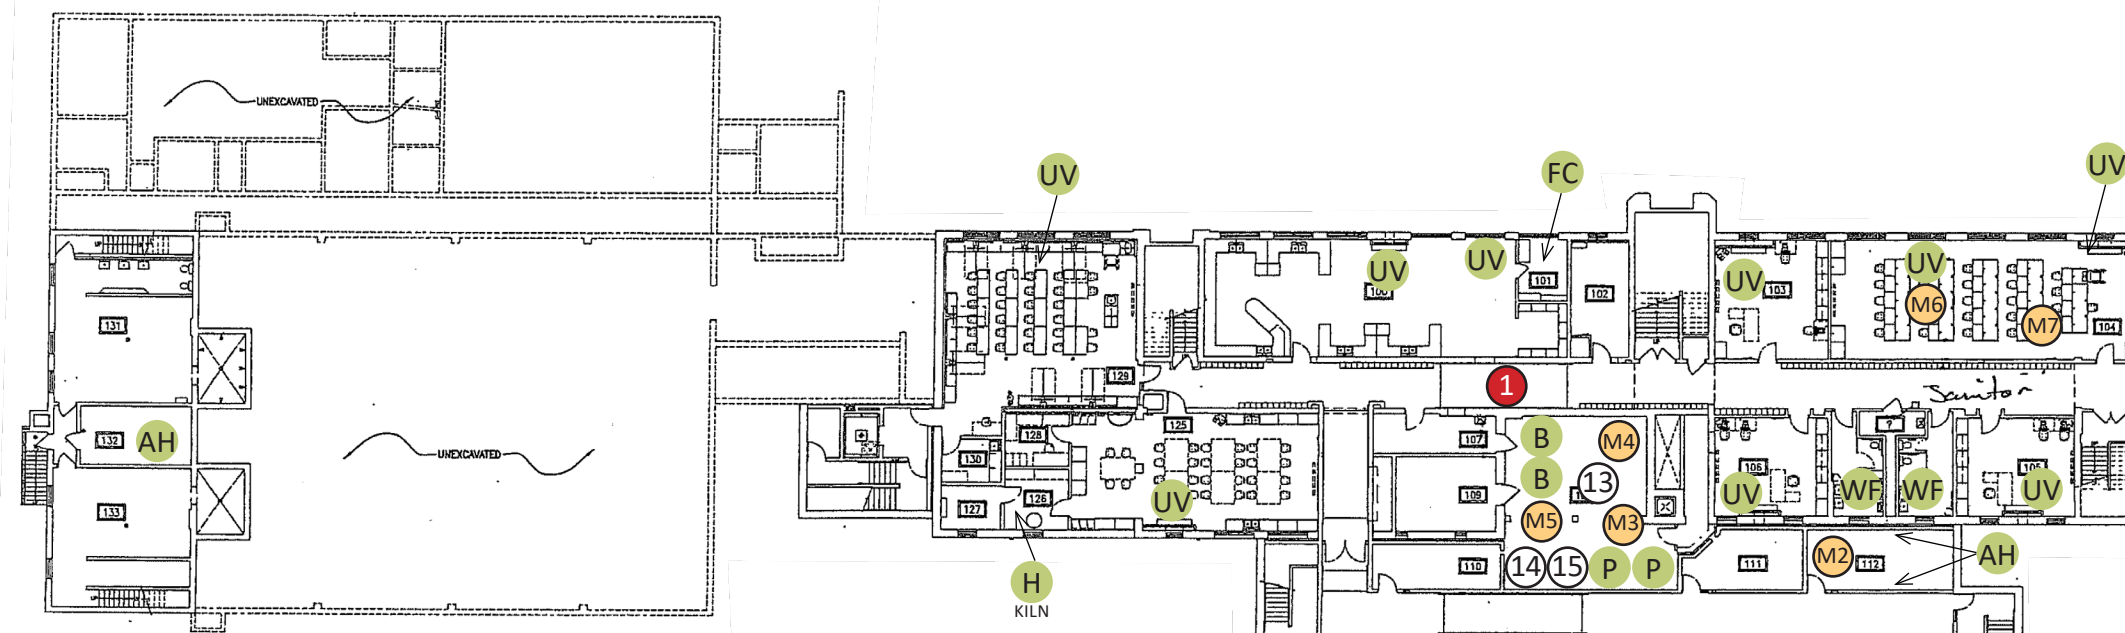
2 No air conditioning

10 Failed damper

14 Pump seal needs replacement

16 Missing pipe insulation

17 Damaged pipe insulation

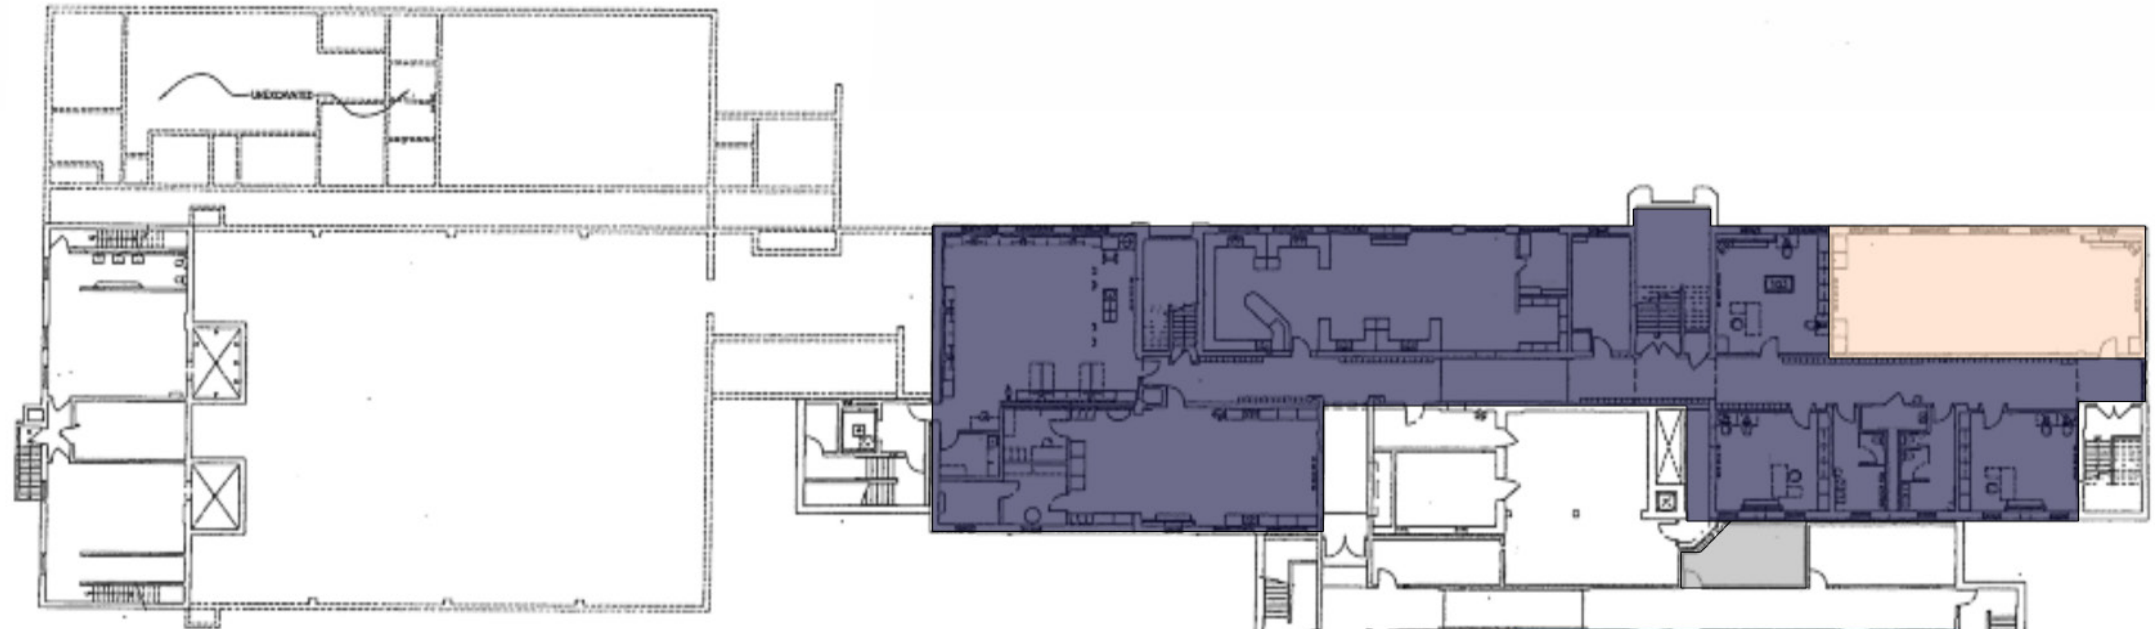
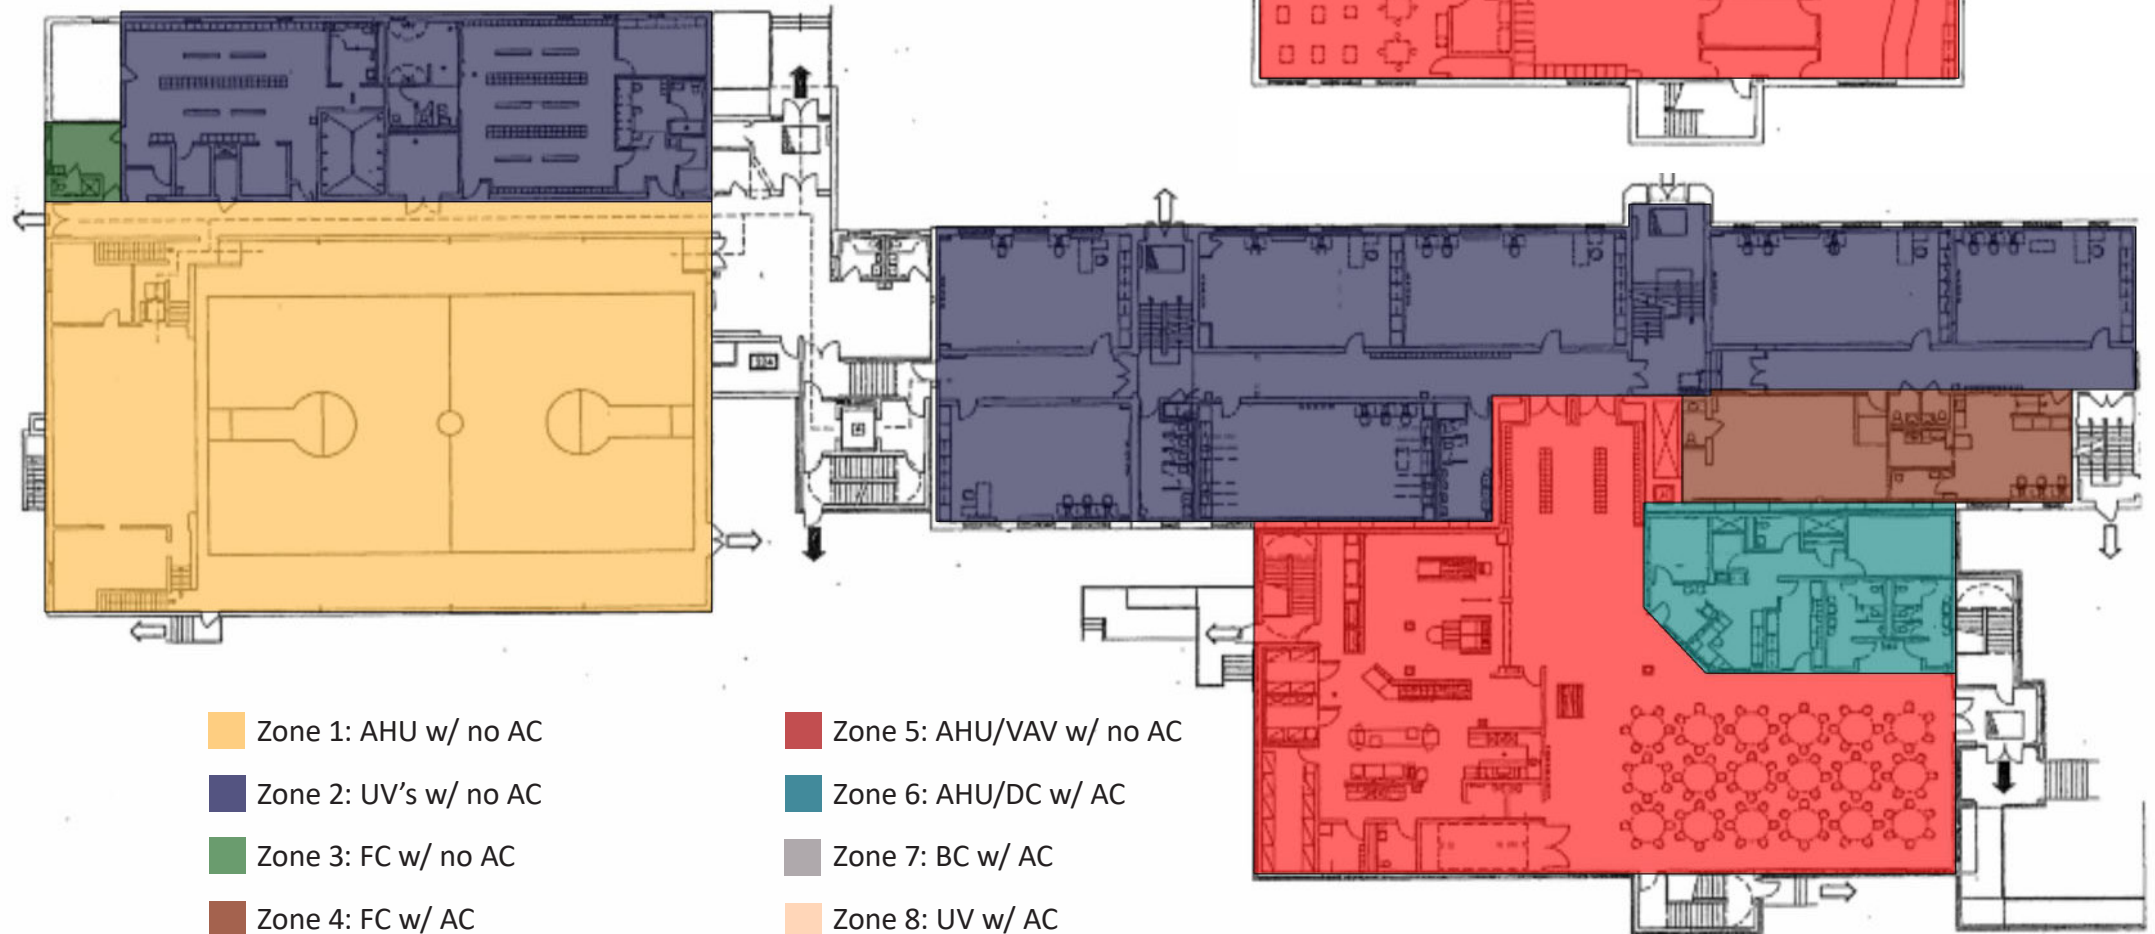
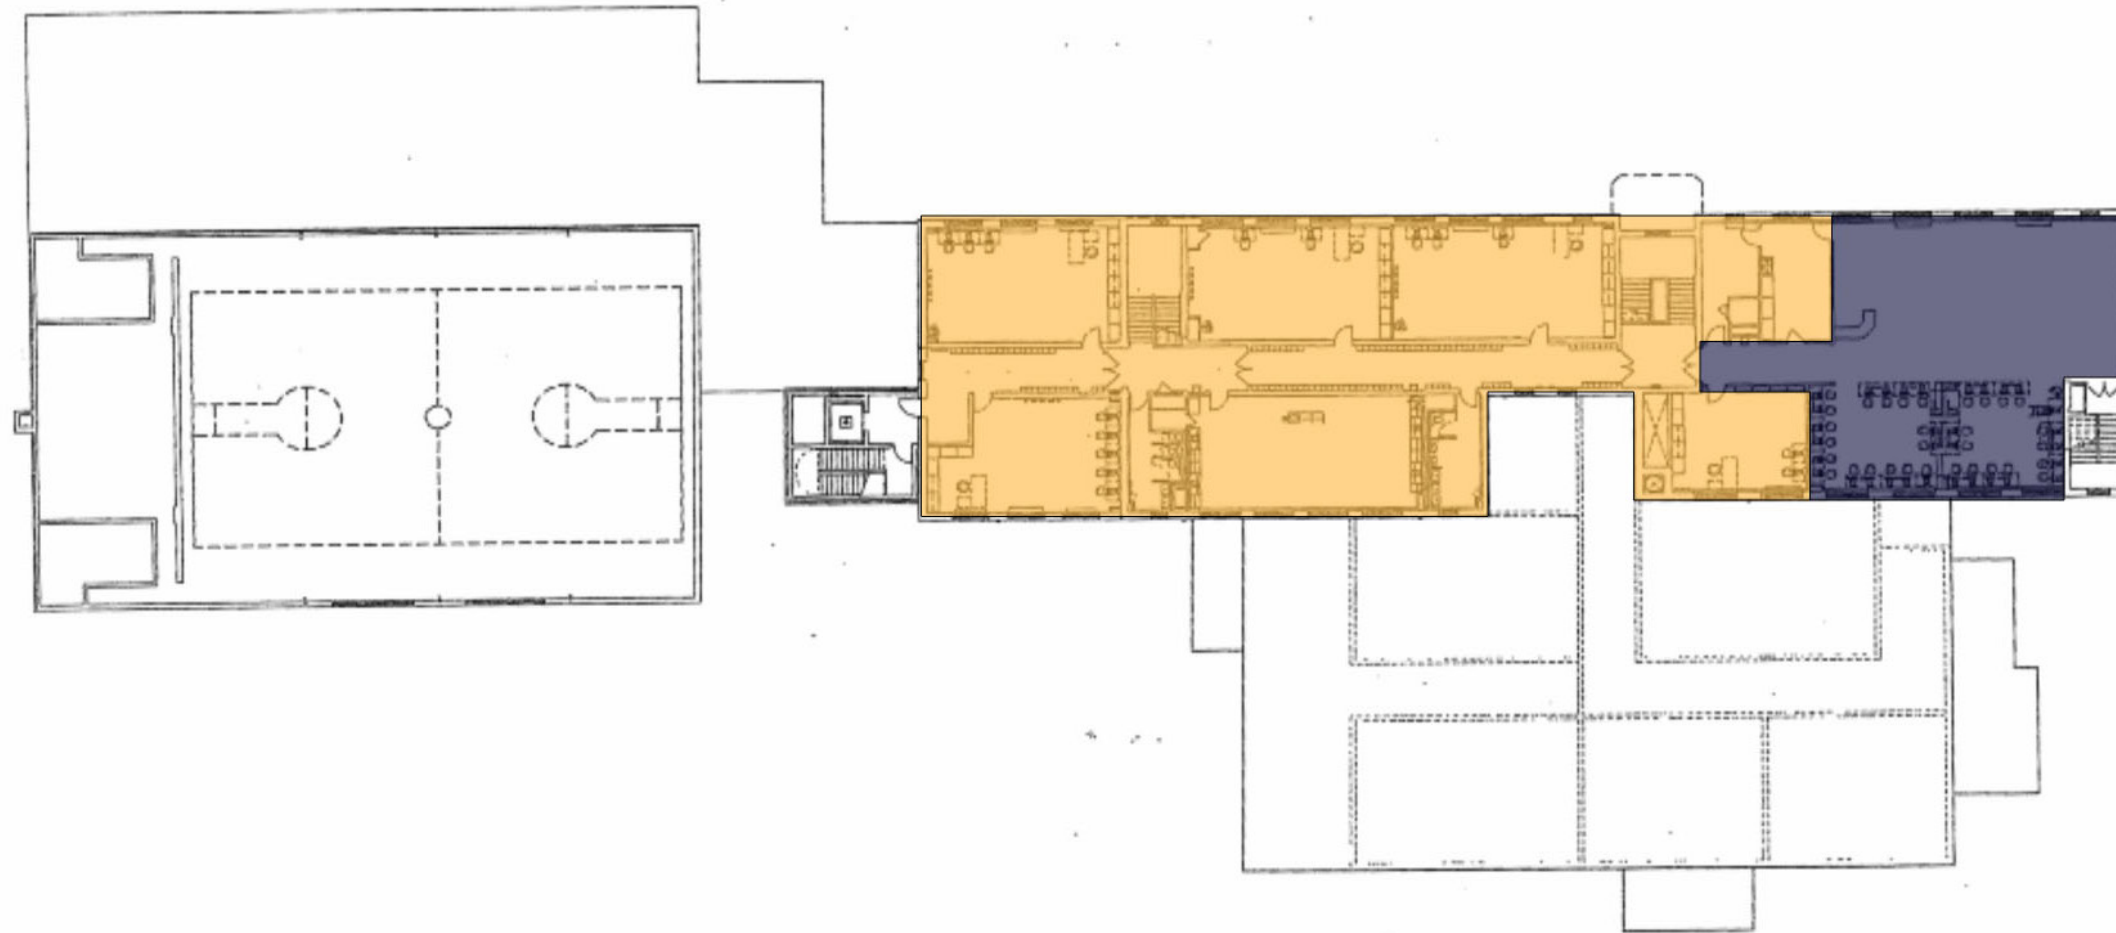
**BOILER SYSTEM:** The facility is served by two gas-fired boilers. The oldest boiler (1999) is a Burnham Model V9 cast iron type standard efficiency boiler (B-1). The boiler and burner have been upgraded in the last 10 years. It appears to be in good working order. The second boiler (B-2) was installed in 2006 and is a DeDietrich cast iron high-efficiency boiler that appears to be in good working order. Combustion air is ducted into the room from the roof, terminating with an open-ended duct near the floor. The boilers are vented together to a masonry chimney. Two Taco base mounted pumps, with variable frequency drives (VFD), are located in this room which distribute heating water throughout the building. One circulating pump currently requires a new seal. The boilers each contain an inline circulating pump that provides the minimum gpm required for the boiler. The pump for B-1 has recently been replaced.

**HVAC SYSTEM:** The building is conditioned by various HVAC systems/ equipment ranging from central air handling units, rooftop air handling units, variable air volume boxes (VAV) with reheat coils, unit ventilators, fan coil units, cabinet unit heaters, wall fin, and convectors. One rooftop air handling unit serves a majority of the 2005 addition (commons, kitchen, music). Supply air distribution for this area of the building is ducted through the ceiling space to ceiling diffusers. Air is relieved from this portion of the building to ceiling grilles ducted to a roof hood. This unit does not have cooling. The other rooftop air handling unit is a 100% outside air unit that provides tempered (heated and cooled) outside air to the 3-story portion of the building. The outside air is ducted to each room and discharged through a ceiling diffuser. Two air handling units are located in the lower level with one serving the tech. ed. classroom and the data room, and one serving the 1st floor office area. Each of these units contains a hot water heating coil and a DX cooling coil (condensing units located on the roof). Supply air distribution for each unit is ducted through the ceiling space to ceiling diffusers. The gym is served by an air handling unit located below the stage area. This unit has a hot water coil for heating, and no air conditioning. Supply and return air are located on the stage end of the gym. Gym relief is through a sidewall louver and damper. This is currently disconnected. The main office area is served by an air handling unit that contains a hot water heating coil and a DX cooling coil (condensing unit located on the roof). Supply air distribution is through ceiling diffusers. Individual space conditioning is provided by VAV/reheats. Rooms 205 and 206 are served by a fan coil unit with a DX cooling coil (condensing unit located on the roof). Supply air distribution is through ceiling diffusers. The remainder of the classrooms and locker rooms are served by unit ventilators with hot water heating coils. A majority of the unit ventilators are vertical type located on the exterior wall. There are some horizontal unit ventilators located at the ceiling that are ducted to ceiling diffusers. DX cooling is provided for the unit ventilators in the library (condensing units located on the roof) and Room 104 (condensing units located at grade). All condensing units use R-22 refrigerant which is being phased out and is no longer available for

new construction. Most of the insulation on the refrigerant piping is old, failing, and in need of replacement. Maintenance staff indicated that room 310 often has control issues that cause over heating in the space. Rooms 229 and 303 are each served by a fan coil unit with a hot water heating coil. Toilet rooms are exhausted through ceiling grilles. Make-up air for the toilet exhaust is transferred out of each classroom through overhead ducted ceiling transfer grilles. The Kitchen contains a Type 1 hood with fire suppression. The shop area wood working exhaust is provided by a grade mounted re-circulation type dust collector. This unit appears newer and in good working order. Maintenance staff indicated that this unit is lightly used. The art room contains a kiln hood that is exhausted to the outside. Vestibules and stairs are typically heated by hot water cabinet unit heaters. Many of the classrooms that are heated and ventilated by unit ventilators also contain hot water convectors for heating. Convectors and wall fin are also used in some toilet rooms and other small areas. Residential style electric baseboard has been installed to heat the elevator equipment room. This room is also exhausted by a through wall fan with make-up air provided from an exterior louver and damper. The damper is currently failed in the open position allowing outside air into the room. It is recommended that the damper should be fixed and a permanent commercial form of heating be installed. There is no exhaust provided for the residential stove located in the room 205 area.

**CONTROLS:** The building utilizes DDC controls installed in 2006. Maintenance staff indicated that upgrades in the system are needed.
