THE SCHOOL DISTRICT OF  
**PRESCOTT**  
Prescott, Wisconsin

# Facilities Study

SDS PROJECT NO.: 1913  
SUMMER 2019

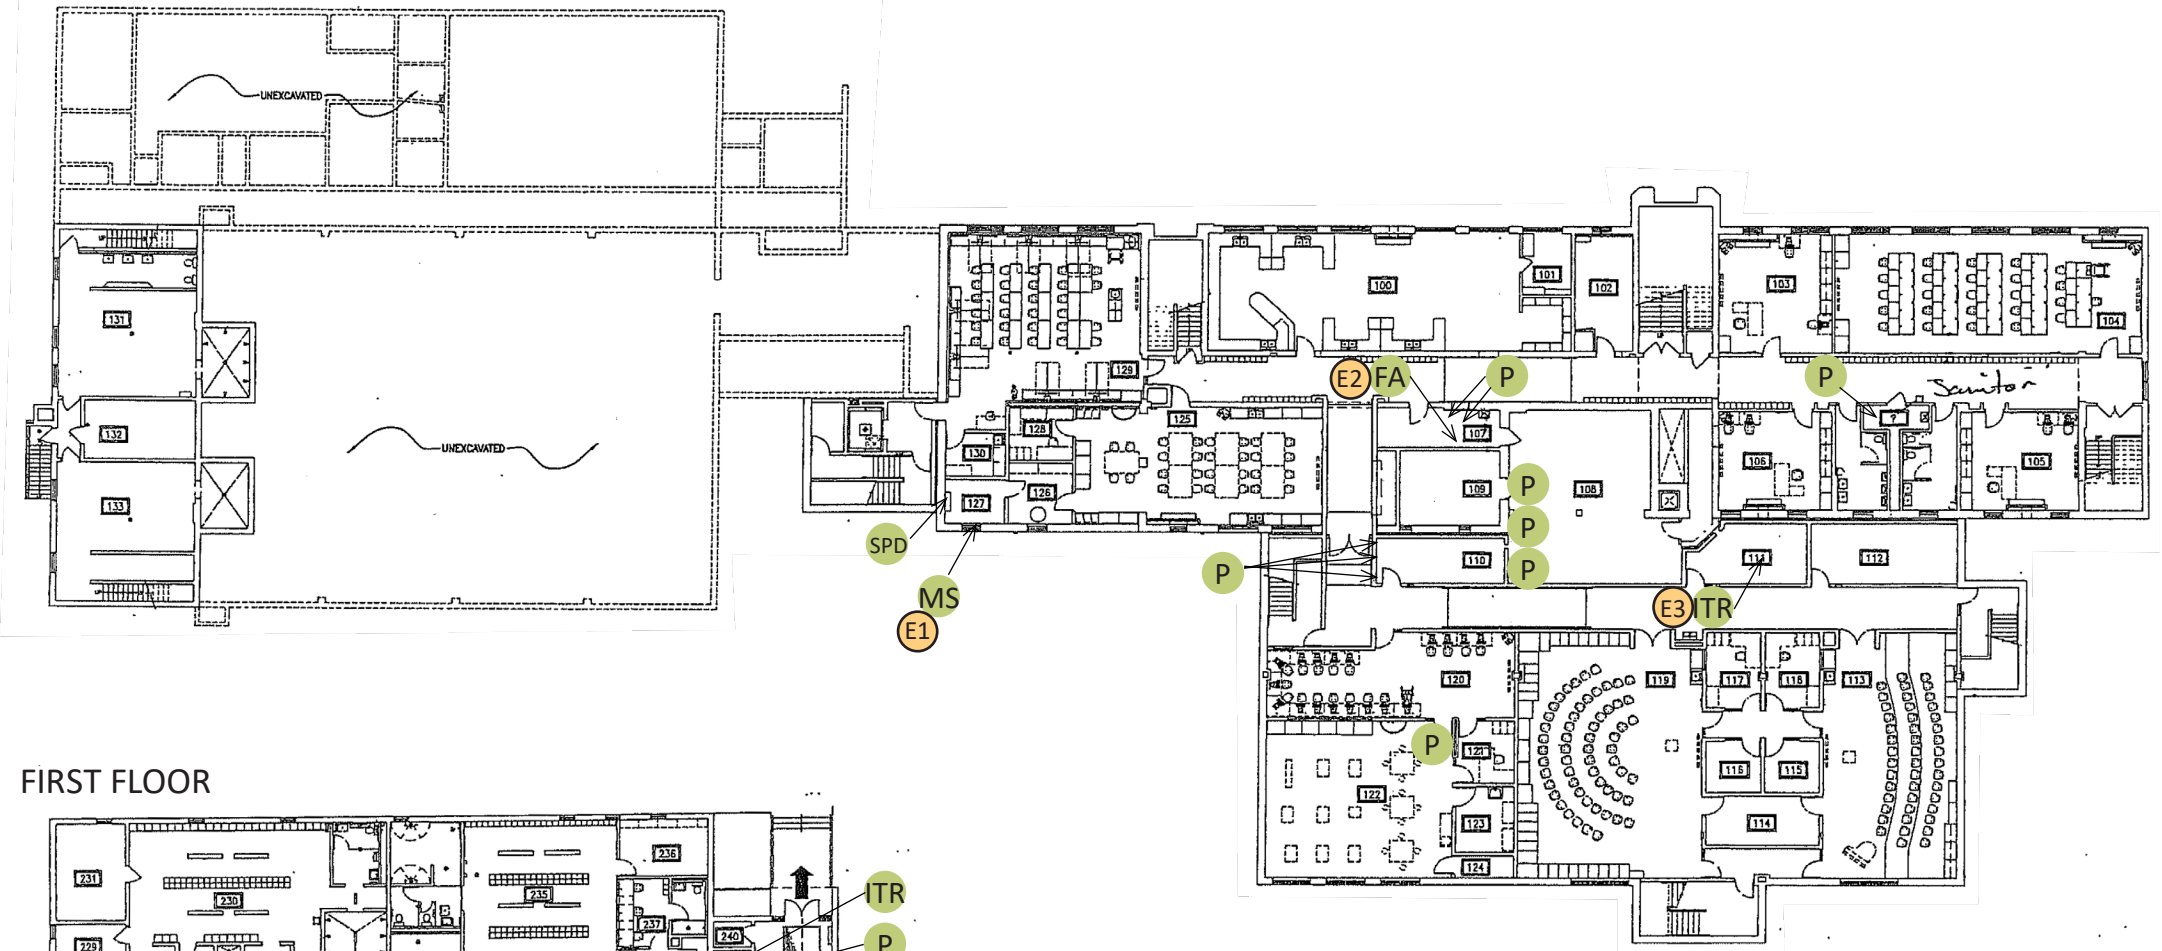
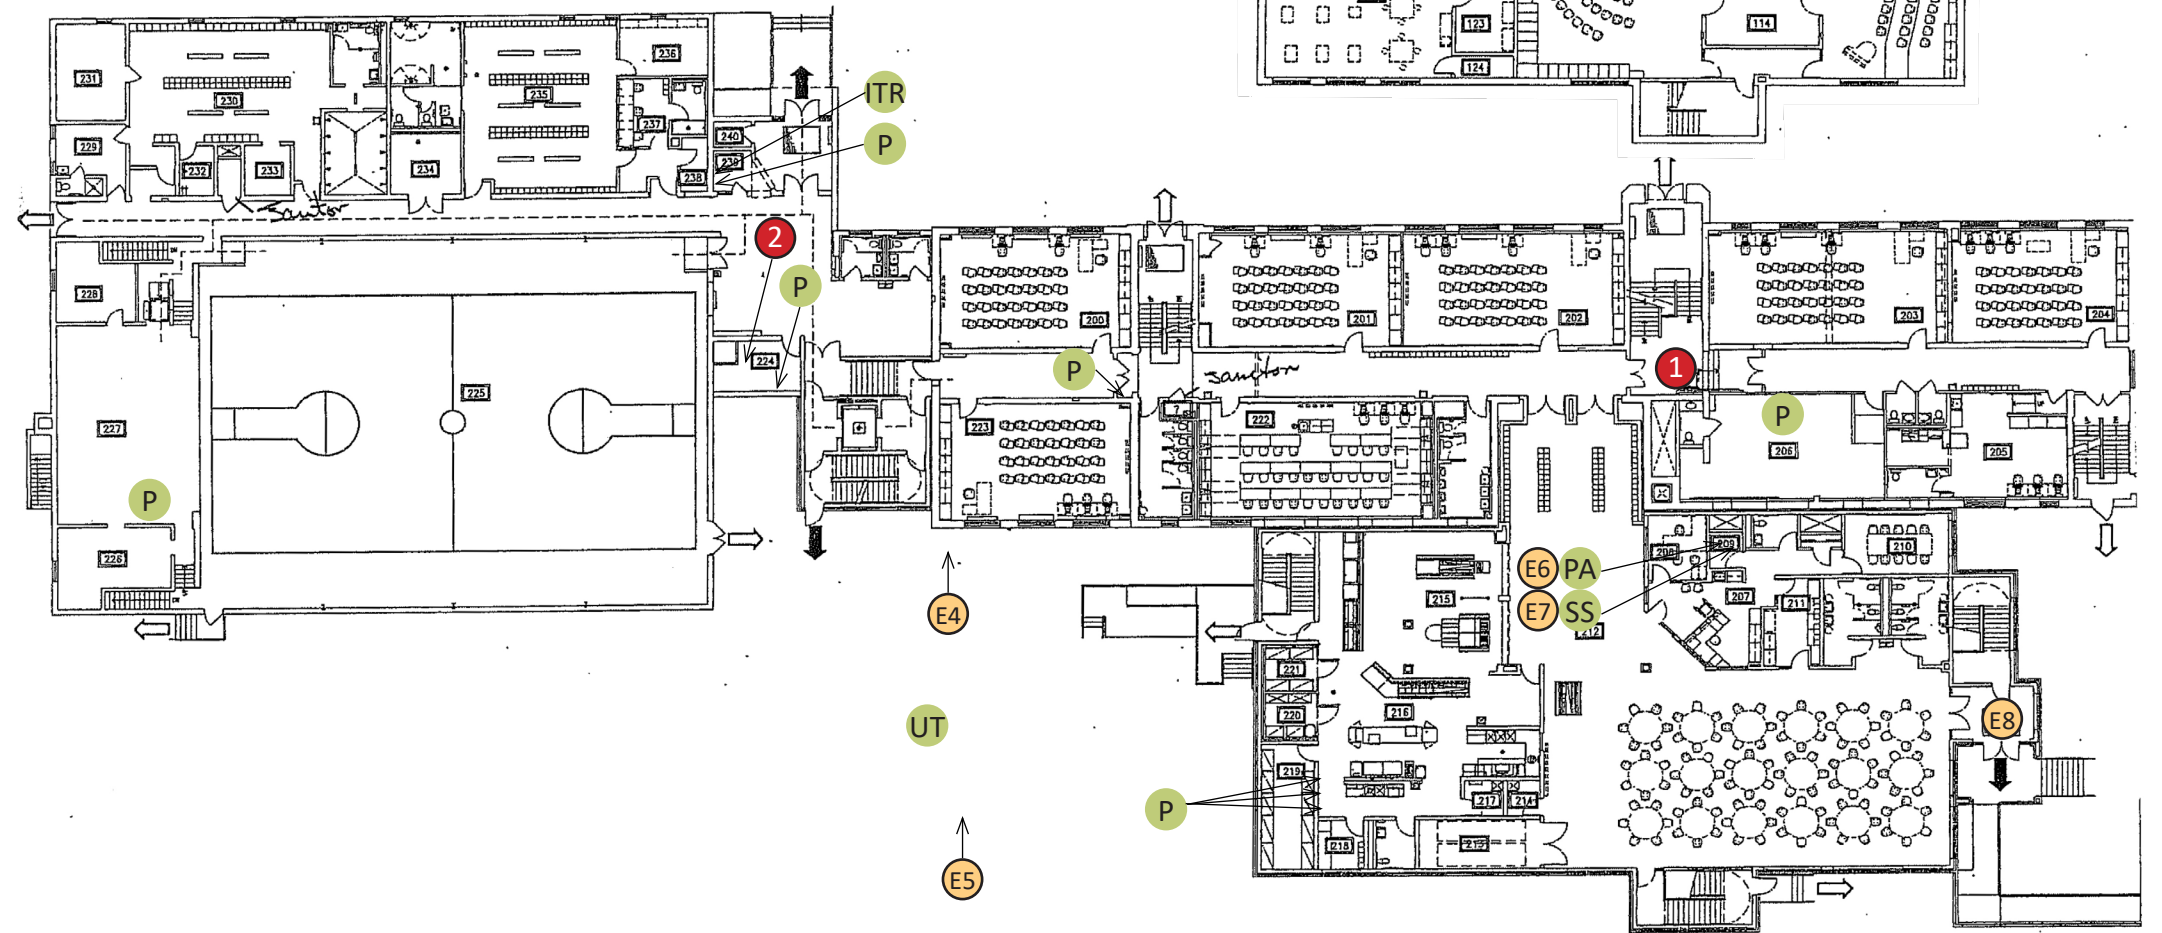
**POWER DISTRIBUTION:** Panelboards are located throughout the building and serve various loads. The majority have been replaced and are of newer vintage. There are a select few that are beyond their life expectancy. Adequate power is provided to the classrooms and supporting spaces.

**LIGHTING AND LIGHTING CONTROLS:** Lighting is original fluorescent troffers with T-8 lamps throughout. Exit signs are newer LED. Emergency egress lighting fixtures are of a newer vintage. Linear fluorescent pendants found in the newest portion of the building are difficult to maintain based on conversations with maintenance personnel. Exterior lighting is on the process of being upgraded to LED. Automatic lighting control via occupancy sensors are the norm throughout the building. Exterior lighting is controlled through a timeclock.

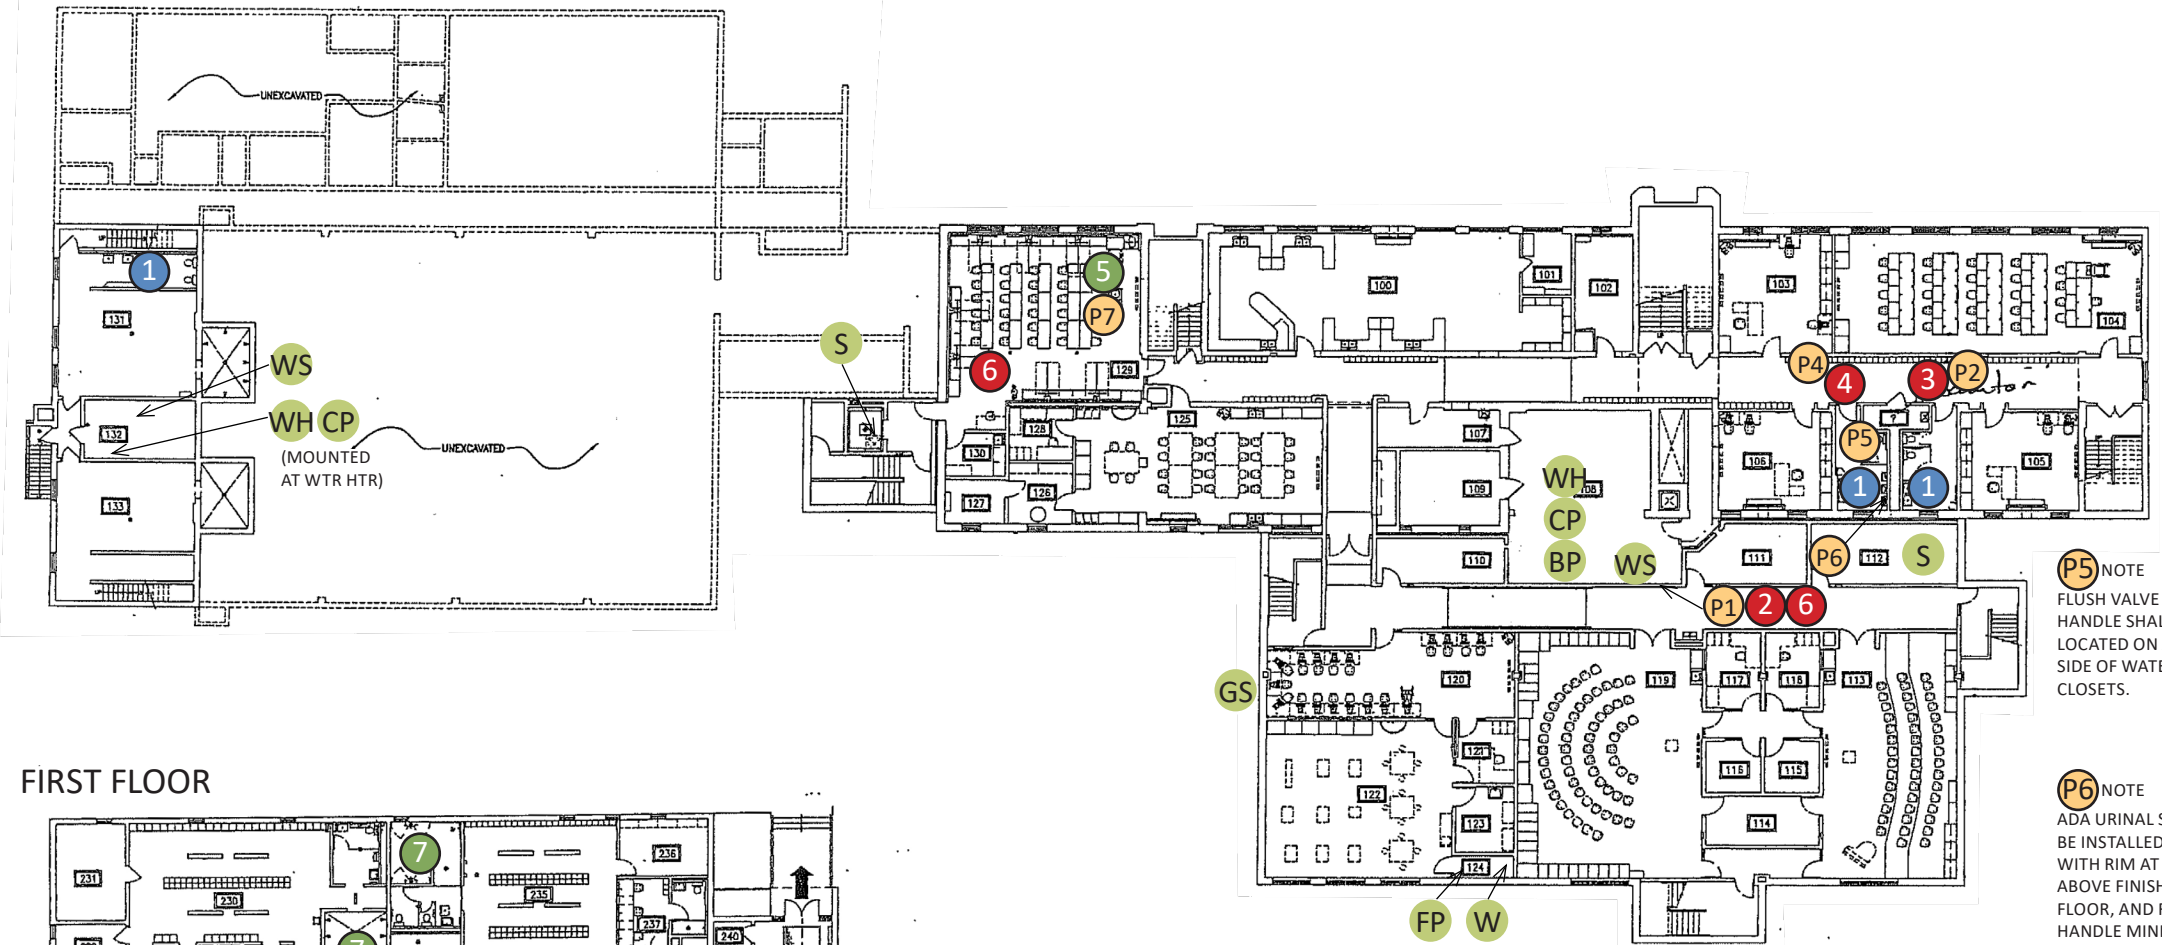
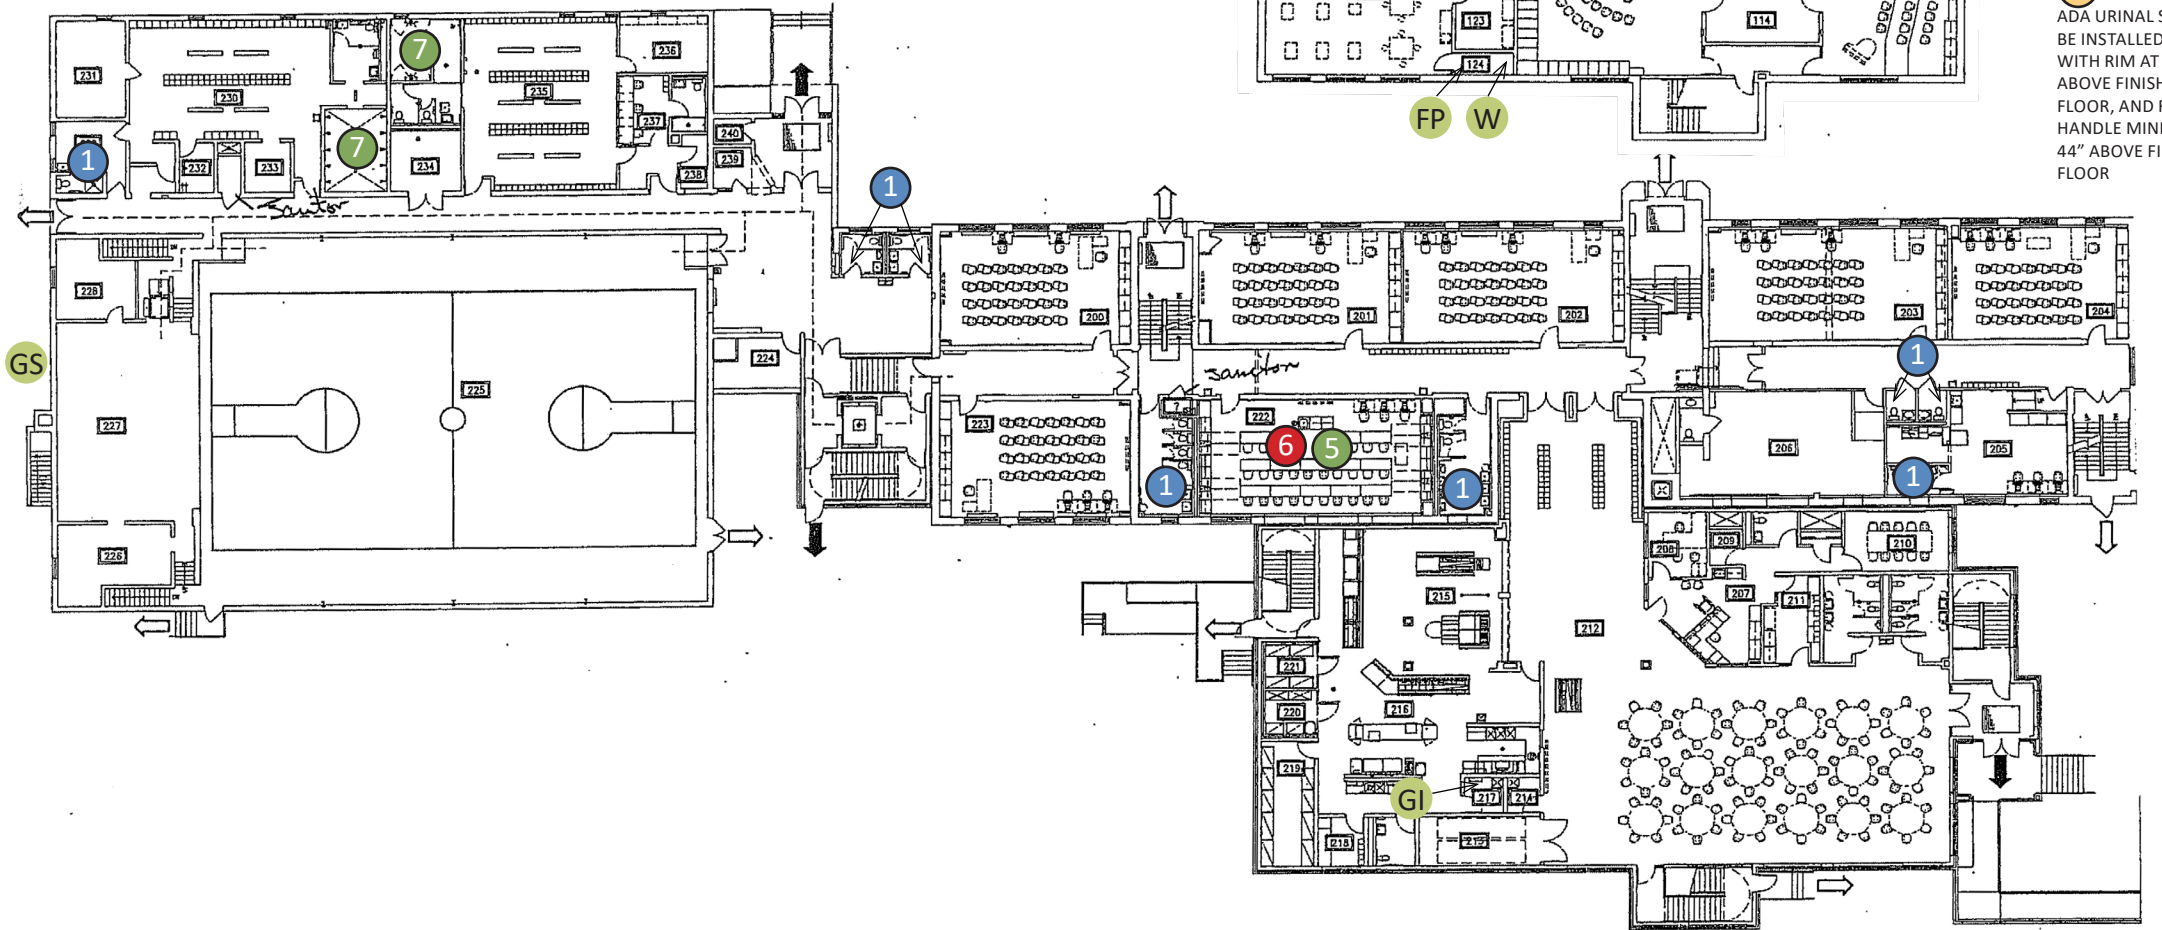
**STORM SEWER:** The 2005 addition roof system collects rain water via roof drains and connected to the rain leader system and discharges on to grade on the Southwest side of the building towards the retention pond. The remaining roofs discharge thru rain gutter systems to grade. Elevator sump pump discharges to grade. The 2005 addition has foundation drainage to sump pump system.

**SANITARY:** All building sanitary is gravity drained with no lift stations or grinder pumps. Piping consist of Cast Iron and galvanized materials with PVC for areas that have been remodel or repaired. The 2005 addition is mainly PVC piping. The Cast Iron and galvanized piping that is visible appears to be in fair condition. The science rooms piping is PVC piping with no acid neutralizer.

**POTABLE WATER DISTRIBUTION:** Potable water is distributed throughout the building via a copper and galvanized distribution on piping located above grade. Piping condition on appears to be in fair condition. Asbestos insulation is likely in the older section of the building and in concealed locations that were not accessed during any remodel or repaired areas.
